SATELLITE ASSESSMENT OVER CORAIL, BARADÈRES & LES CAYES, HAITI AFTER HURRICANE SANDY

Analysis based on SPOT-5 satellite data acquired on 03 November 2012

Situation Update 2: Tropical Storm Sandy over Haiti. Corail, Baradères, and Les Cayes

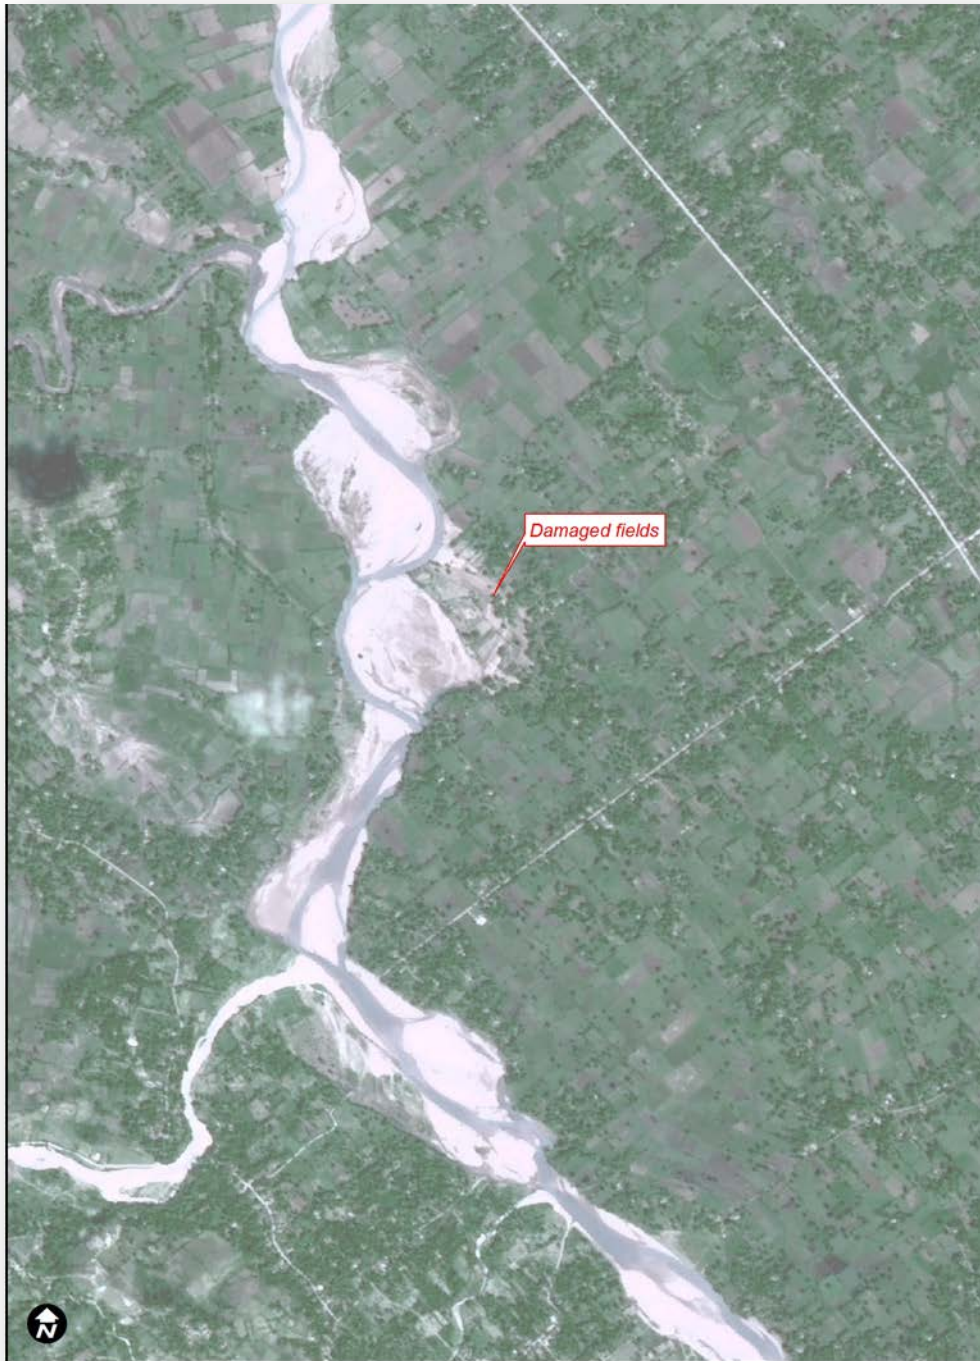
Site 1: A very swollen river and possible damage to agricultural land caused by flash flooding. The light coloured sections of the river are water containing high levels of sediment.

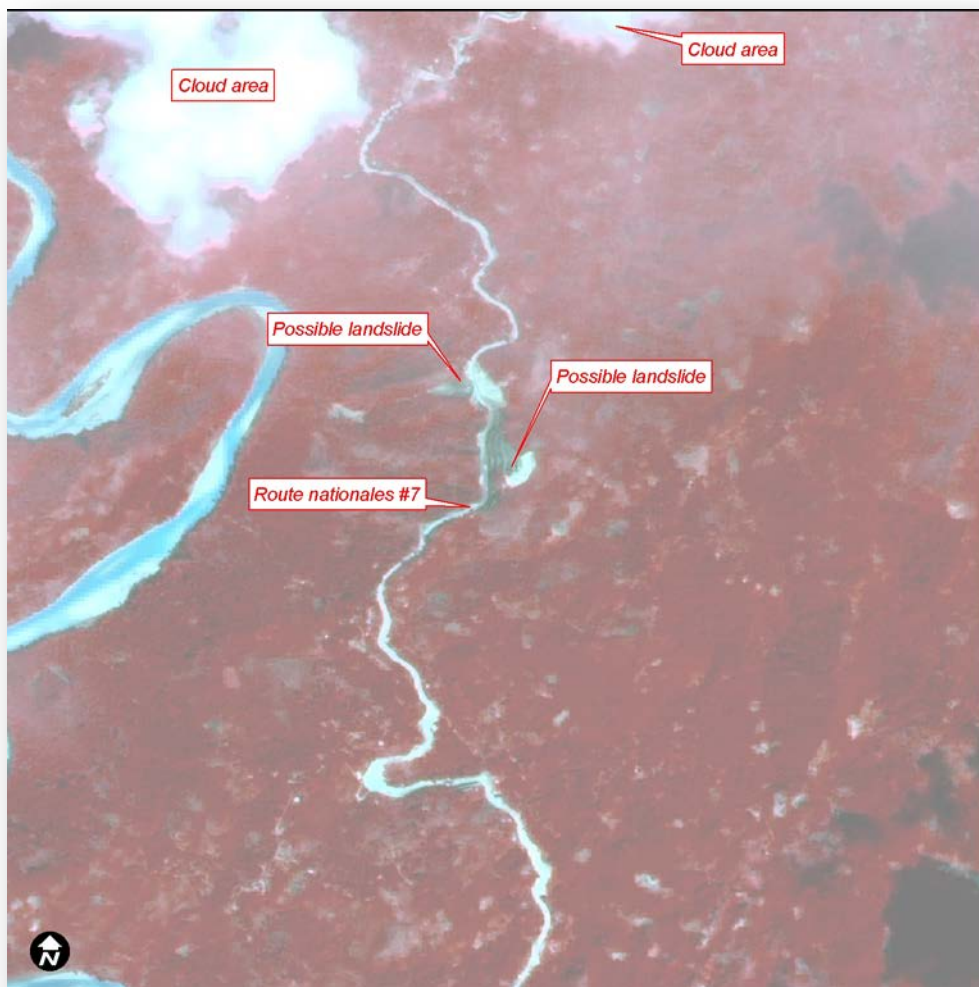
Site 2: A possible landslide along the Route Nationales #7. Red indicates vegetation, the light blue area is a river and the off-white stripe running down the middle of the image is Route Nationales #7.

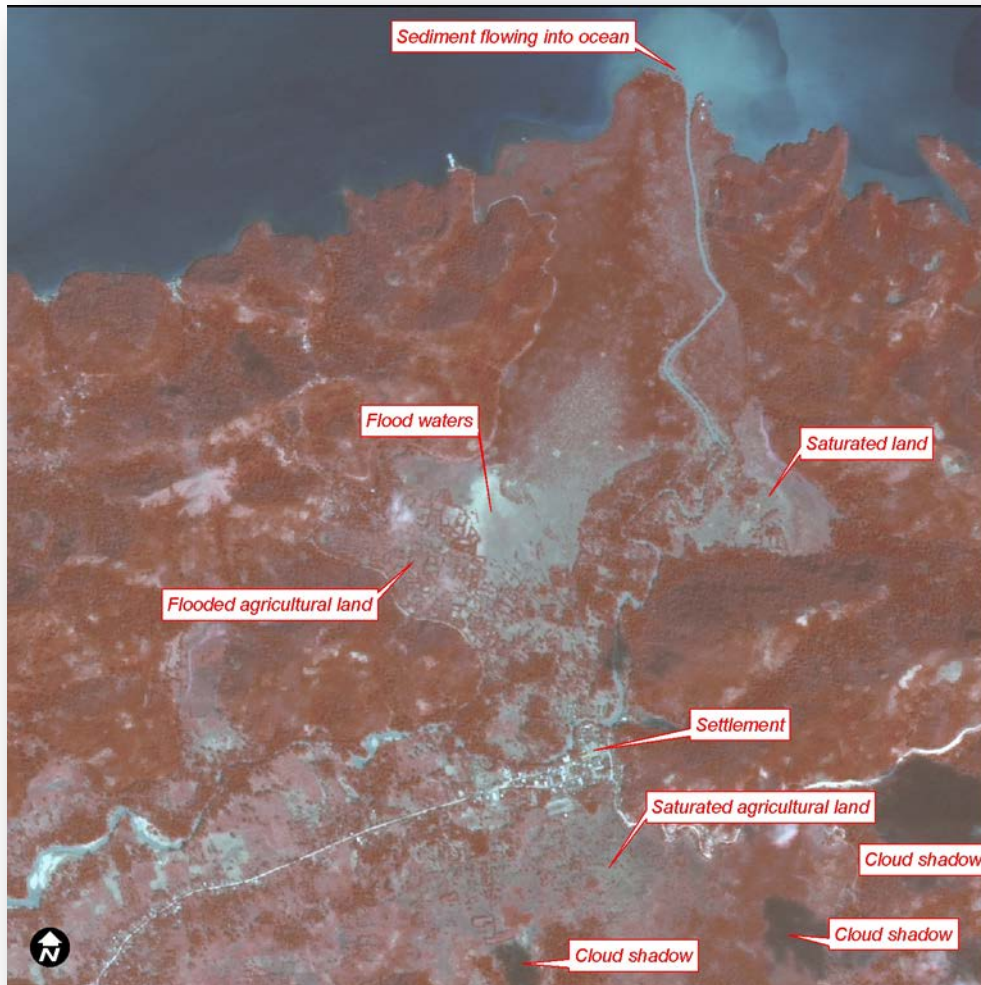
Site 3: Flood affected land around Baraderes. Red indicates vegetation, blue indicates water, light blue indicates sediment filled water, and off-white indicates bare soil. The settlement appears to have saturated soil around it.

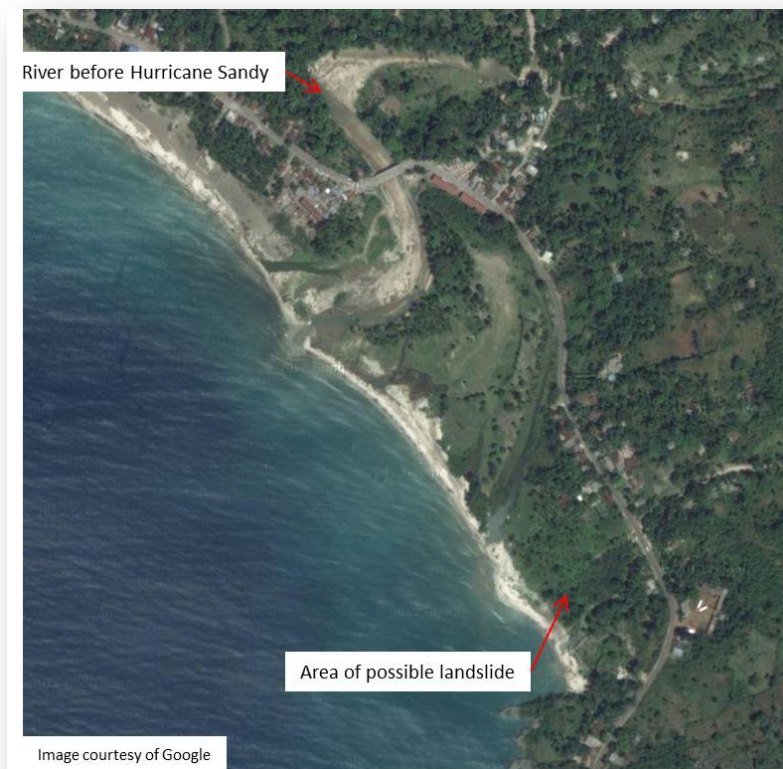
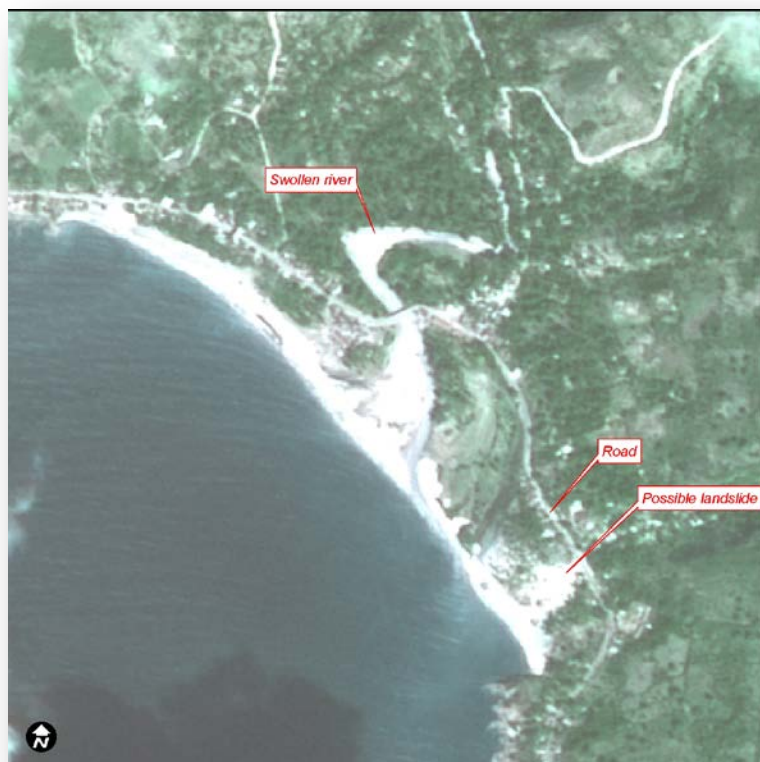
Site 4: Possible landslide along the coast.

Google Earth - 16 August 2011

Spot-5 – 03 November 2012

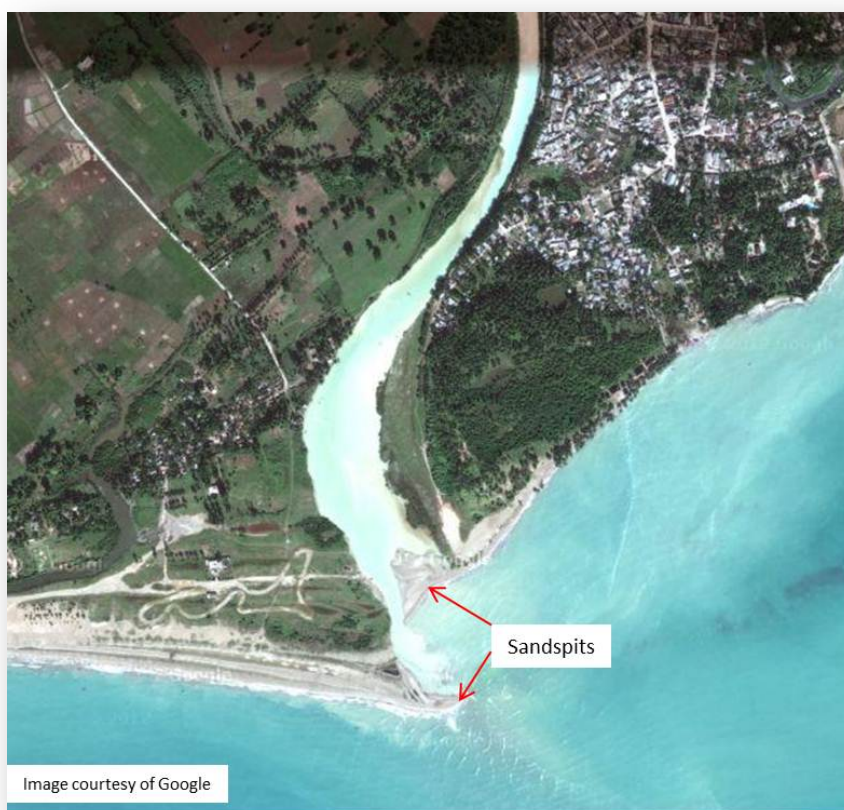
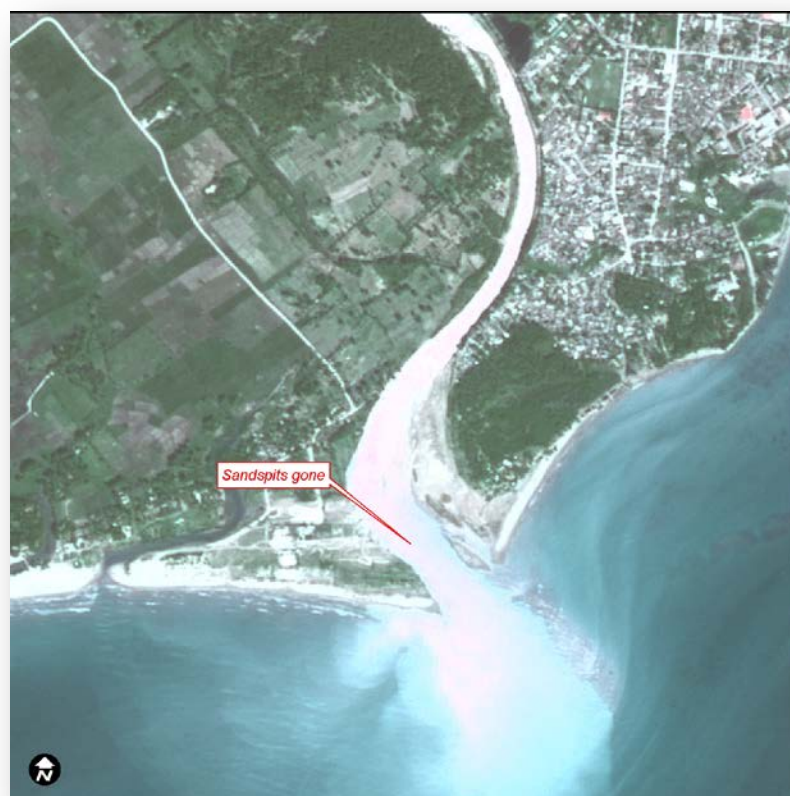
Site 5: Sandspits destroyed at the mouth of the Riviere la Ravine du Sud

Google Earth – 27 June 2009

Spot-5 - 03 November 2012

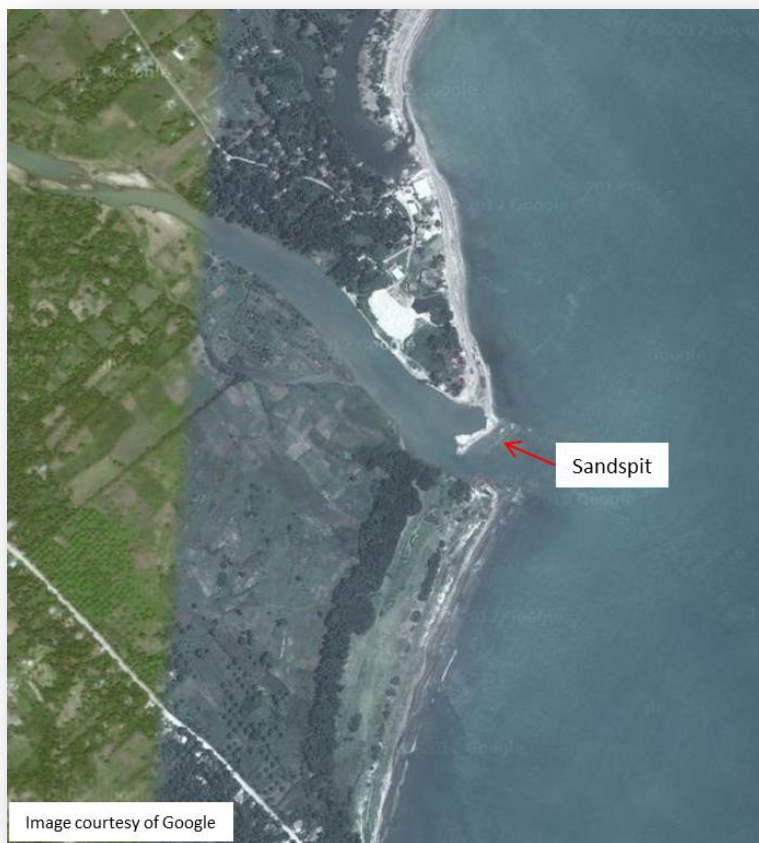
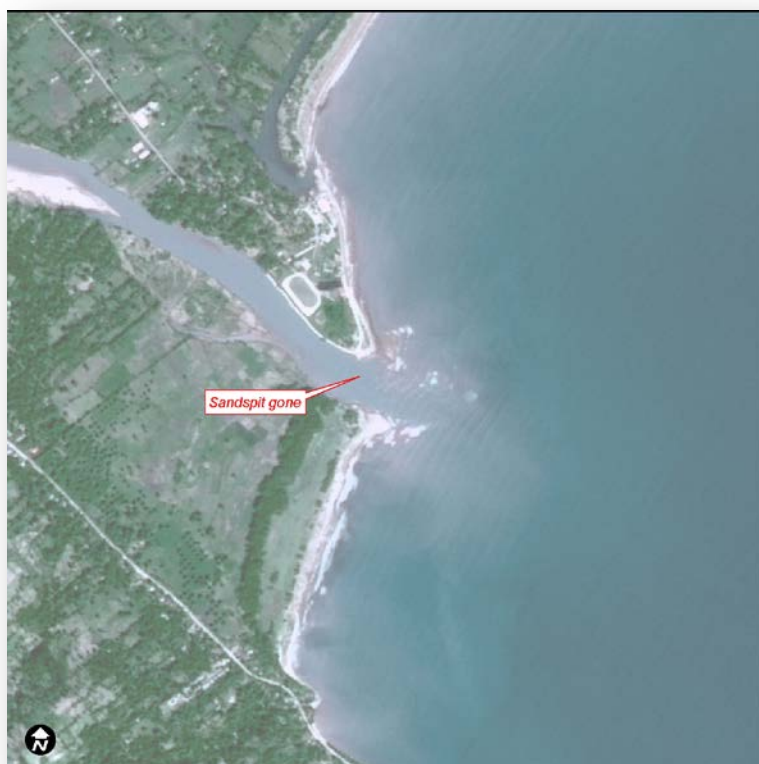
Site 6: Sandspits destroyed at the mouth of the Acul River

Google Earth – 12 September 2011

Spot-5 - 03 November 2012
