## Damage assessment of the Cultural Heritages Sites in Tongatapu Island, Tonga – Tropical Cyclone GITA-18

23 February 2018

UNITAR – UNOSAT, following the request of UNESCO Office for the Pacific States, has performed a satellite based analysis of the cultural heritages sites of :

The aim is to search for signs of damage, after the passage of the Tropical cyclone GITA-18 that struck Tongatapu Island, Tonga on the 12 February 2018.

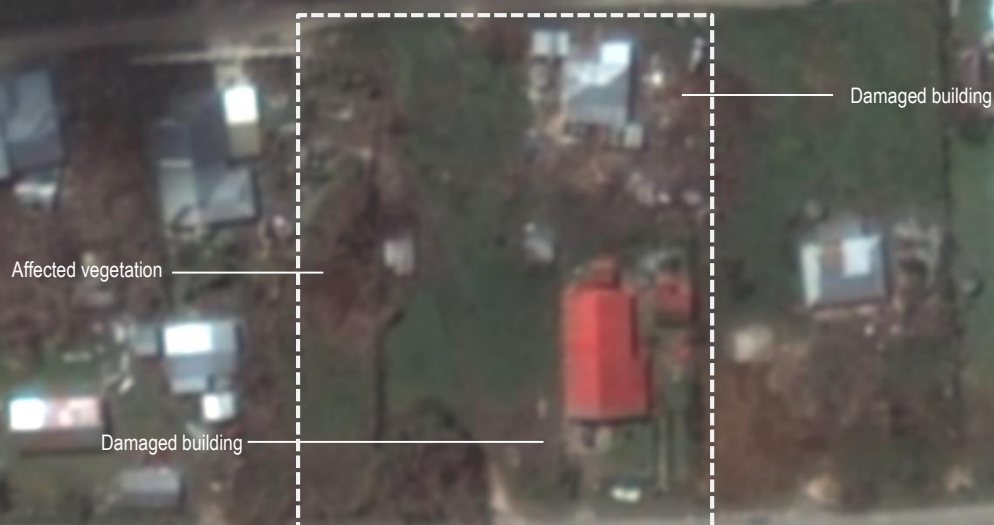
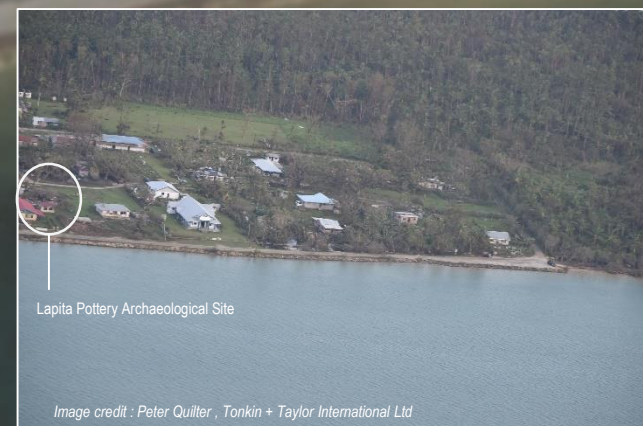
## Lapita Pottery Archaeological Site Visible damaged buildings

Image collected on 16 February 2018 shows the presence of damaged buildings and structures within the Lapita Pottery Archaeological Site. Also affected vegetation, fallen trees and debris are observed in the surrounding area. The damage of the Lapita Pottery Archaeological Site might be underestimated due to the characteristics (resolution, angle, cloud cover percentage...) of the satellite image. Field assessments are needed to validate the analysis and determine whether other damage not observed in the satellite image is present.

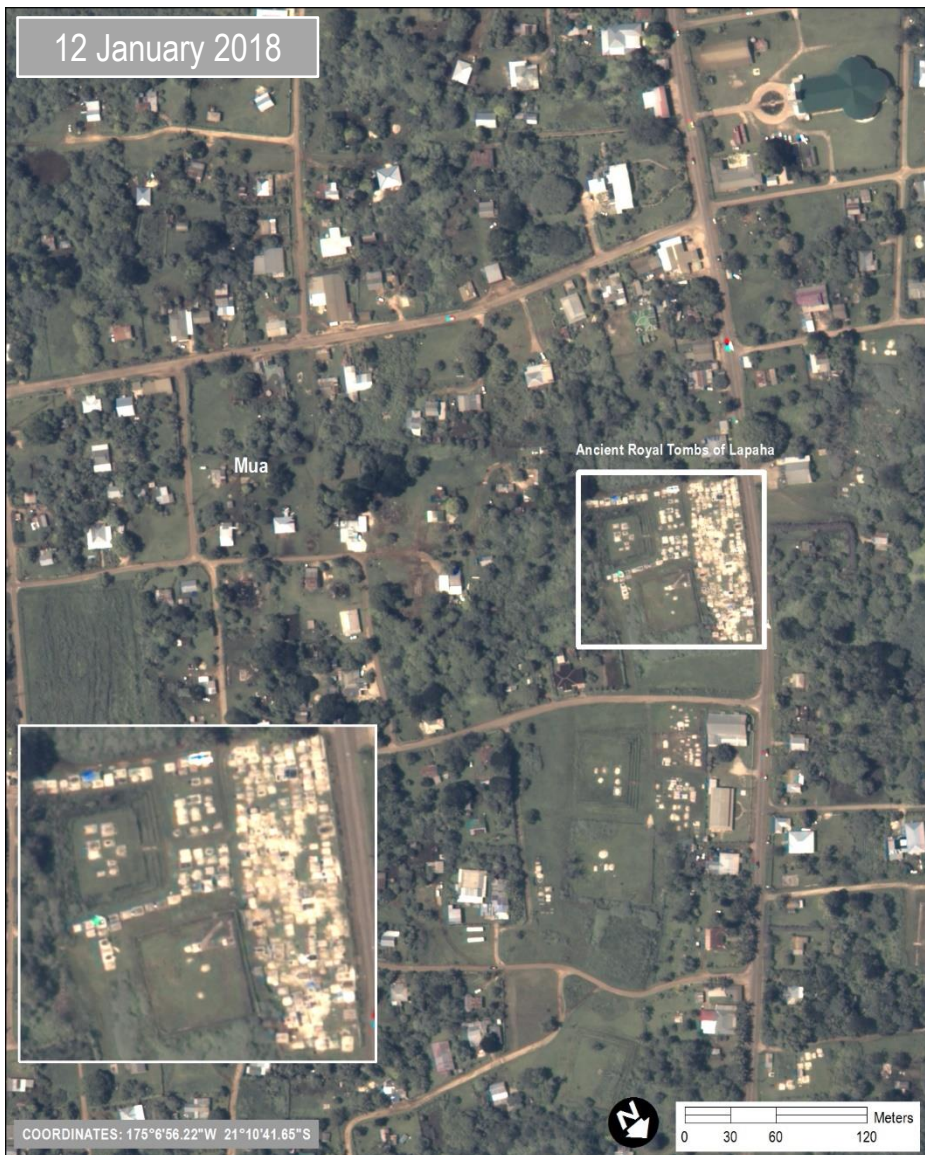
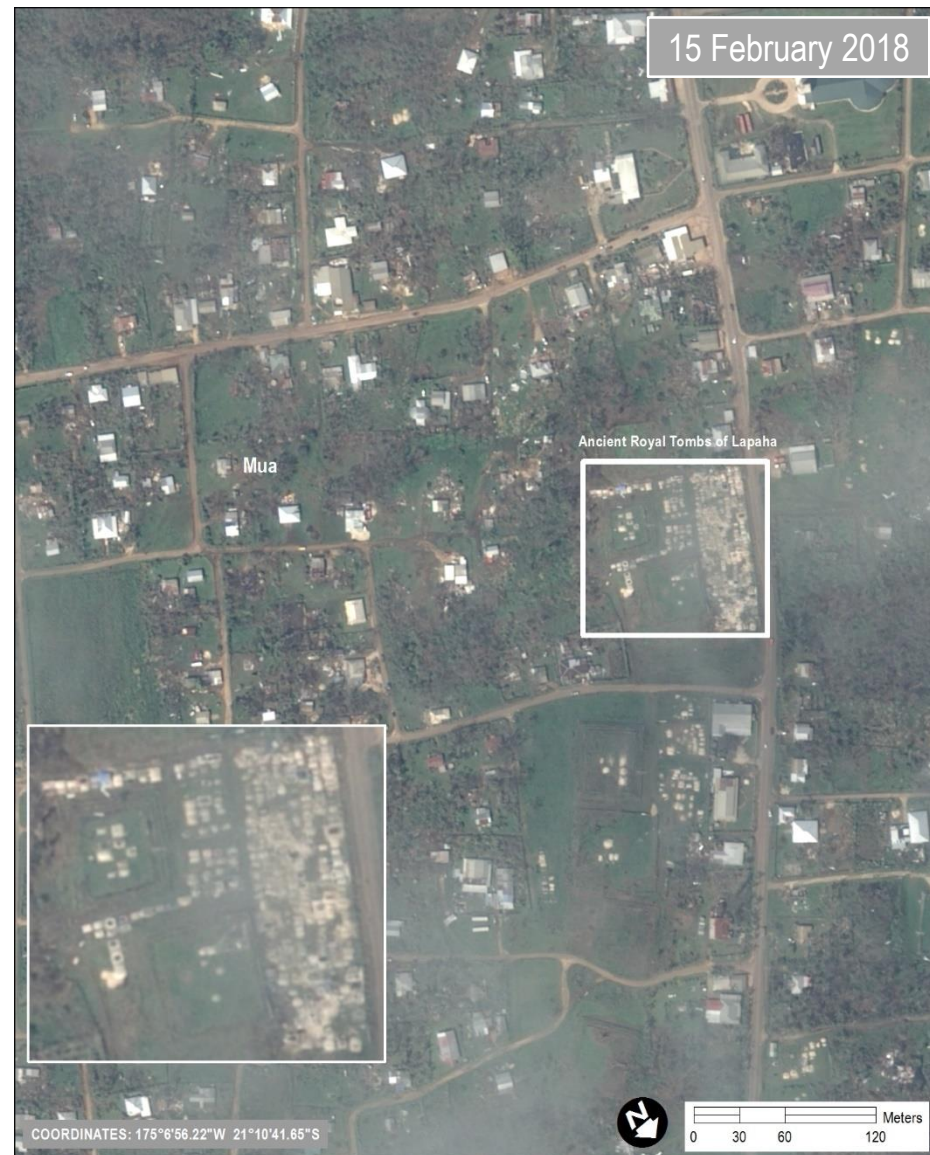
Ancient Royal Tombs of Lapaha  
Potential visible damage

Damaged buildings

Affected vegetation

Image collected on 15 February 2018 shows the presence of potentially damaged tombs inside the Ancient Royal Tombs site of Lapaha in the town of Mua. Also affected vegetation, fallen trees and damaged buildings are observed in the surrounding area. The damage of Ancient Royal Tombs of Lapaha might be underestimated due to the characteristics (resolution, angle, cloud cover percentage...) of the satellite image. Field assessments are needed to validate the analysis and determine whether other damage not observed in the satellite images is present.
