# TROPICAL CYCLONE DOVI, PRELIMINARY SATELLITE- DERIVED DAMAGE ASSESSMENT,

Dillon's Bay, Erromango Island, Tafea province, Vanuatu

Status: Landslides, affected structures and damaged roads observed

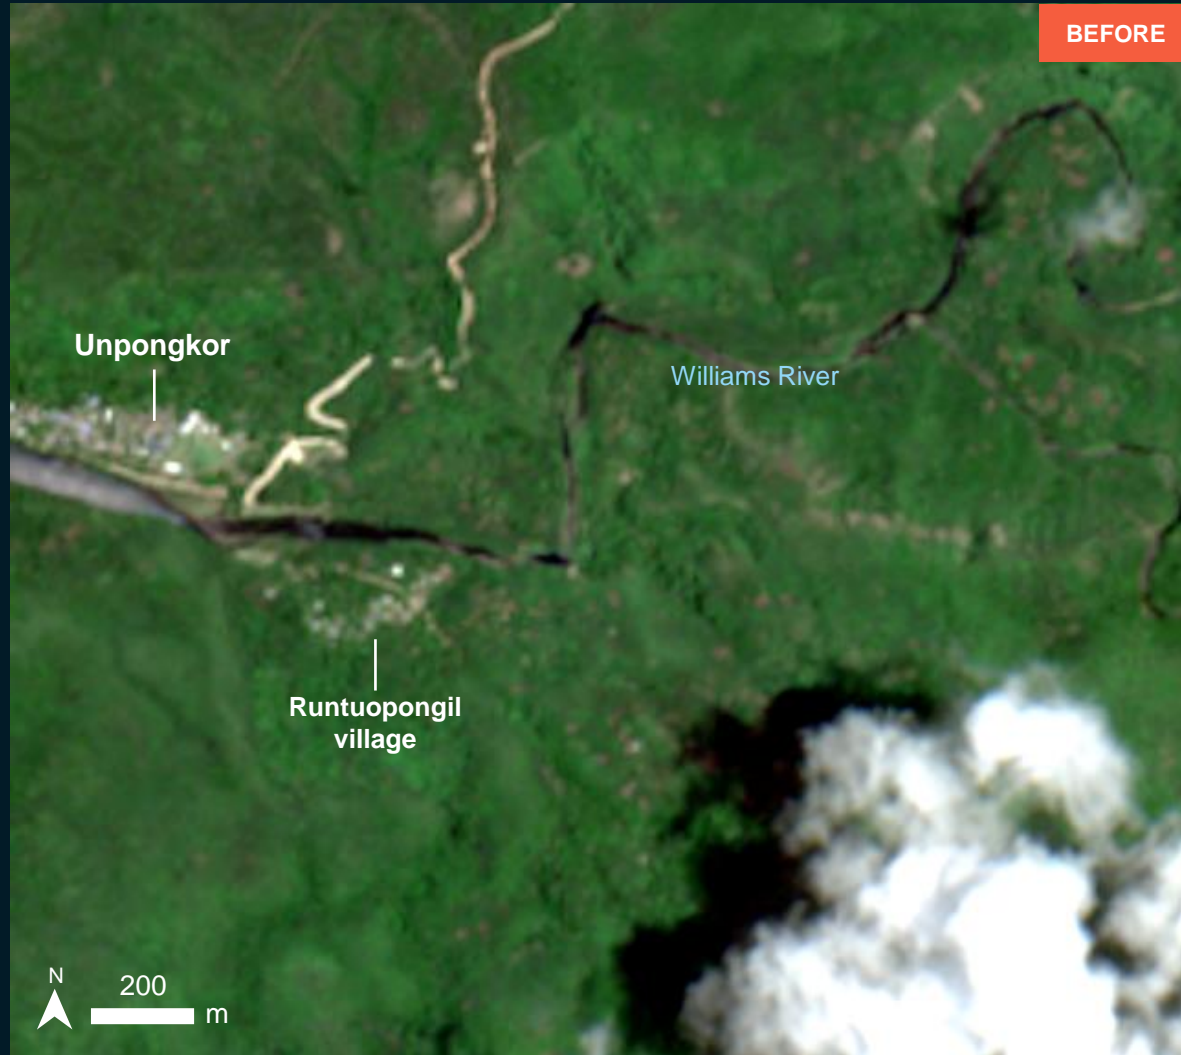
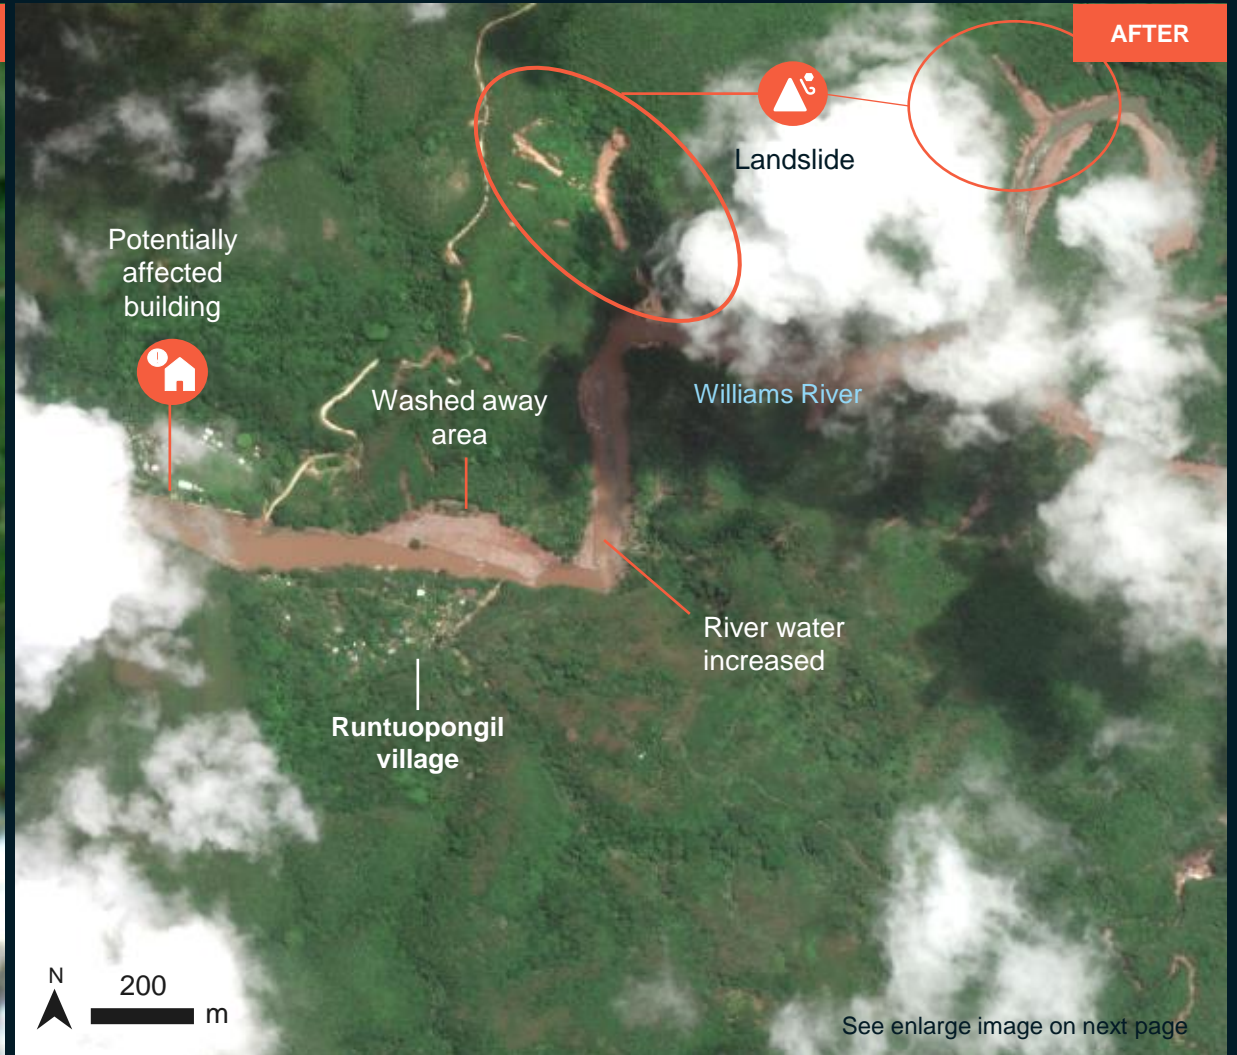
# AOI 1- RUNTUOPONGIL VILLAGE, NORTH ERROMANGO COUNCIL, TAFEA PROVINCE

Landslides and damages along the river observed

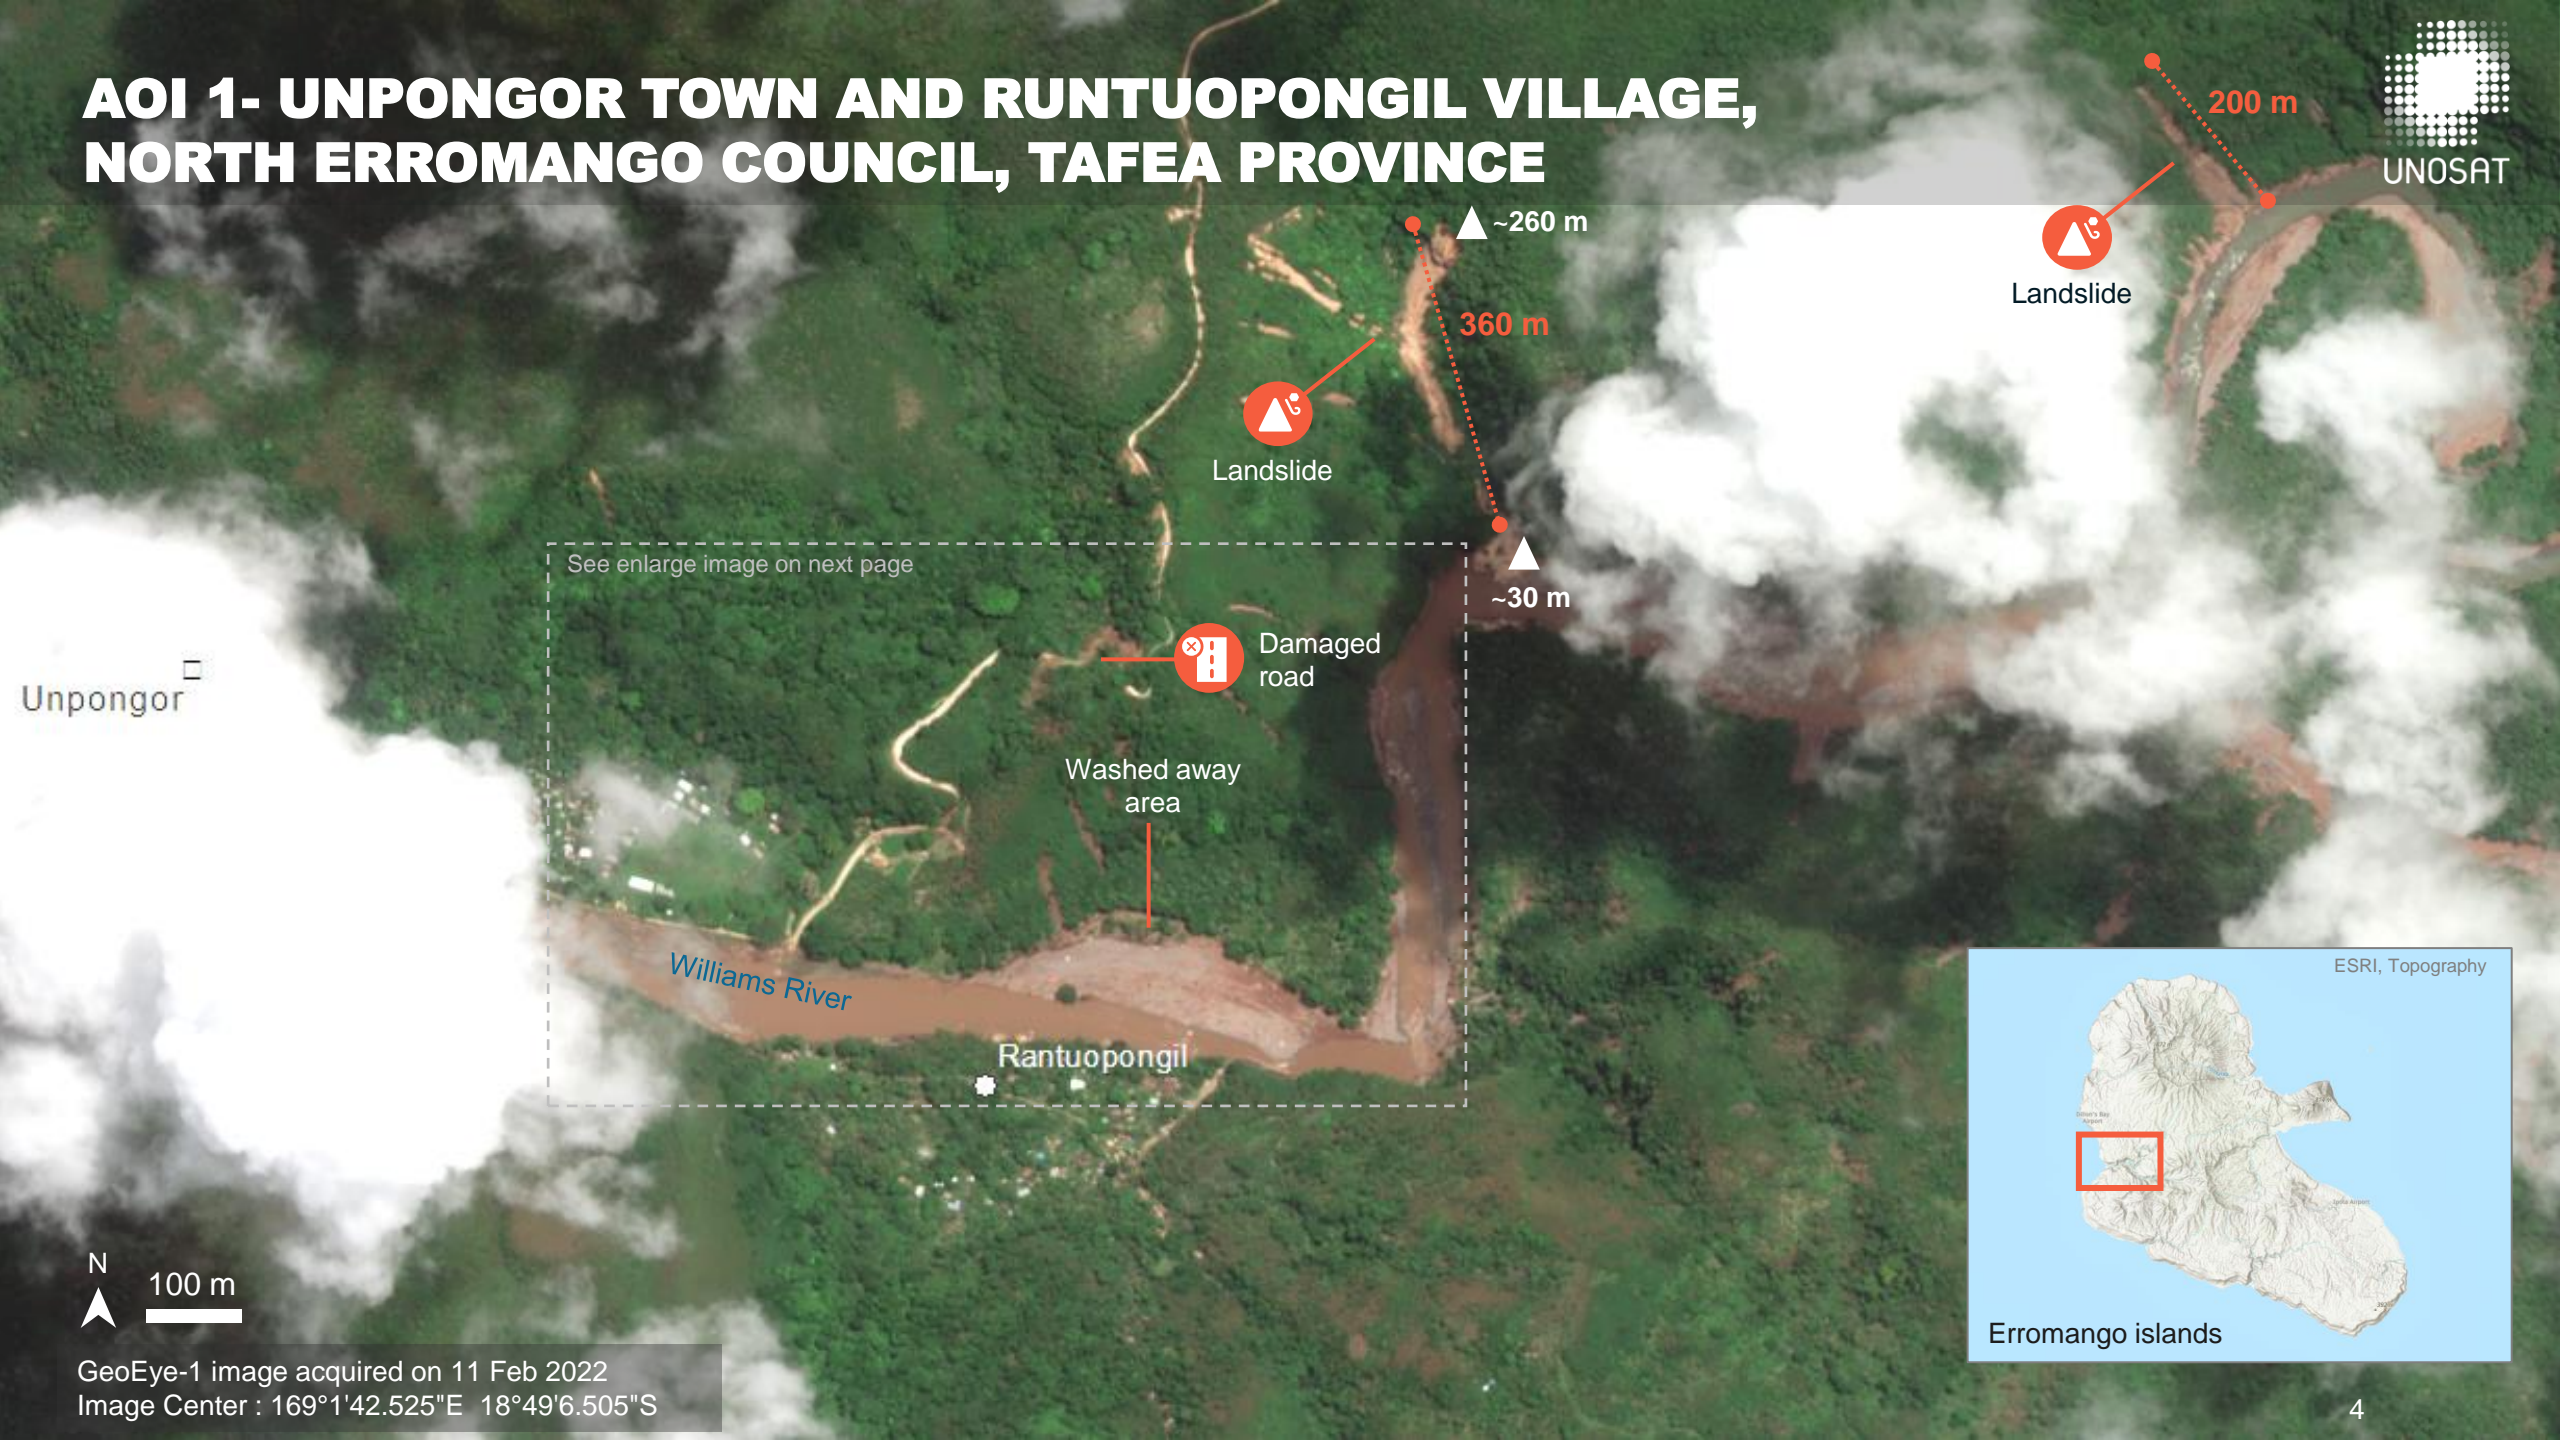
# AOI 1- UNPONGOR TOWN AND RUNTUOPONGIL VILLAGE, NORTH ERROMANGO COUNCIL, TAFEA PROVINCE

Landslide

~260 m

Damaged road

Washed away area

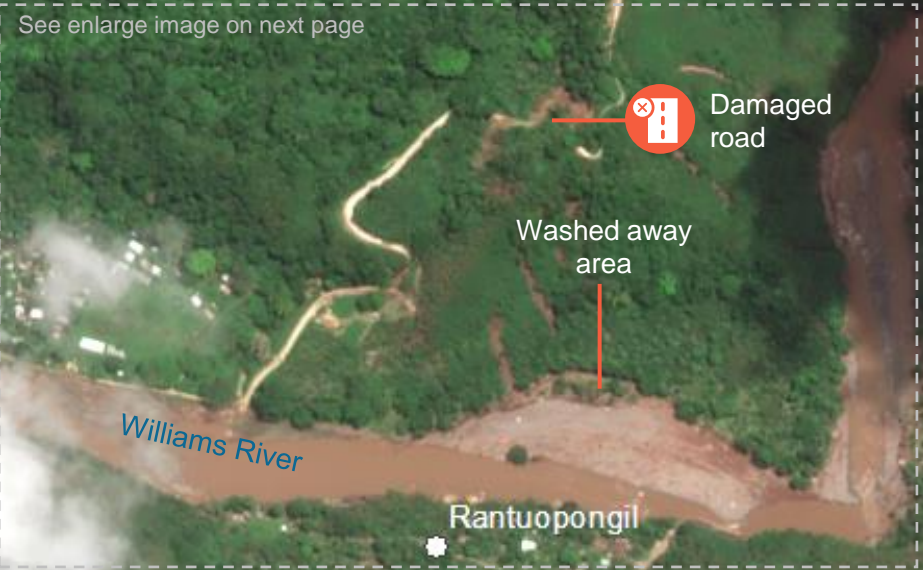
~30 m

Williams River

- Multiple landslides observed close to Unpongor town as of 11 February 2022
- Washed away area observed at 500m east of Unpongor along the William river as of 11 February 2022;
- Potentially damaged roads and potentially affected structures observed in Unpongor town as of 11 February 2022;
- Inundated structures observed in Runtuopongil village along the William river as of 11 February 2022;
- Affected area and potentially affected structures along the shoreline of Dillon's Bay observed as of as of 11 February 2022.

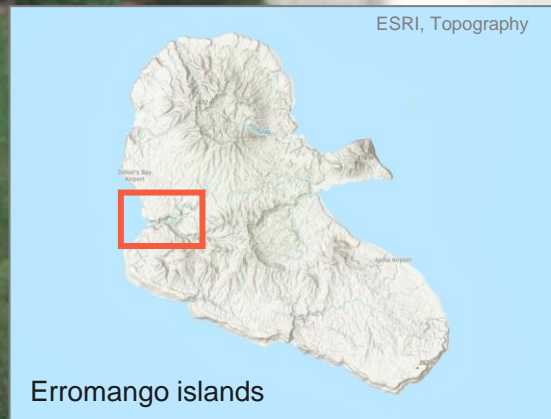
GeoEye-1 image acquired on 11 Feb 2022  
Image Center : 169°1'42.525"E 18°49'6.505"S

Rantuopongil

Unpongor

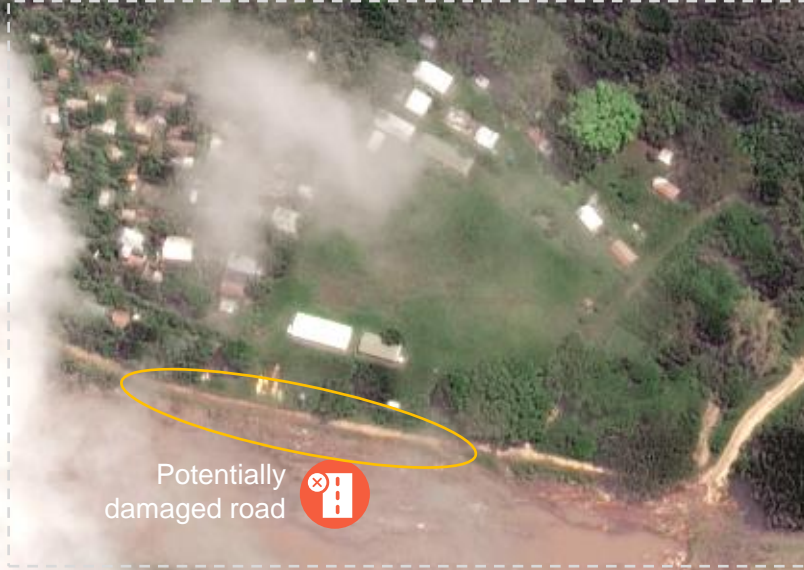
# AOI 1- UNPONGOR TOWN AND RUNTUOPONGIL VILLAGE, NORTH ERROMANGO COUNCIL, TAFEA PROVINCE

Damaged road

~130 m

Landslide

Washed away area

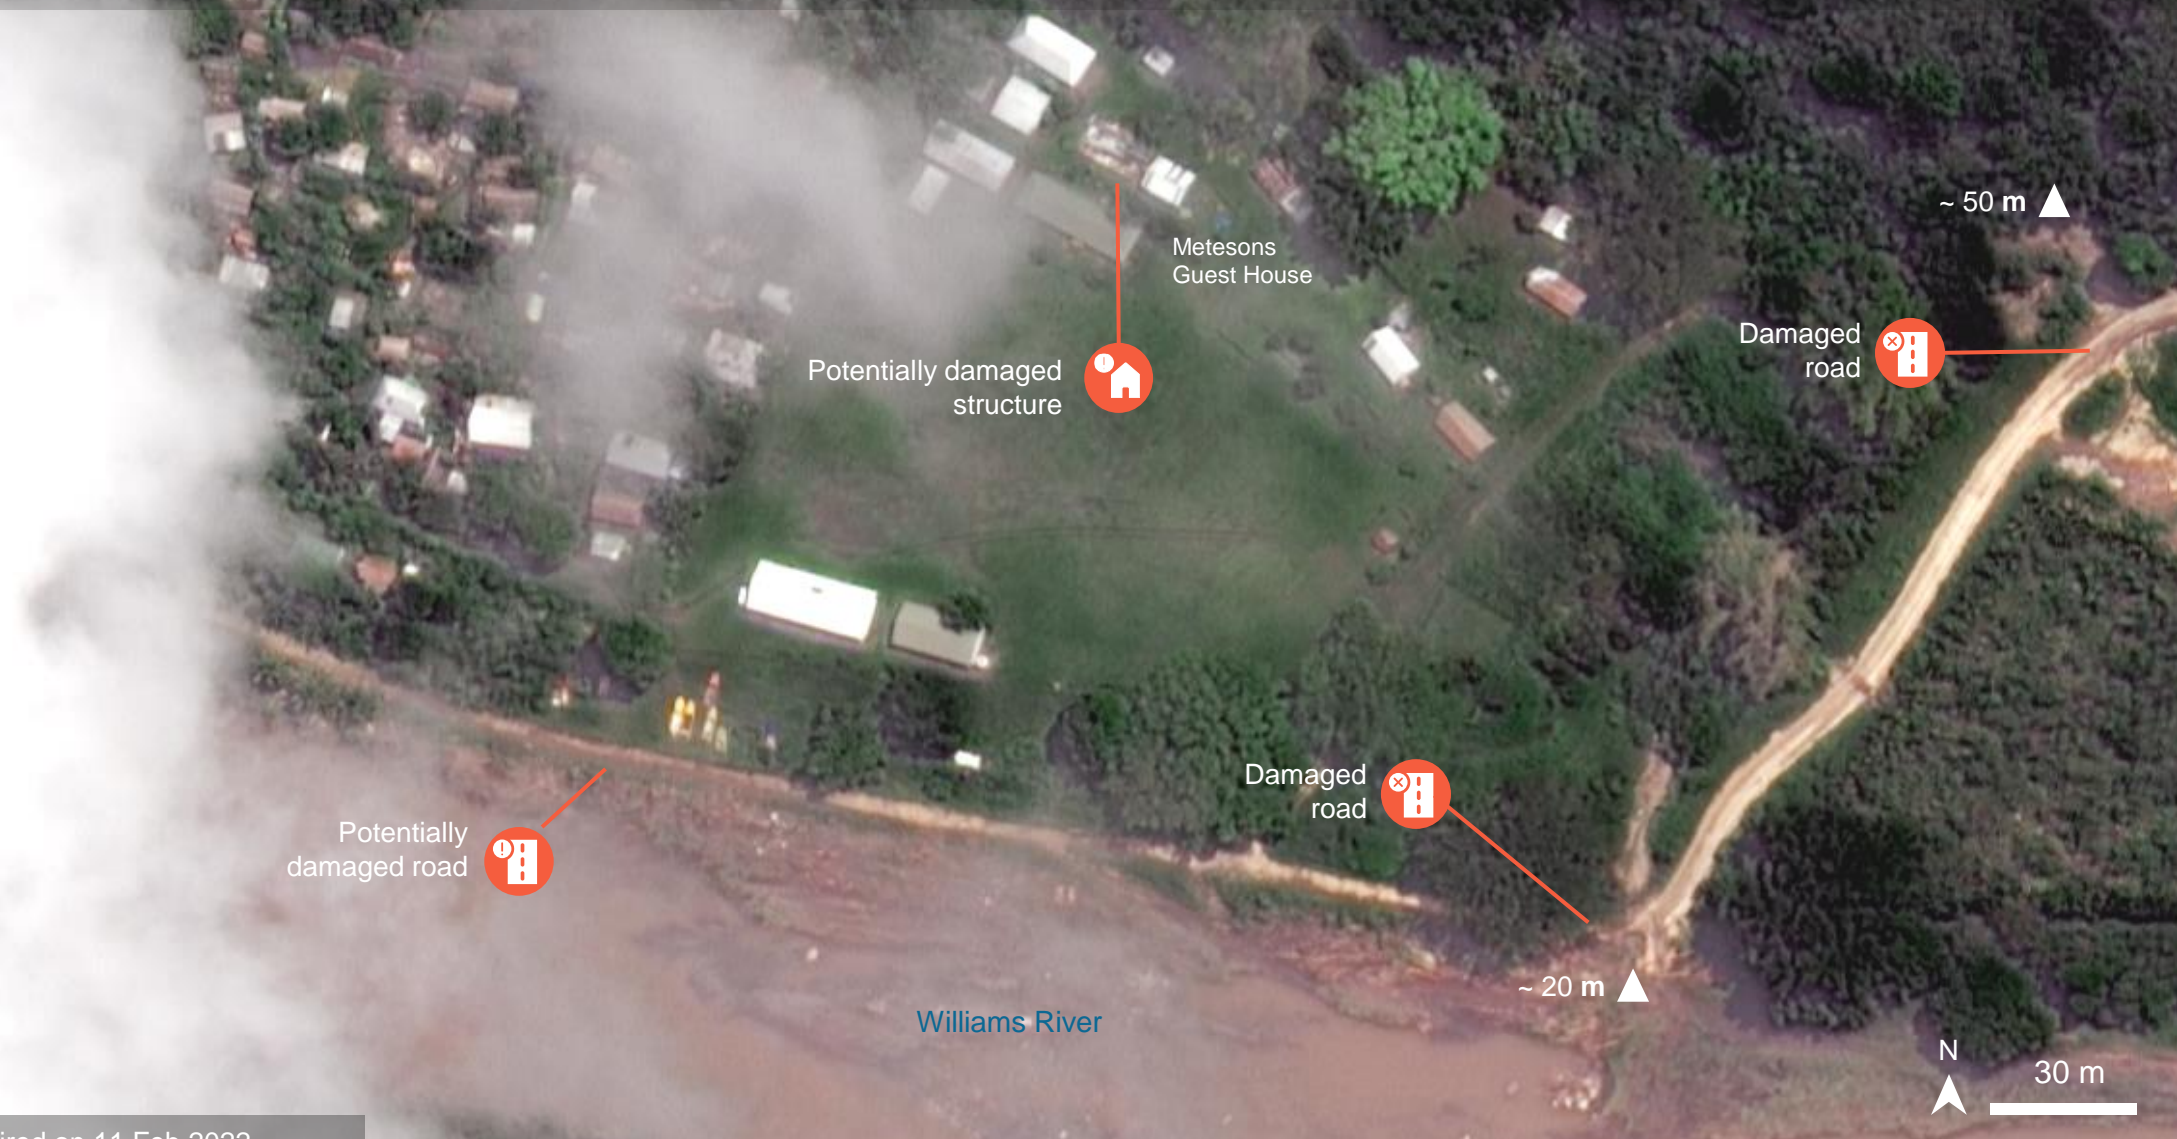
# AOI 1-1 - UNPONGOR TOWN, NORTH ERROMANGO COUNCIL, TAFEA PROVINCE

Potentially damaged structure

Damaged road

Potentially damaged road

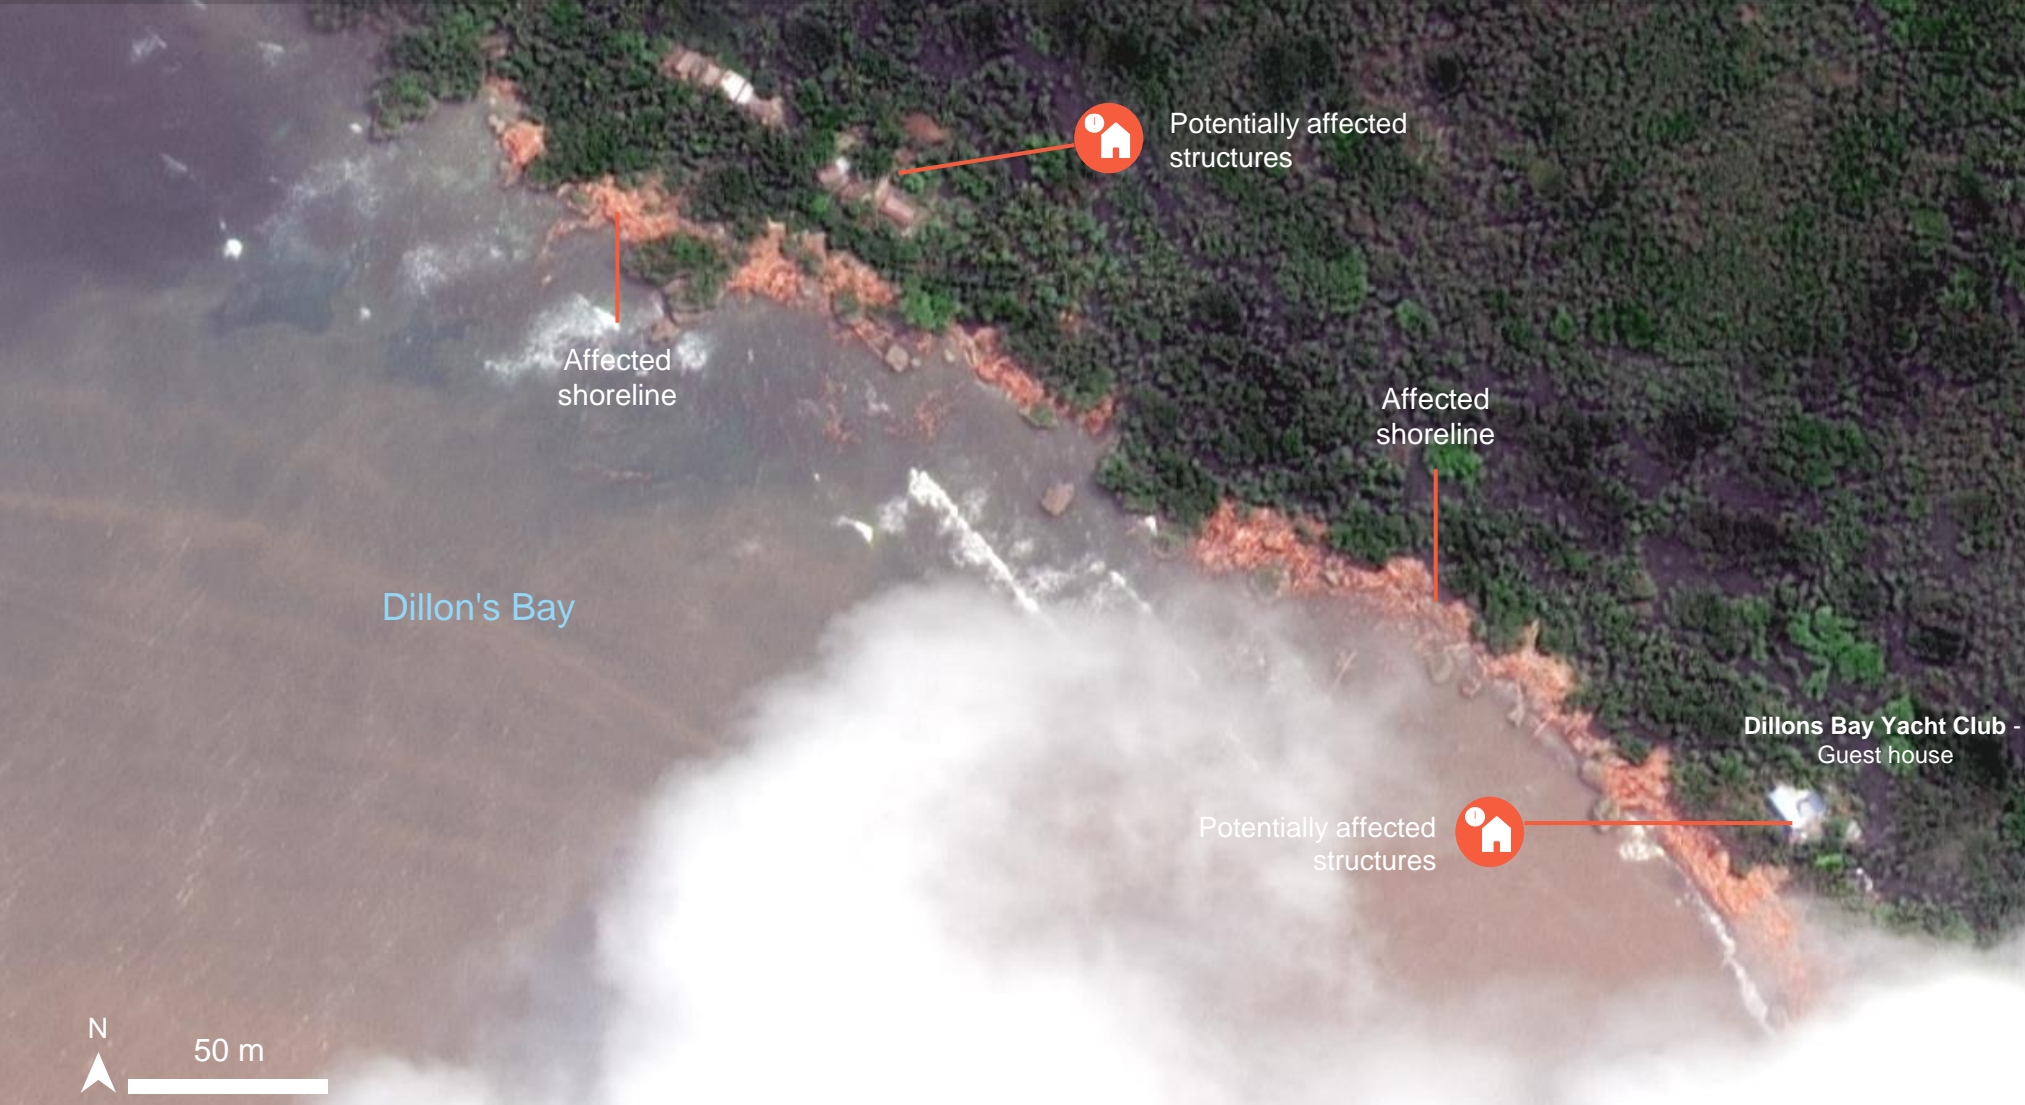
# AOI 2- DILLON'S BAY, NORTH ERROMANGO COUNCIL, TAFEA PROVINCE

Affected shoreline

Potentially affected structures

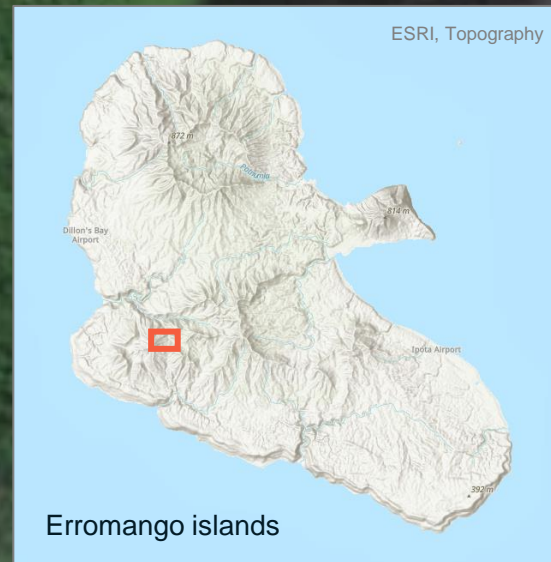
GeoEye-1 image acquired on 11 Feb 2022  
Image Center : 169°2'40.346"E 18°50'44.8"S

# AOI 3- SOUTH ERROMANGO COUNCIL, TAFEA PROVINCE
