# 14 August 2021 M7.2 Haiti Earthquake. Preliminary Satellite-Based Comprehensive Damage Assessment Report

Grande'Anse, South, and Nippes departments of Haiti

The 27th of August 2021

Prepared By  
United Nations Satellite Centre (UNOSAT)

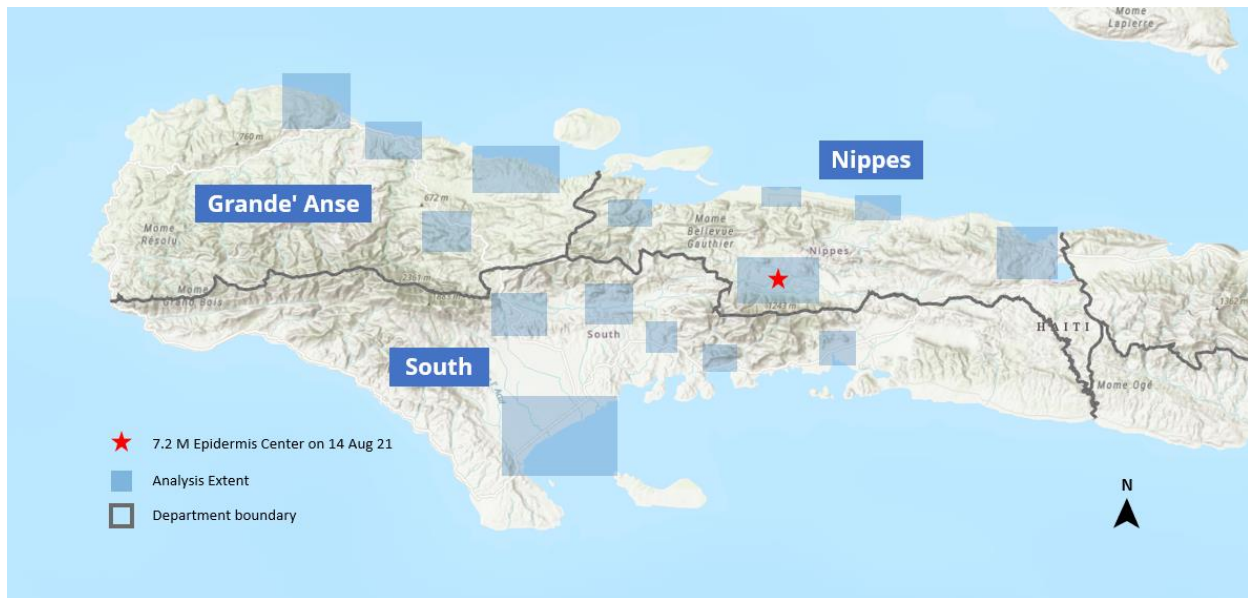
This comprehensive damage analysis identifies a total of 1,842 buildings/structures with visible damages and approximately 130 locations with visible road obstacles and/or access constraints within South, Grande' Anse, and Nippes departments.

Figure 3. This map depicts the analysis extents in the Grande' Anse, South, and Nippes departments of Haiti examined by UNOSAT, SERTIT, and Copernicus EMS to determine infrastructure damage caused by the M7.2 earthquake on the 14th of August 2021.

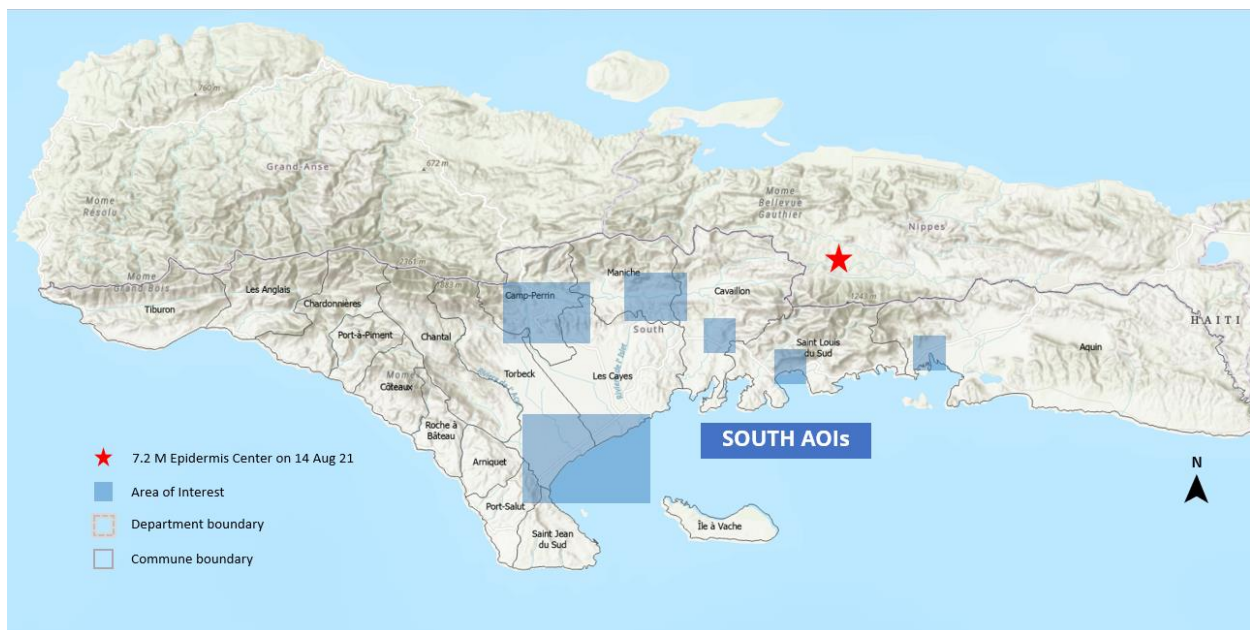
UNOSAT and partners' preliminary analysis shows 581 buildings/structures with visible damages (1% of the total building in AOIs) and approximately nine locations with visible road obstacles and/or access constraints.

Figure 4. This map depicts the analysis extents in the South departments of Haiti examined by UNOSAT, SERTIT, and Copernicus EMS to determine infrastructure damage caused by the M7.2 earthquake on the 14th of August 2021.

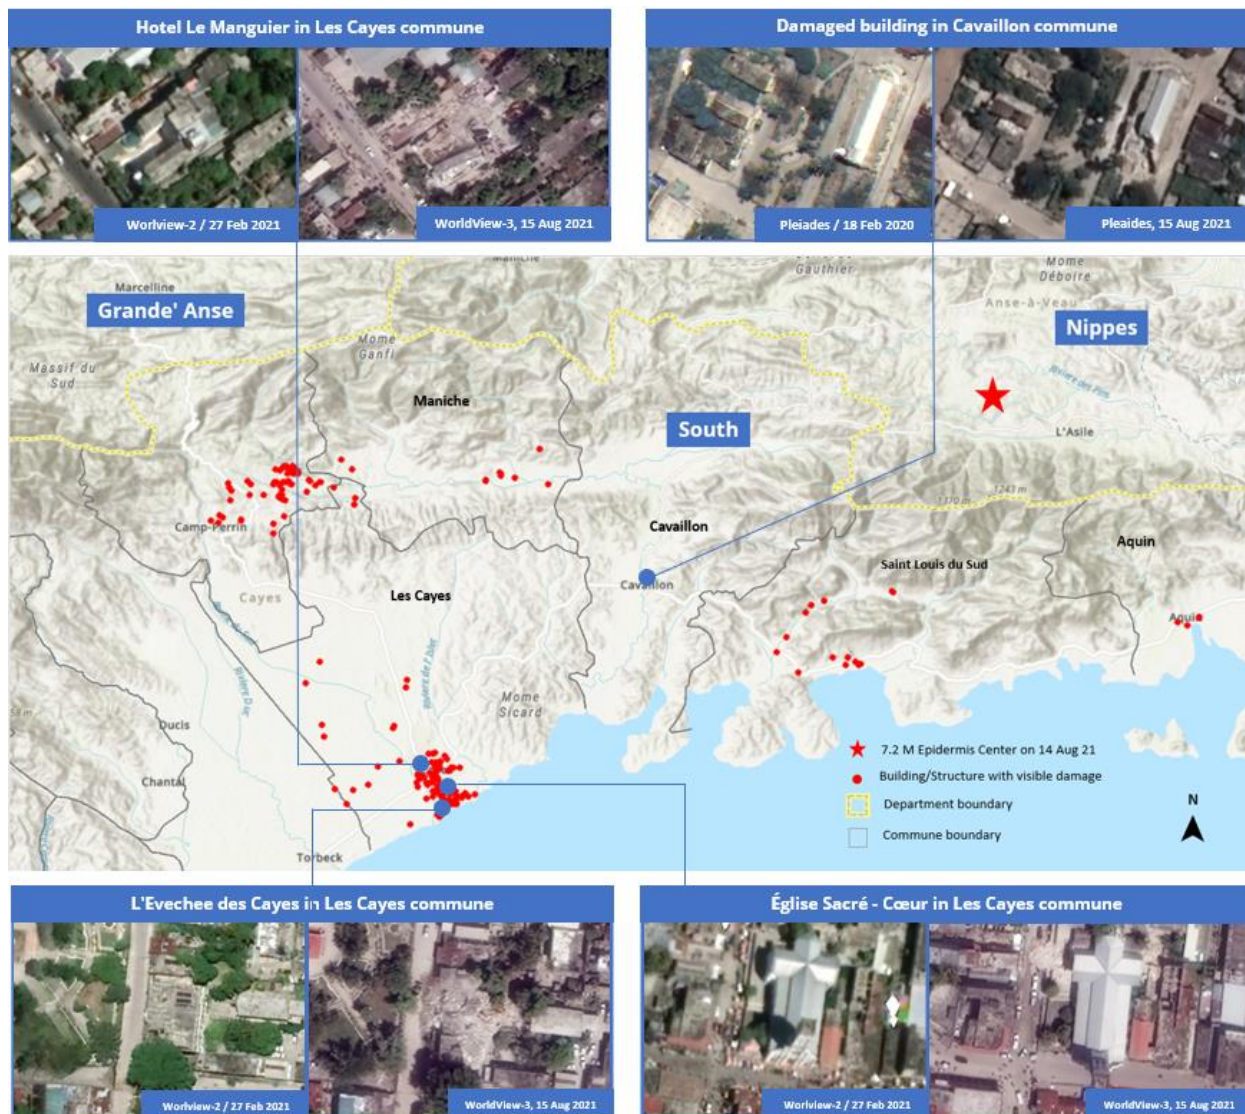
Preliminary building/structure damage assessments were conducted through visual interpretation by UNOSAT and partners, utilising before and after very high-resolution satellite images. The post-disaster satellite images were acquired after the earthquake on the 14th of August 2021, along with available pre-disaster images. A total of 581 buildings were identified with prominently visible damage within the analysed areas. Les Cayes commune had the highest number of affected buildings, with over 340 damaged buildings detected.

Figure 5. This map depicts the extent of damaged buildings in the South department of Haiti, specifically in the Les Cayes, Cavaillon, Camp-Perrin, Maniche, Saint Louis du Sud, and Aquin communes. Additional inset images from WorldView-3 and Pleiades satellite acquired on the 15th of August 2021 highlight and visualise the extent of damage to buildings within Les Cayes and Cavaillon communes.

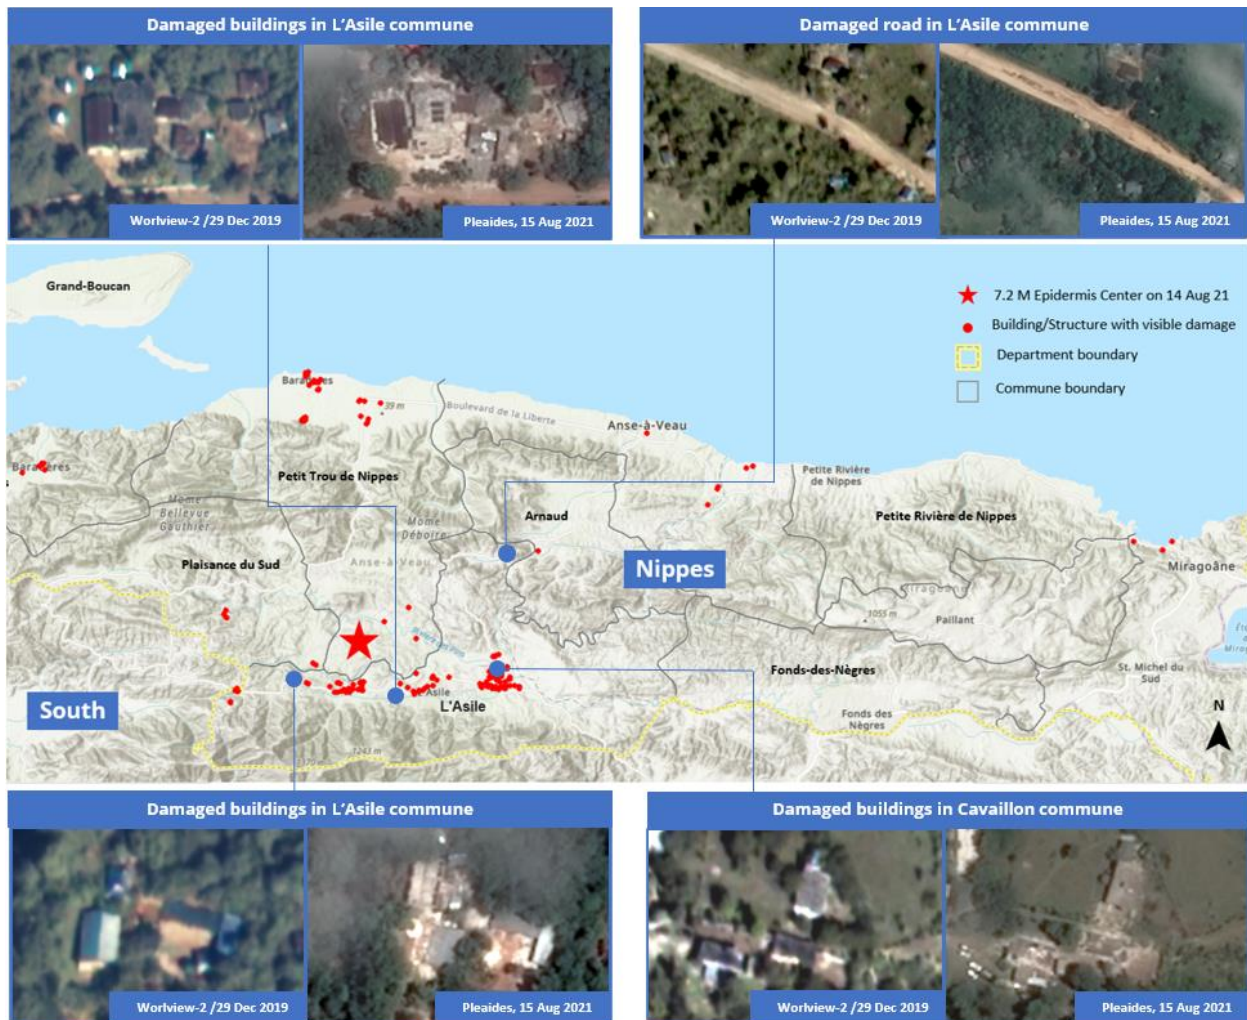
Preliminary building/structure damage assessment was conducted through visual interpretation by UNOSAT and partners utilising before and after very high-resolution satellite imagery. The post-disaster satellite images were acquired after the earthquake on the 14th of August 2021 with available pre-disaster images. A total of 562 buildings were identified with prominently visible damage within the analysed areas. L'Asile commune had the highest number of affected buildings, with over 300 damaged buildings detected.

Figure 9. This map depicts the extent of damaged buildings in the Nippes department, specifically in the Baradères, Plaisance du Sud, Petit Trou de Nippes, L'Asile, Arnaud, Anse-à -Veau and Miragoane communes. Additional inset images from the Pleiades satellite acquired on the 15th of August 2021 highlight and visualise the extent of damage to buildings within Les Cayes and Cavaillon communes.
