25 June 2021

PRELIMINARY SATELLITE- DERIVED FLOOD ASSESSMENT

Region 1, 7, 8 & 9

Status: Water decreased observed along the Takutu and Mazaruni rivers

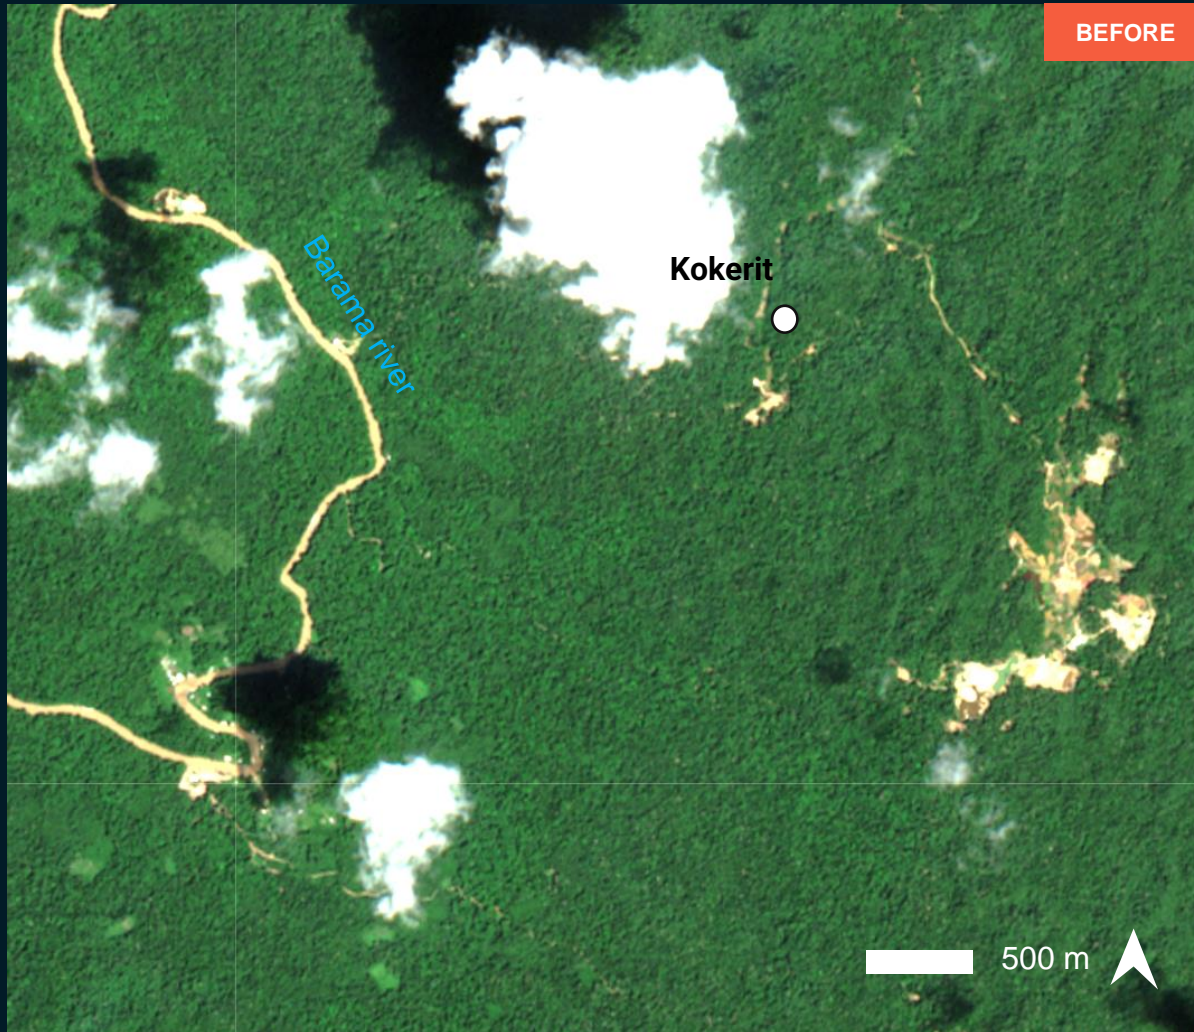
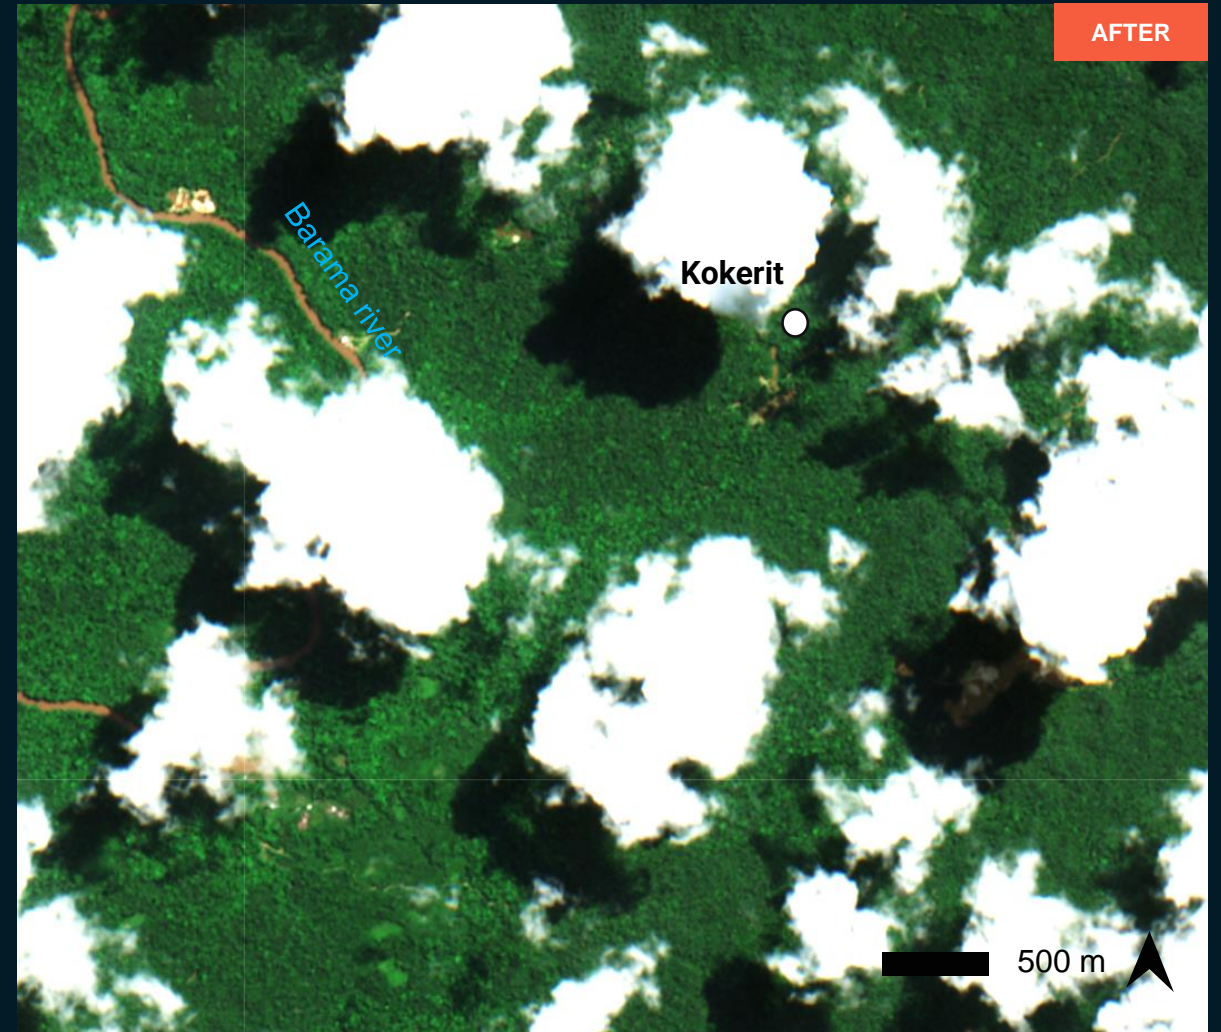
Kokerit: Waini Sub-Region, Region 1 - Barima-Waini

No floods observed

Sentinel-2 / 19 Feb 2021

Sentinel-2 / 24 June 2021

- Decreased water level in the Mazaruni river in Upper Mazaruni AOI, Mazaruni/L.B.E.Rive Sub-Region, Region 7 as of 23 June 2021;
- No floods observed over Kokerit village, Waini Sub-Region, Region 1 as of 24 June 2021;
- Decreased water level in the Takutu river near Lethem city, Rupununi West Sub-Region, Region 8 as of 23 June 2021;
- No floods observed over Chenapau village, Ireng/Upper Potaro Sub-Region, Region 8 as of 23 June 2021;

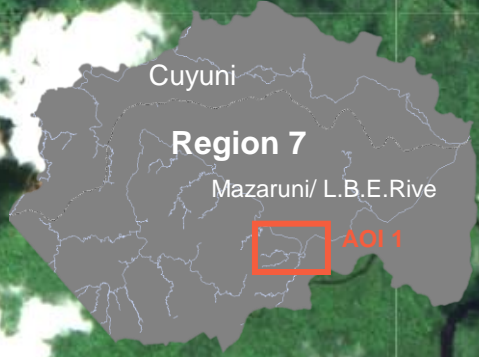
Upper Mazaruni : Mazaruni/ L.B.E.Rive Sub-Region, Region 7- Cuyuni-Mazaruni

Floods detected along the river
as of 14 June 2021

Sentinel-2 image acquired on 14 June 2021
Image Center : 59°40'13.62"W 5°42'41.72"N
