UKRAINE

KREMENCHUK, POLTAVA OBLAST

IMAGERY ANALYSIS: 29 June 2022 PUBLISHED: 09 February 2023 V1

UNOSAT Damage Assessment Overview Map

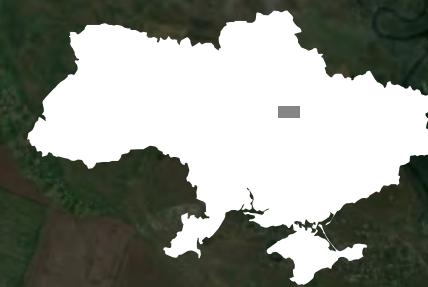
This map illustrates a satellite imagery based building damage assessment in the city of Kremenchuk, Ukraine. Based on imagery collected on 29 June 2022, the analysis showed 26 structures with visible damage. Out of these, 1 is destroyed, 7 severely damaged, 3 moderately damaged and 15 possibly damaged. Inset 1 shows a building identified as severely damaged on 29 June 2022.

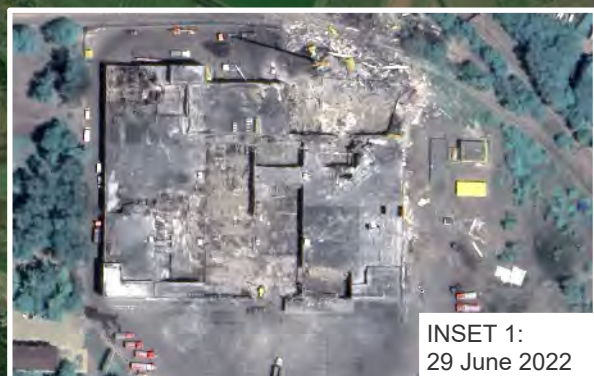
TOTAL VISIBLY DAMAGED BUILDINGS	DESTROYED	SEVERELY DAMAGED	MODERATELY DAMAGED	POSSIBLE DAMAGED
26	1	7	3	15
