27 February 2023

# PRELIMINARY SATELLITE- FLOOD ASSESSMENT REPORT

Vohipeno District, Madagascar

Status: Flood water detection after tropical cyclone Freddy

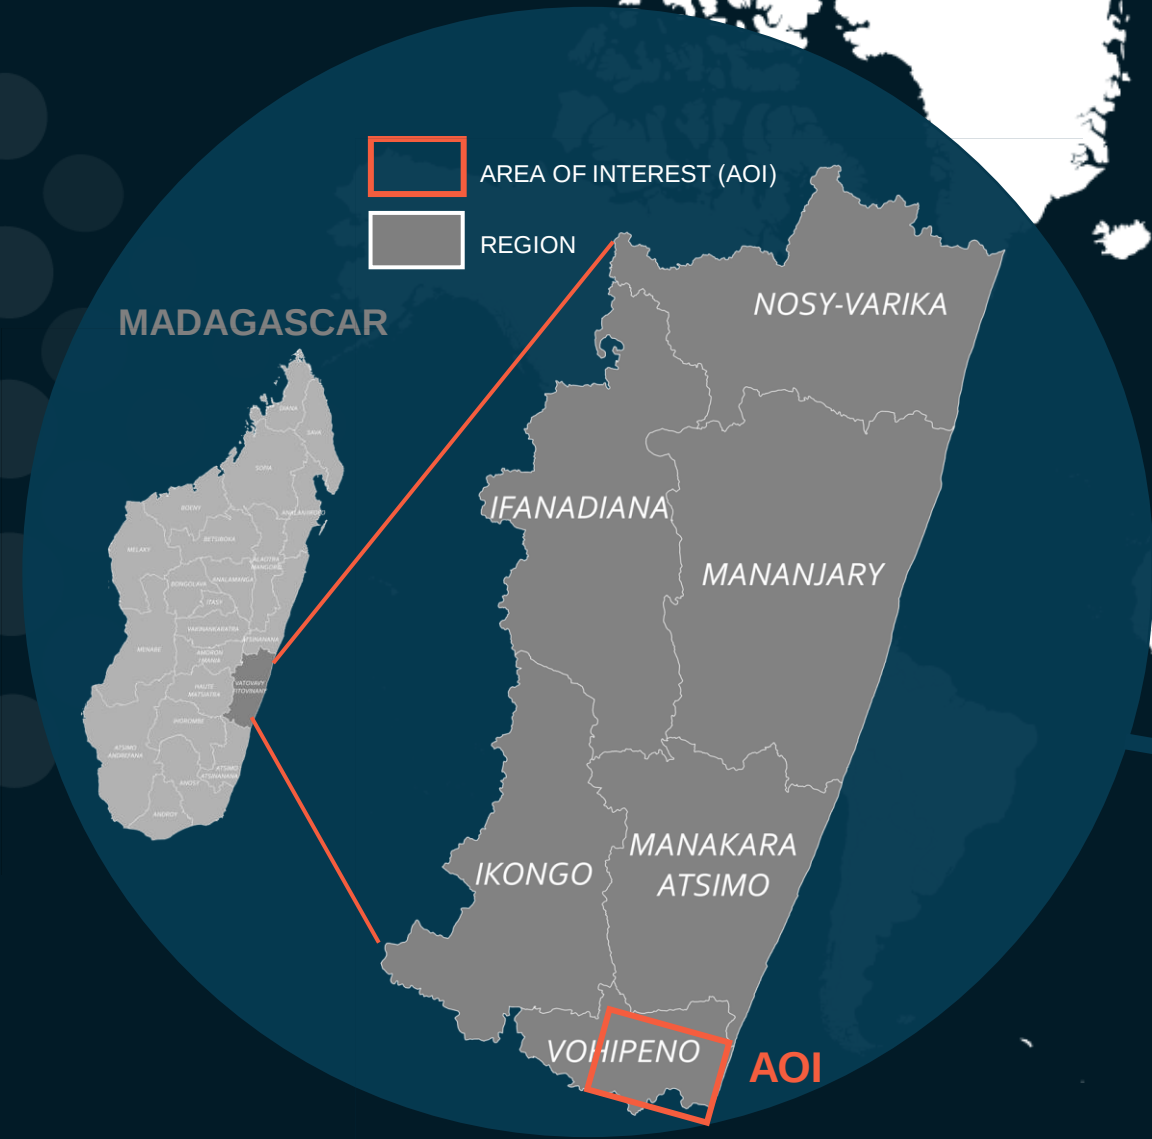
# VOHIPENO DISTRICT, VATOVAVY FITOVINANY REGION, MADAGASCAR

Sentinel-2 image acquired on 24 February 2023  
Image Center : 22°21'36.7"S 47°50'28.4"E

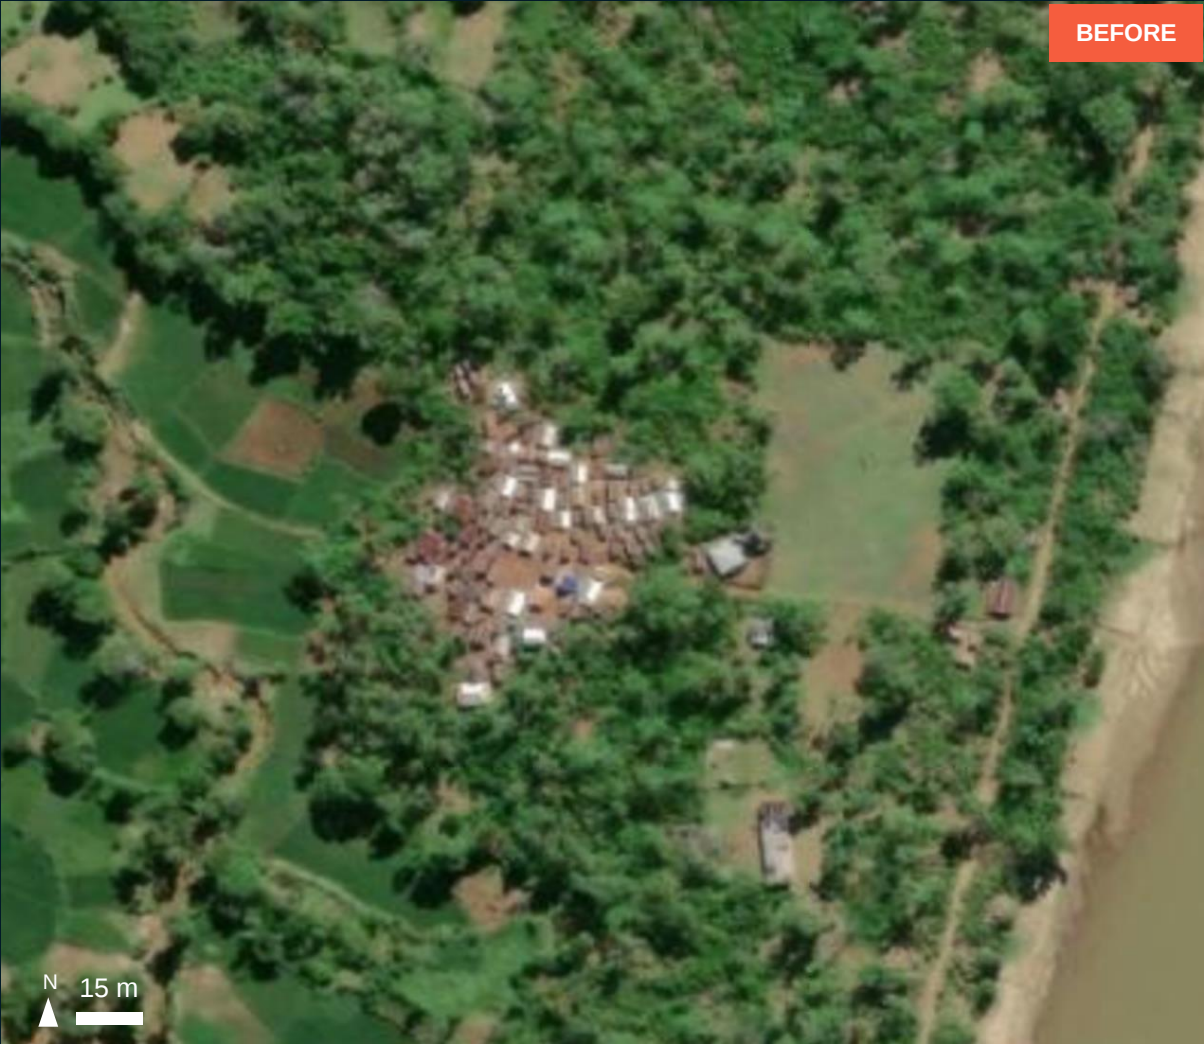
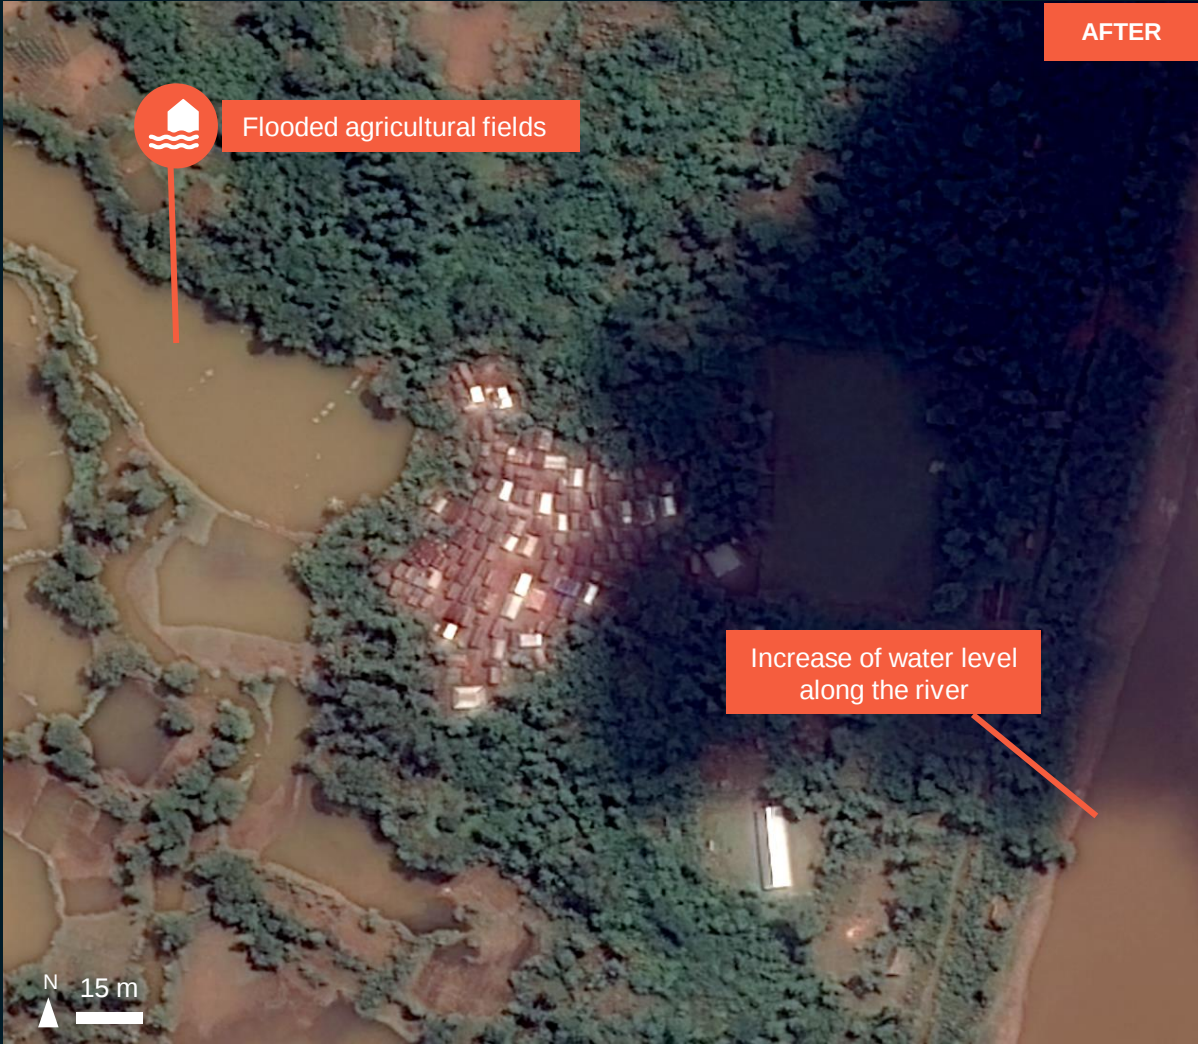
# AOI 1: Maraokanjo Fokontany, Ankarimbary Commune, Vohipeno District

Increase of water level along the Sandrananta river and flooded agricultural fields

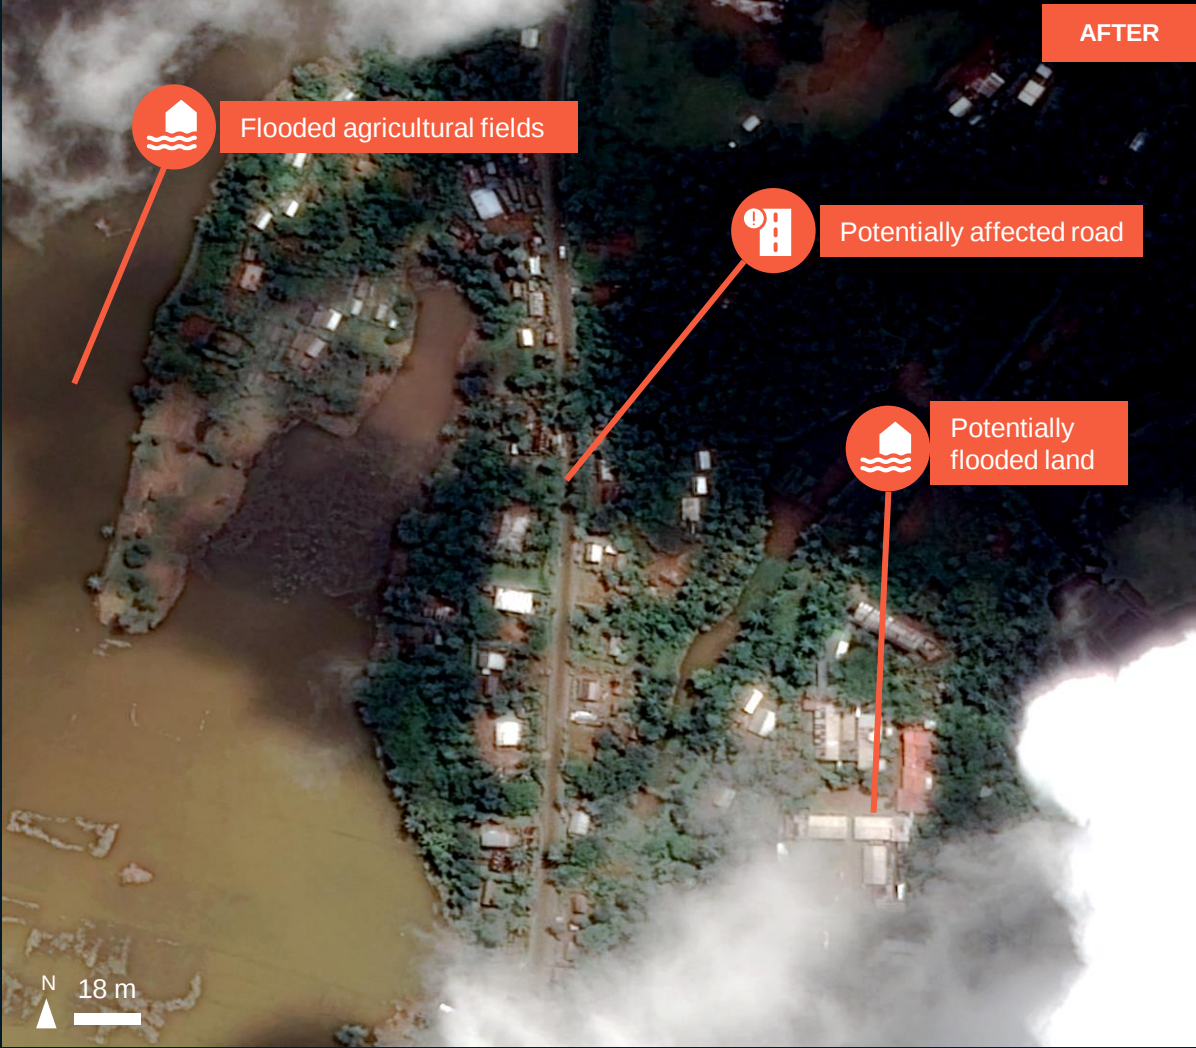
# AOI 2: Maromoby Fokontany, Vohipeno Commune, Vohipeno District

Flooded agricultural fields and potentially affected road

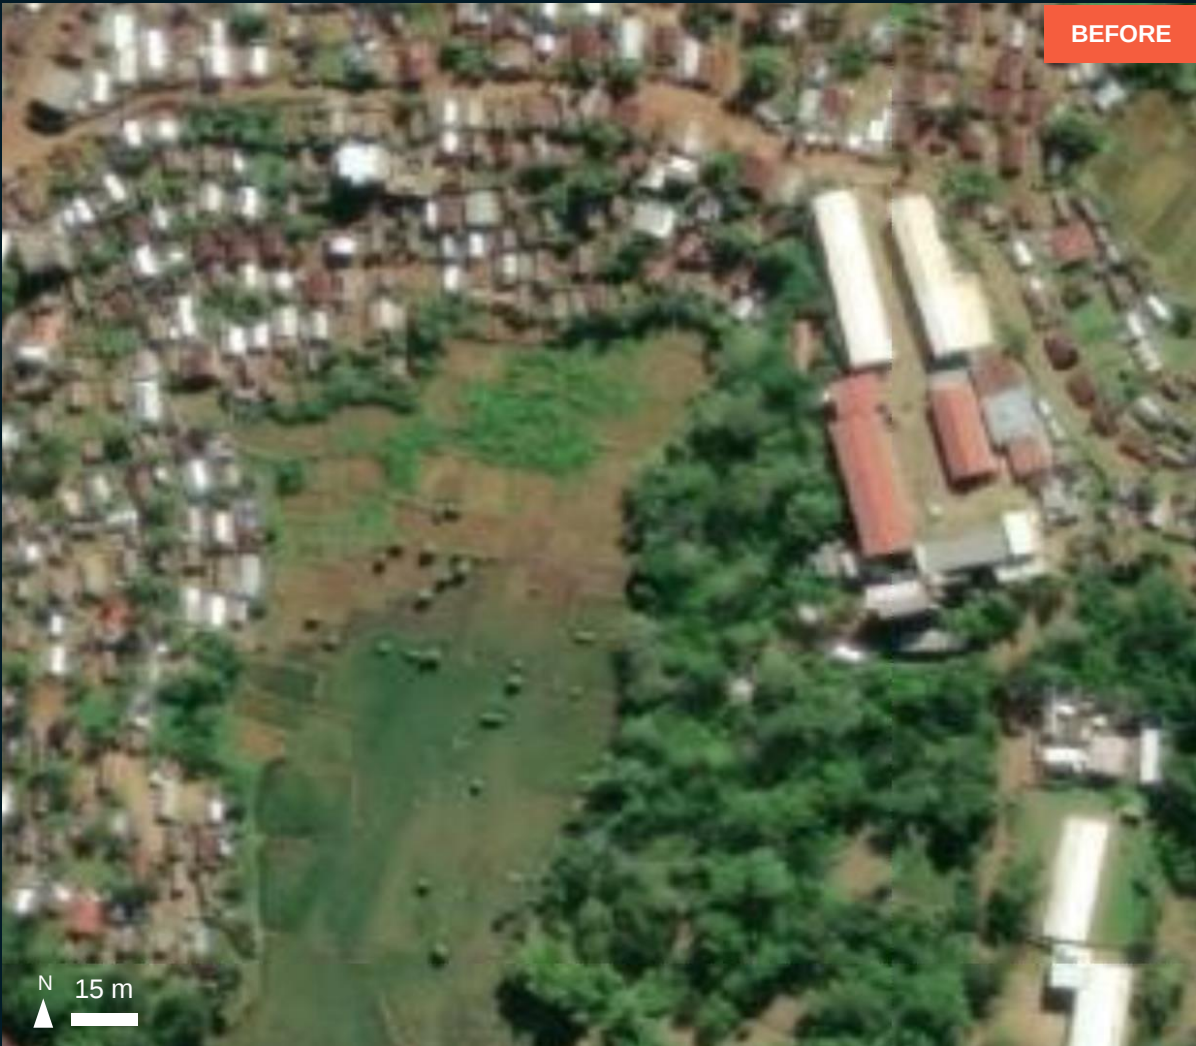
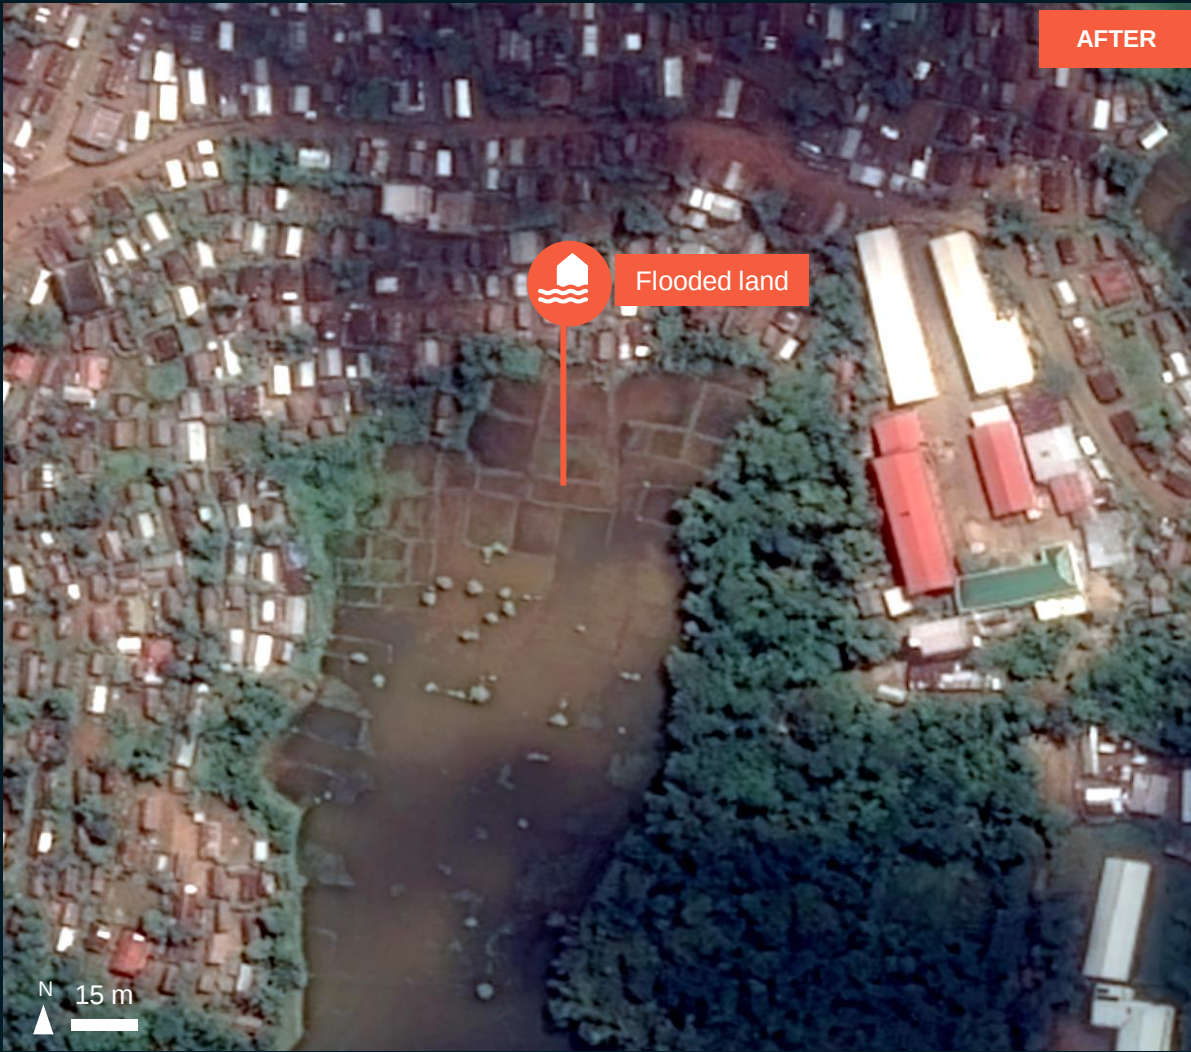
# AOI 3: Vohipeno town, Vatomasina Fokontany, Vohipeno Commune, Vohipeno District

Flooded land
