# 6 February 2023 M 7.8 Marash/Antep (Kehramanmarash) Earthquake, Preliminary Satellite-Based Comprehensive Damage Assessment Report

Latakia, Aleppo, and Idlib Governorates  
Syrian Arab Republic

16 March 2023

Prepared By  
United Nations Satellite Centre (UNOSAT)

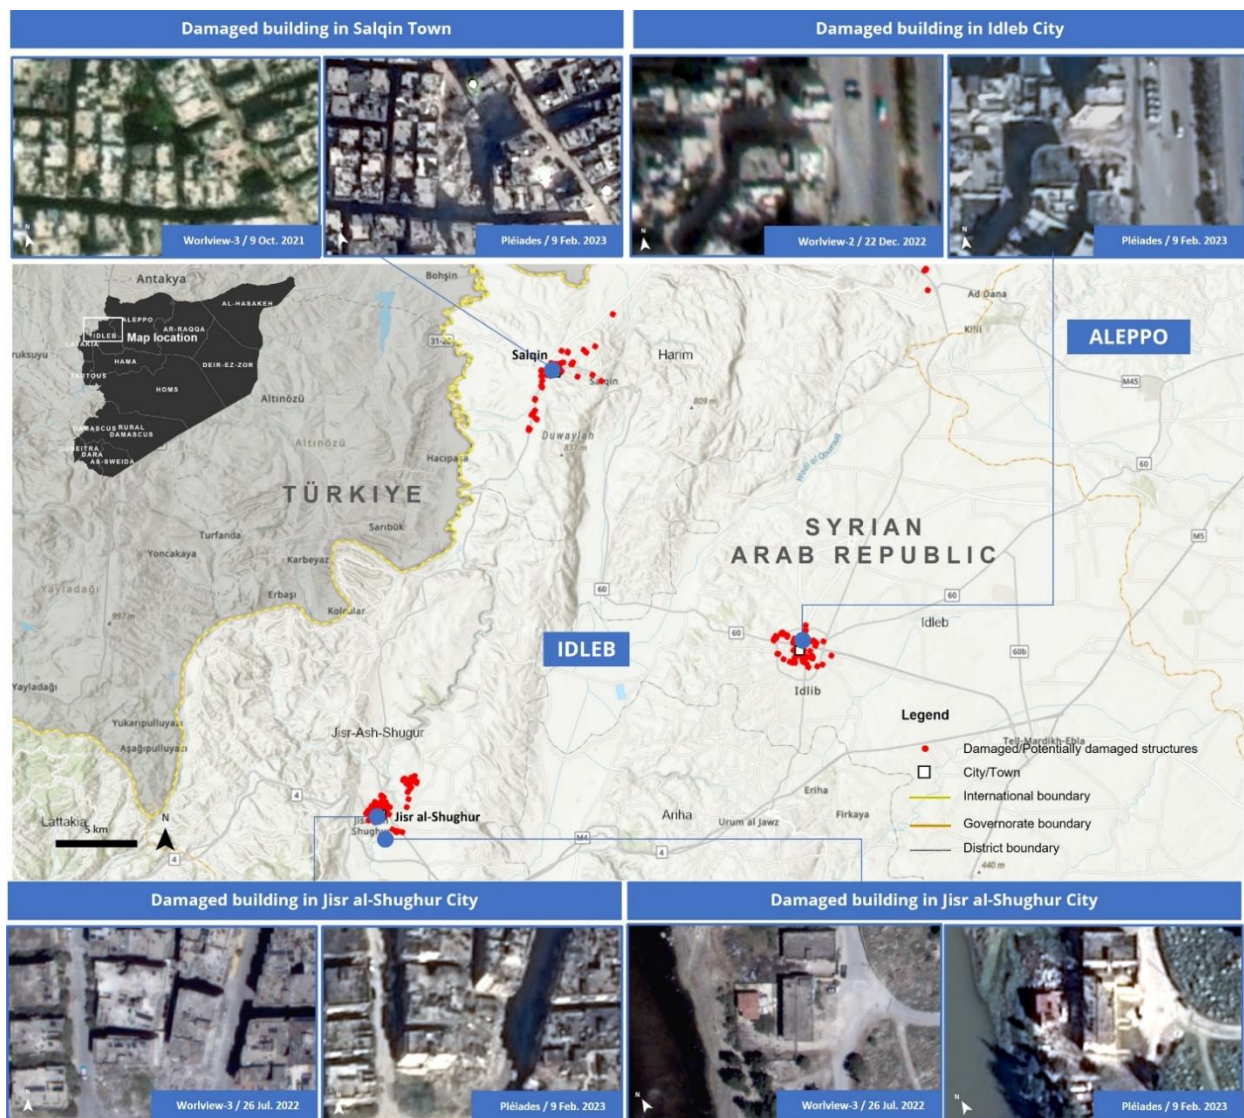
The preliminary assessment of damage to buildings and structures in Latakia Governorate was conducted by the UNOSAT team and other partners using a photo-interpretation approach, using very high-resolution satellite images before and after the earthquake event made available through the Space Charter. Post-event satellite images were acquired on 9<sup>th</sup>, 16<sup>th</sup>, 17<sup>th</sup>, 22<sup>th</sup> of February 2023, together with the images available before the disaster. In the analysed areas, 103 buildings with significant visible damage were observed. In Salqin Town the analysts observed the highest number of earthquake affected buildings, with 96 damaged and potentially damaged detected.

Figure 8. This map depicts the extent of damaged buildings in Idlib Governorate of Syrian Arab Republic, specifically in the Idlib, Jisr-Ash-Shughur, and Harim districts. Additional inset images from the Pleiades satellite acquired on the 9th of February 2023 highlight and visualise the extent of damage to buildings within Idlib City, Jisr-Ash-Shughur City, and Salqin Town.

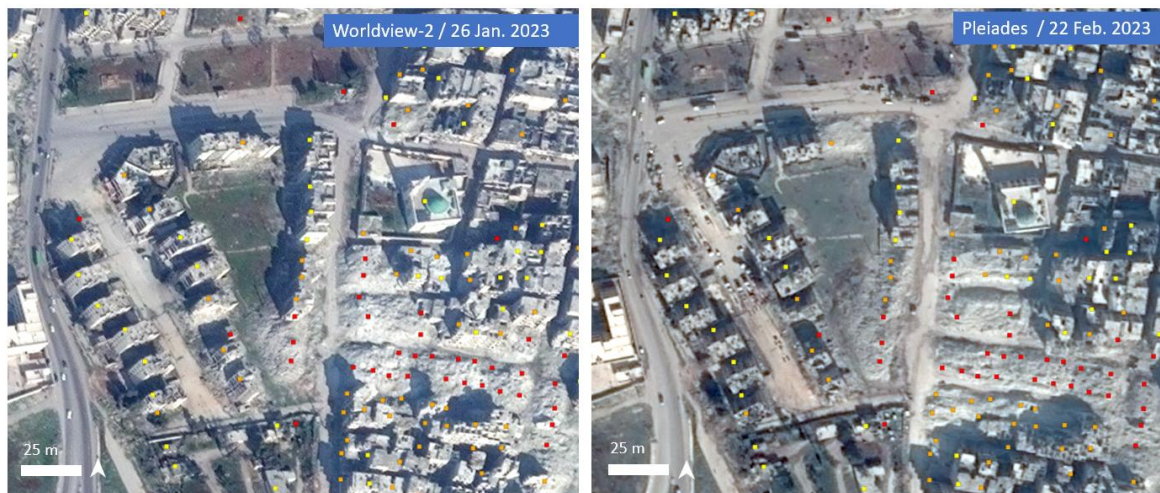
Figure 12. This image shows inset 1 with destroyed, damaged and potentially damaged buildings in southwestern part of the city Aleppo before and after the earthquake of 6th of February 2023. The pre imagery from the Worldview-2 satellite acquired on the 26th of January 2023, and the Pleiades satellite acquired on the 22nd of February 2023 visualise that damage was already existent prior to the earthquake.

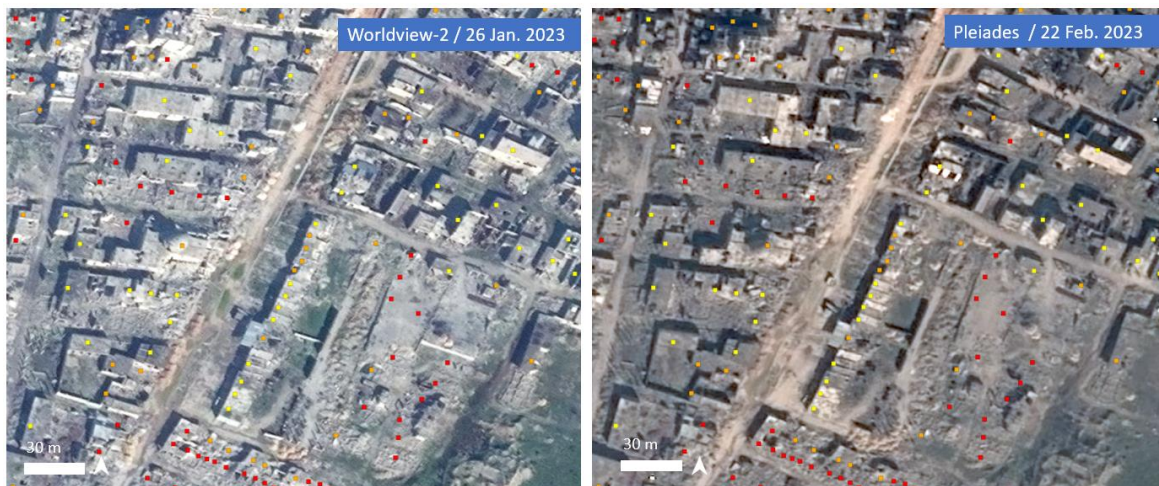
Figure 13. This image shows inset 2 with destroyed, damaged and potentially damaged buildings in southwestern part of the city Aleppo before and after the earthquake of 6<sup>th</sup> of February 2023. The pre imagery from the Worldview-2 satellite acquired on the 26<sup>th</sup> of January 2023, and the Pleiades satellite acquired on the 22<sup>nd</sup> of February 2023 visualise that damage was already existent prior to the earthquake

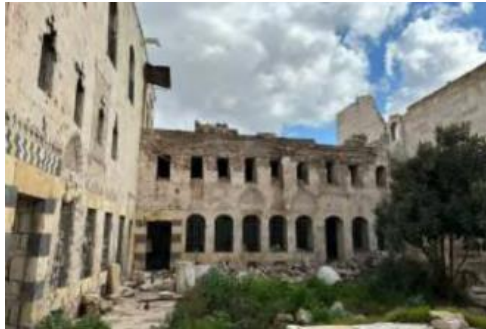
Figure 15. This field photo illustrates damaged building over the cultural site Bayt Ghazale by the Syrian Directorate-General of Antiquities & Museums (DGAM)

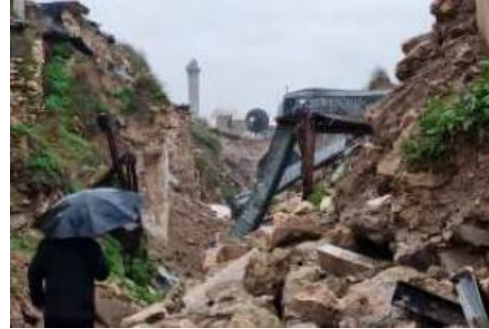
Figure 16. This field photo illustrates damaged building in area between Suq al-Attarin and Suq al-Ebi, Ancient City of Aleppo by the Syrian Directorate-General of Antiquities & Museums (DGAM)

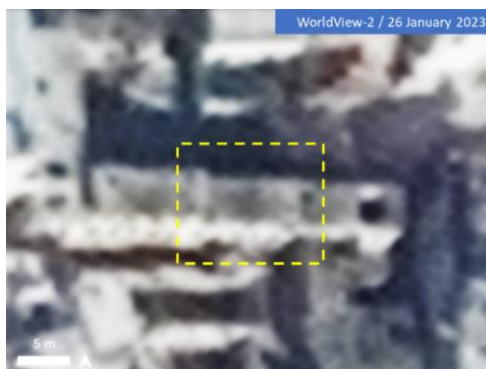
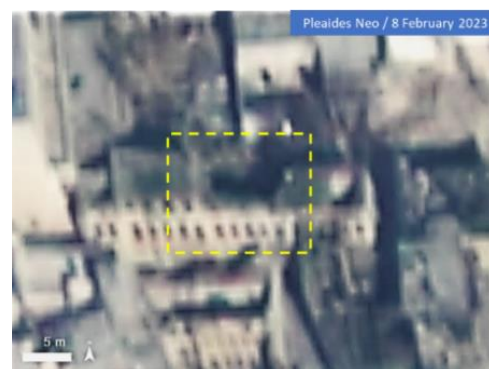
Figure 17. These images illustrate severe damage in cultural site Bayt Ghazale Ancient City of Aleppo

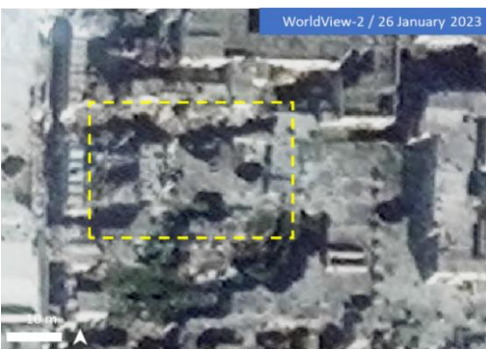
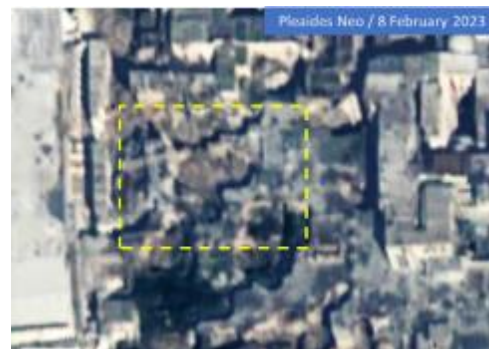
Figure 18. These images illustrate severe Bayt Ghazale, Ancient City of Aleppo

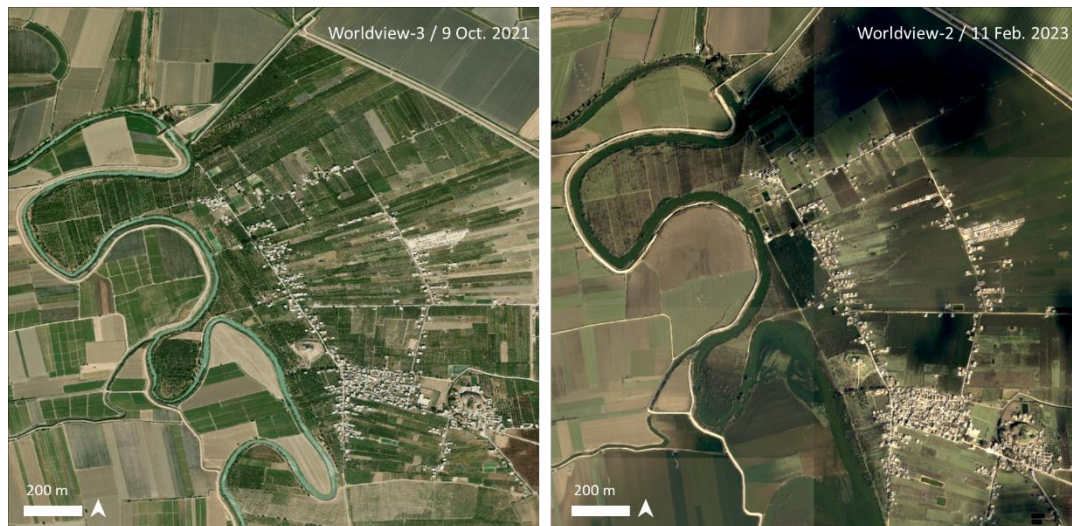
Figure 23. The Orontes River before and after floods. The pre-image is acquired by Worldview-3 on the 9<sup>th</sup> of October 2021, while the post image is acquired by Worldview-2 on the 11<sup>th</sup> of February 2023. The post image shows extensive floods and the affected village Al Tloul.

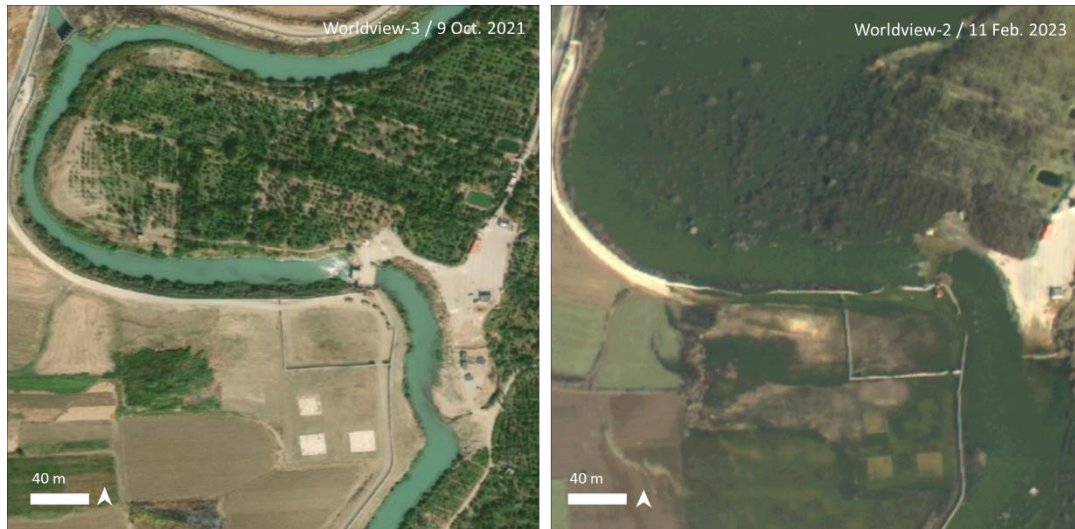
Figure 24. The Orontes River before and after floods. The pre image is acquired by Worldview-3 on the 9<sup>th</sup> of October 2021, while the post image is acquired by Worldview-2 on the 11<sup>th</sup> of February 2023. The post image shows damage on water infrastructure.

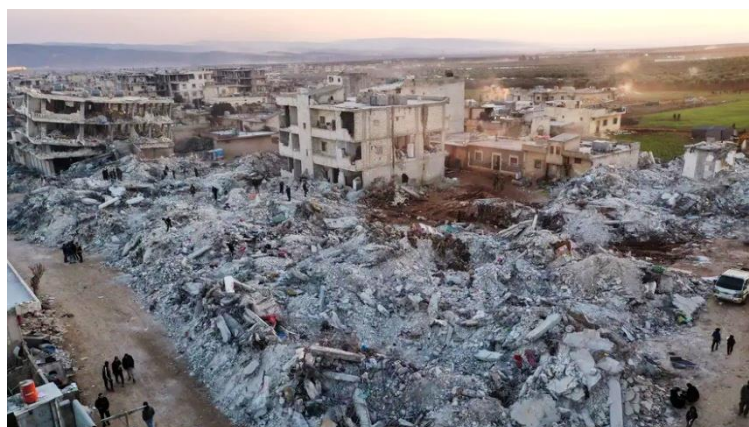
Figure 30. Completely collapsed buildings in the town of Jindires, Syria

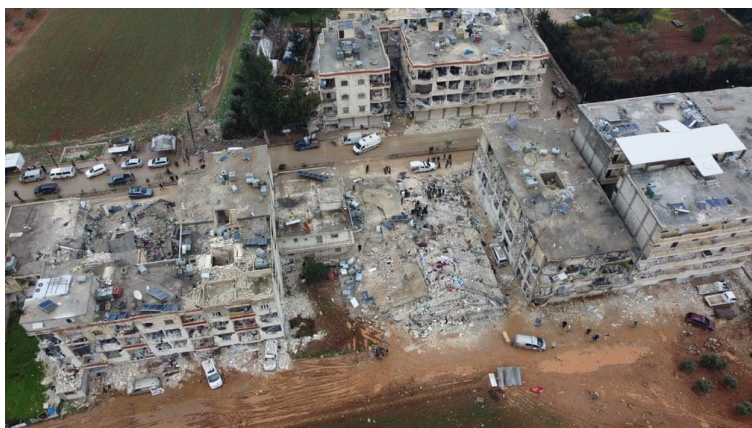
Figure 31. Collapsed building in in the Cenderes district of Aleppo, Syria.

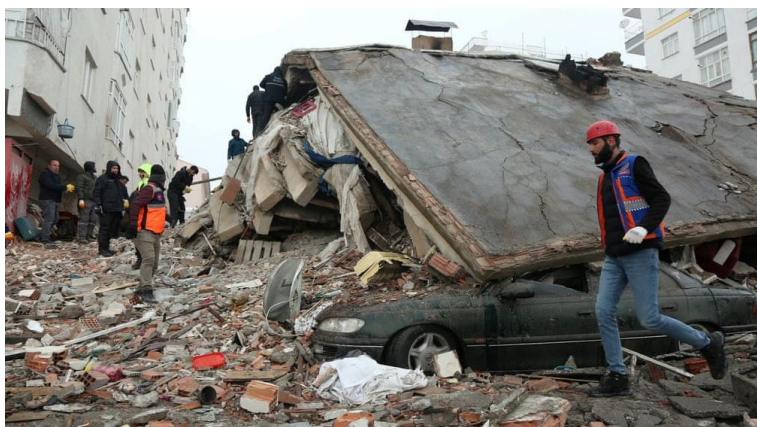
Figure 32. Collapsed structures, and rescue team searching for survivors in Diyarbakir city in Türkiye.

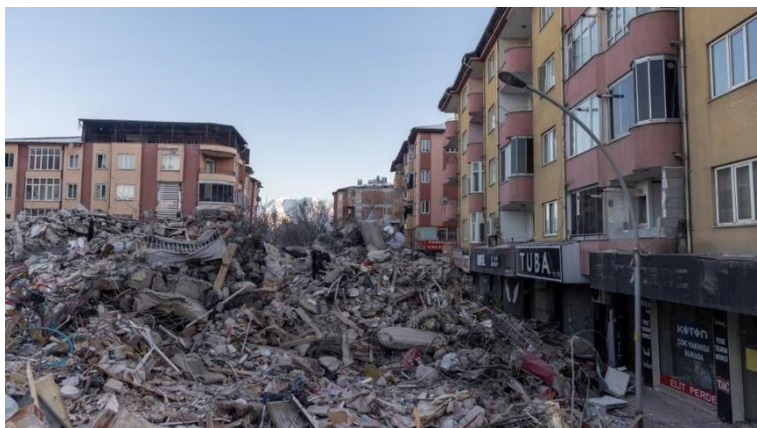
Figure 33. Collapsed structures in Elbistan, Türkiye.
