DEMOCRATIC REPUBLIC OF THE CONGO

KALEHE TERRITORY, SUD-KIVU PROVINCE

IMAGERY ANALYSIS: 09/05/2023 PUBLISHED 10/05/2023 V1

Damage assessment in Chabondo village, Kalehe Territory, Sud-Kivu Province, DR. of the Congo as of 09 May 2023

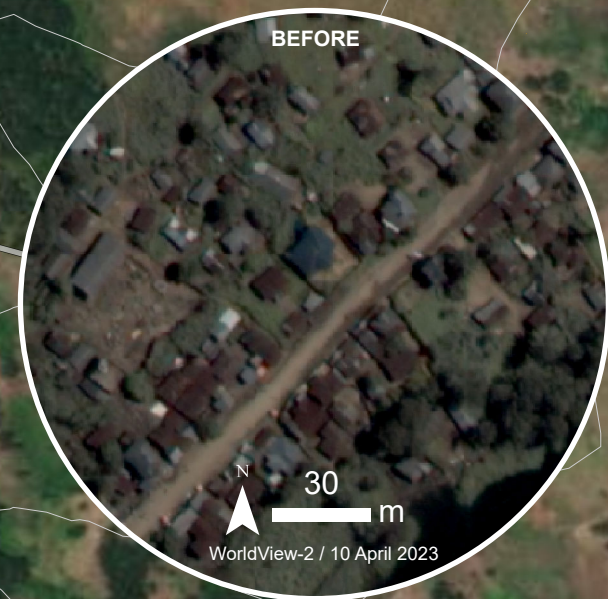
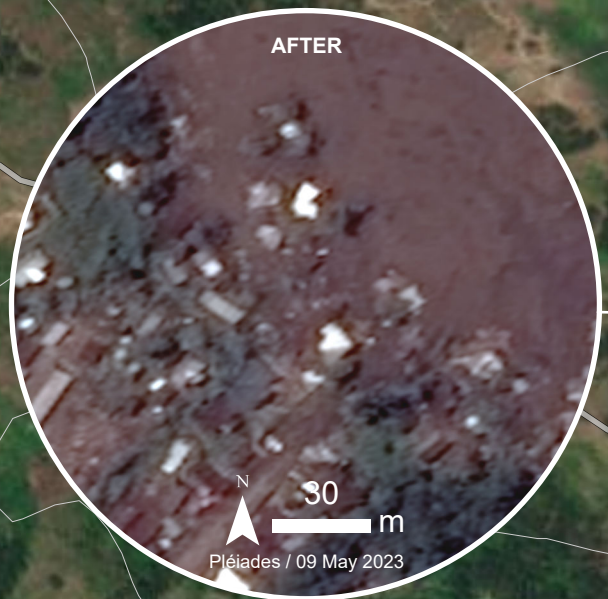
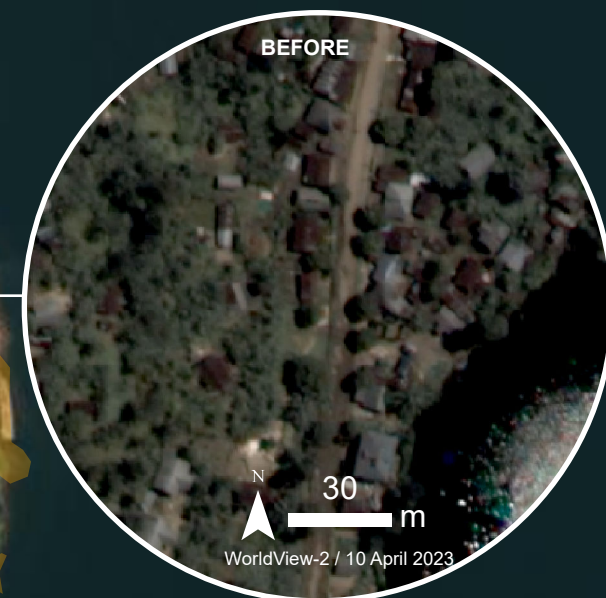
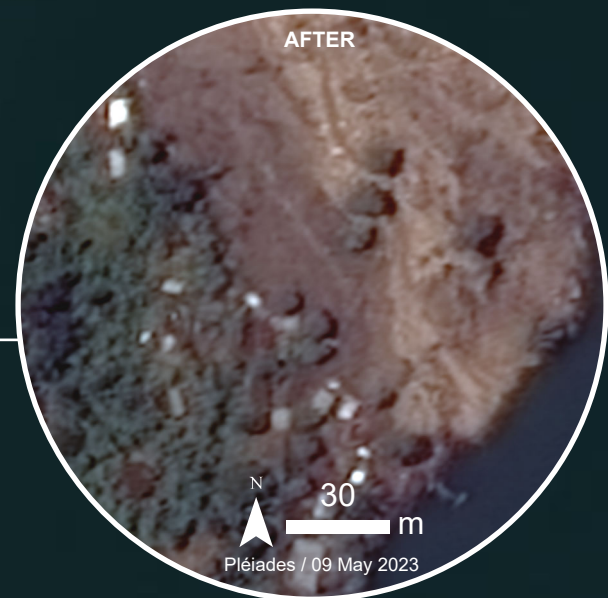
This map illustrates the potentially damaged structures/buildings affected by landslides in Chabondo village, Kalehe Territory, Sud-Kivu Province, DR. of the Congo as detected from a Pleiades image acquired on the 09th May 2023.

Within the extent of this map, about 516 structures appear to be affected and 28 are potentially affected.

This is a preliminary analysis and has not yet been validated in the field. Please send ground feedback to the United Nations Satellite Centre (UNOSAT).
