GAZA STRIP

IMAGERY ANALYSIS: 03 May 2024 / PUBLISHED: 31 May 2024 / V1

COMPLEX EMERGENCY
CE20231007PSE

UNOSAT Damage Assessment Overview Map

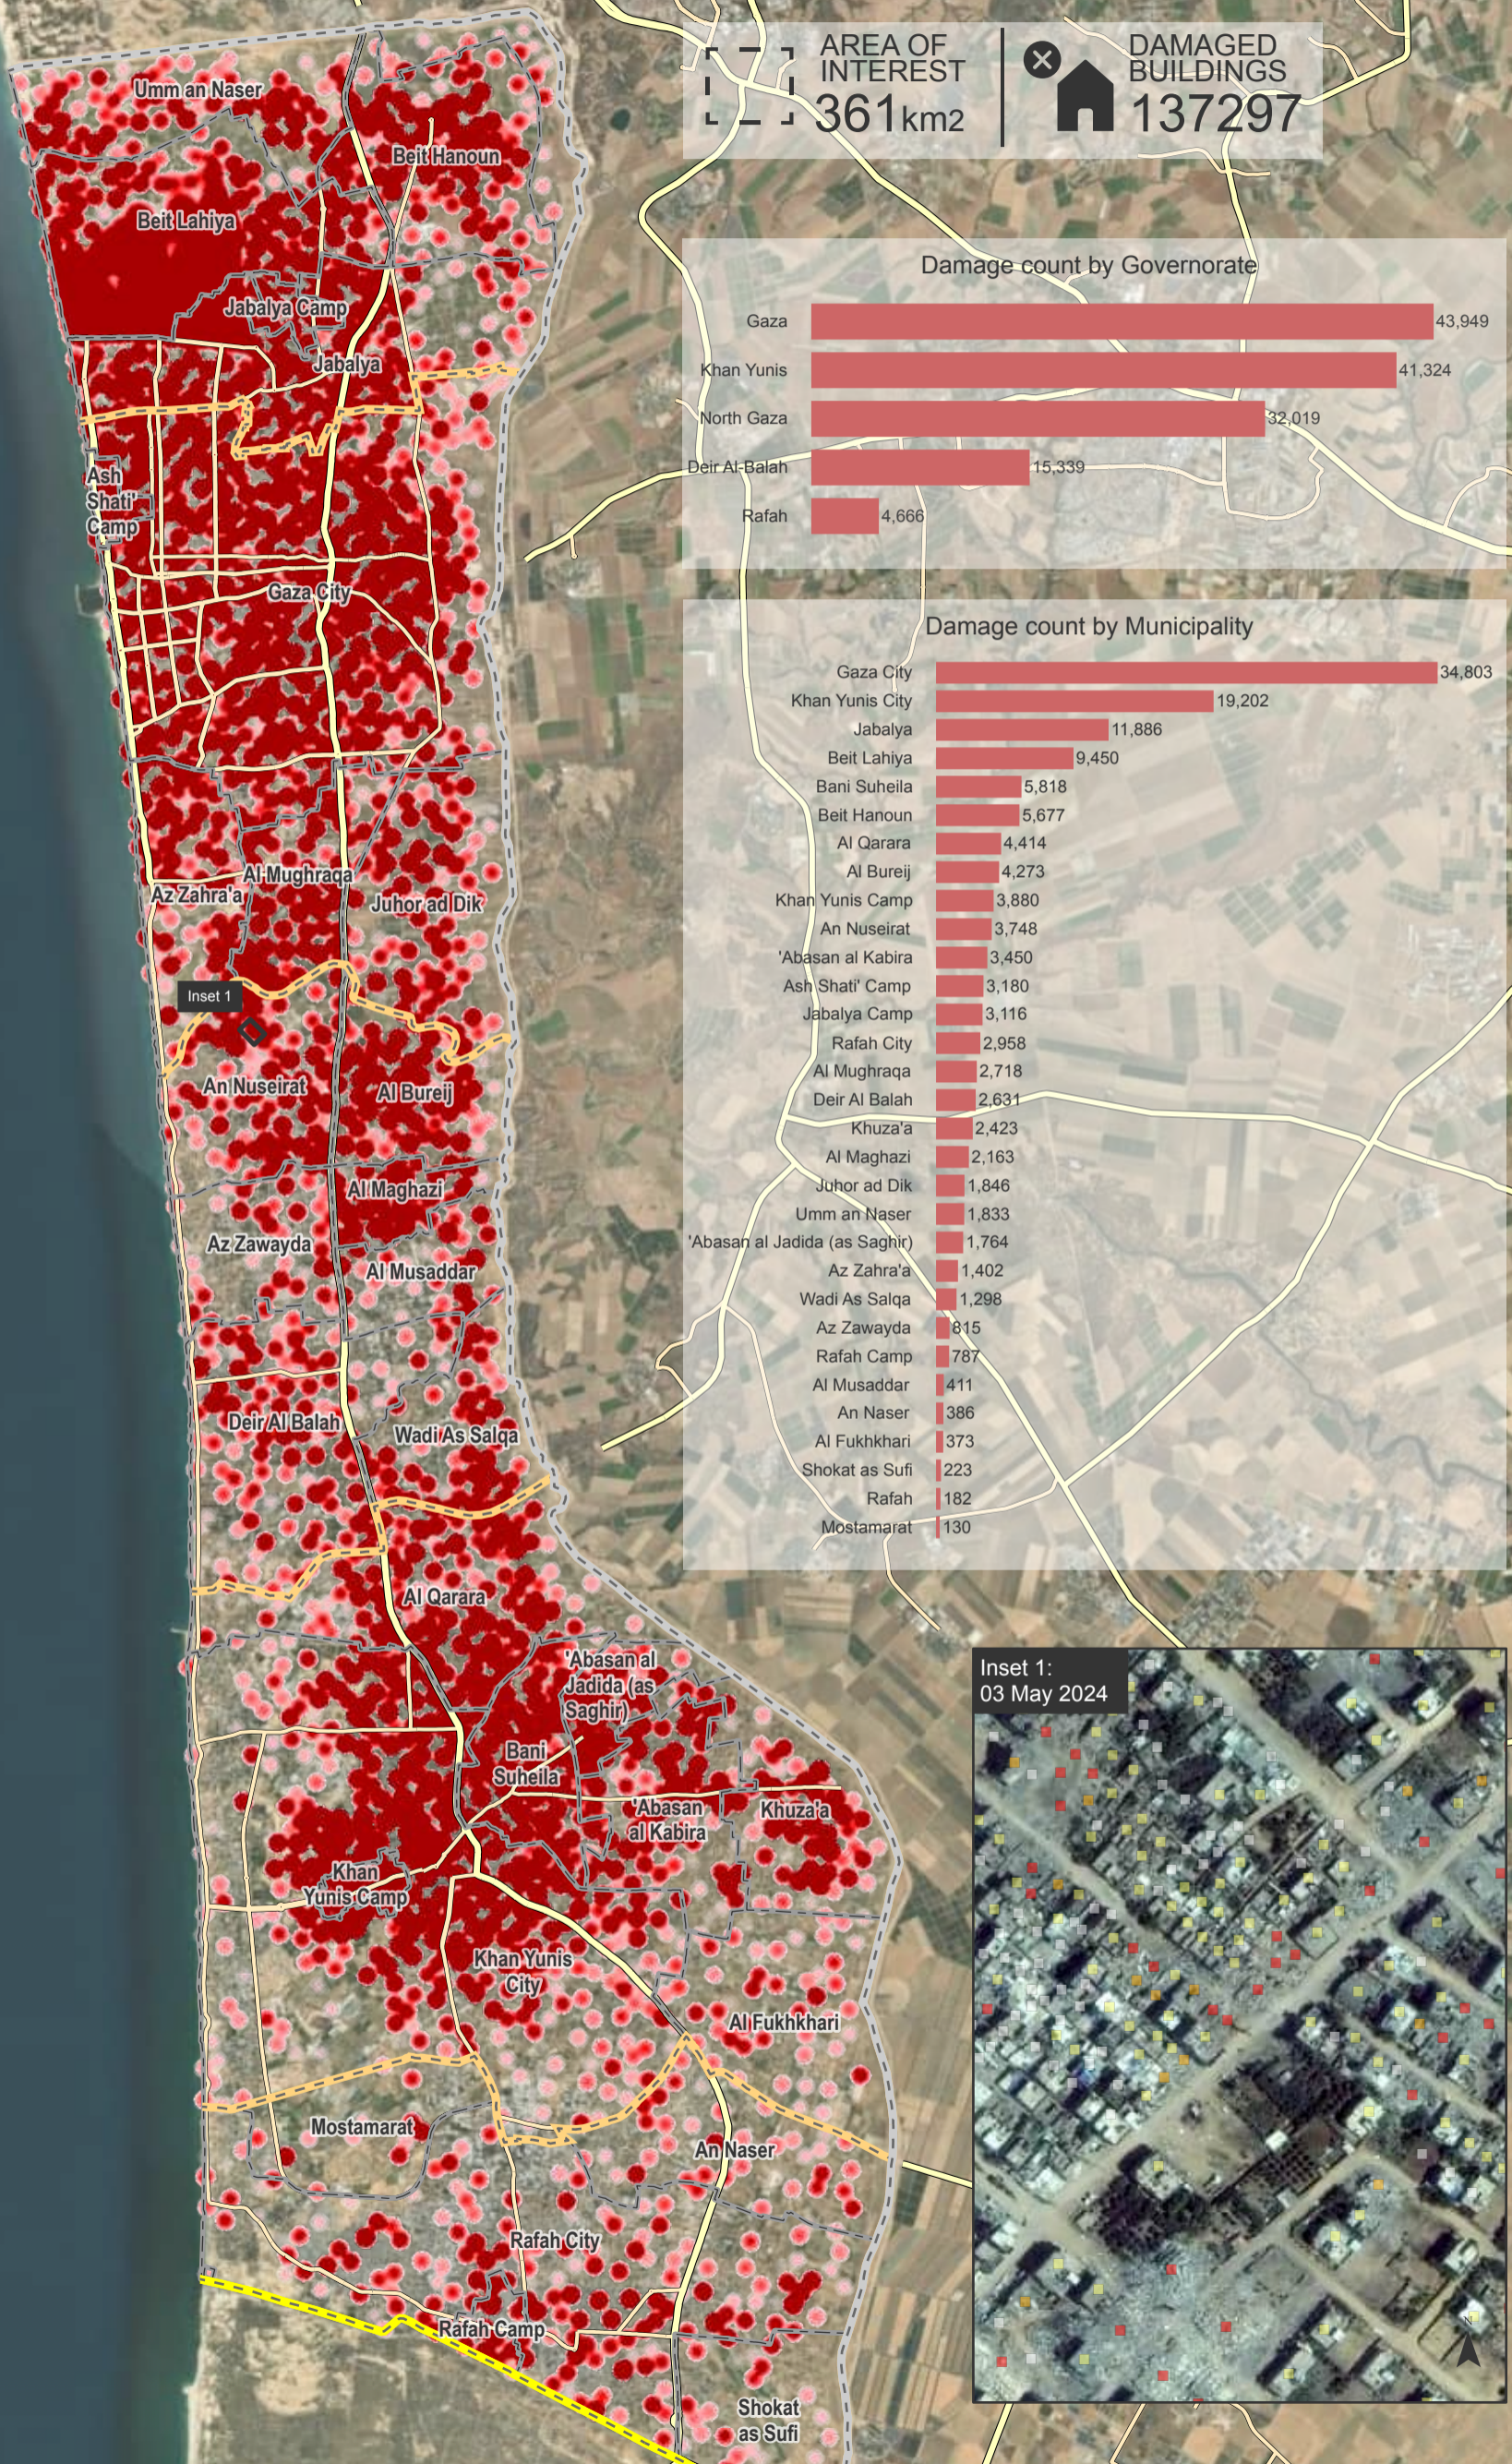
DAMAGED BUILDINGS
137,297

This map illustrates a satellite imagery based comprehensive assessment of damage and destruction to structures within the area of interest in the Gaza Strip, Occupied Palestinian Territory, based on images collected on 1 May 2023, 10 May 2023, 18 September 2023, 15 October 2023, 7 November 2023, 26 November 2023, 6-7 January 2024, 29 February 2024, and 31 March - 1 April 2024. According to satellite imagery analysis, UNOSAT identified 36,591 destroyed structures, 16,513 severely damaged structures, 47,368 moderately damaged structures, and 36,825 possibly damaged structures for a total of 137,297 structures. These correspond to around 55% of the total structures in the Gaza Strip and a total of 135,142 estimated damaged housing units. The governorates of Deir Al-Balah and Gaza have experienced the highest rise in damage compared to the 1 April 2024 analysis, with 2,613 new structures damaged in Deir Al-Balah and 2,368 in Gaza. Within Deir Al-Balah, An Nuseirat municipality had the highest number of newly damaged structures, totaling 1,216. This is a preliminary analysis and has not yet been validated in the field.
