# OCCUPIED PALESTINIAN TERRITORY

## GAZA STRIP

IMAGERY ANALYSIS: 06 July 2024 / PUBLISHED: 31 July 2024 / V1

### UNOSAT Damage Assessment Overview Map

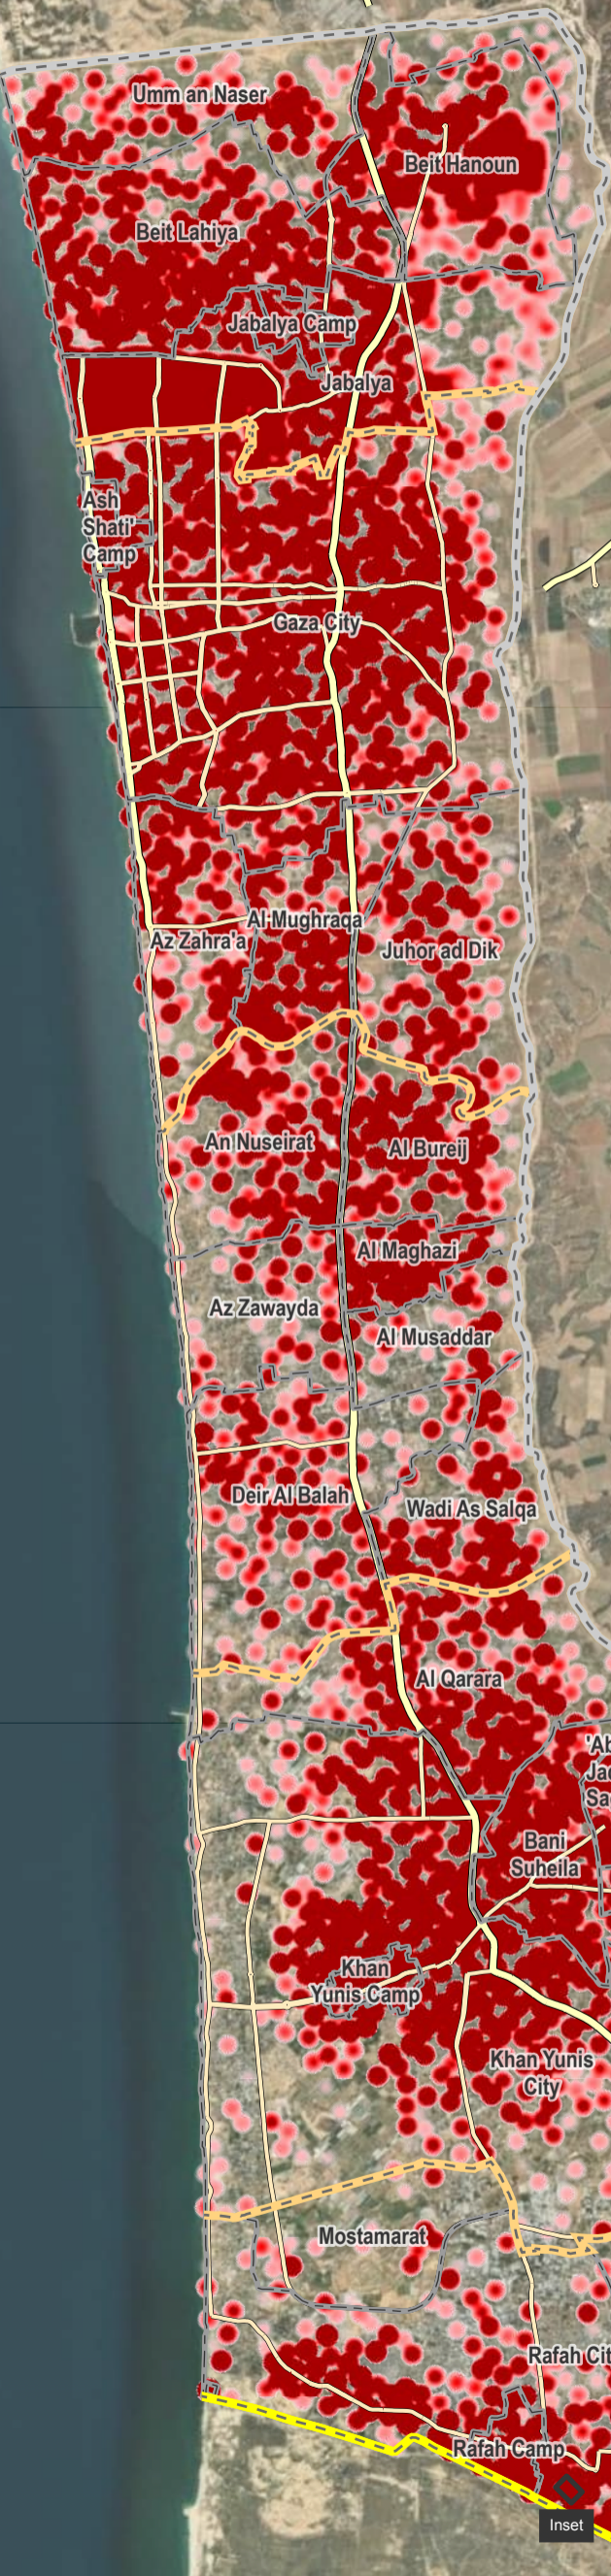
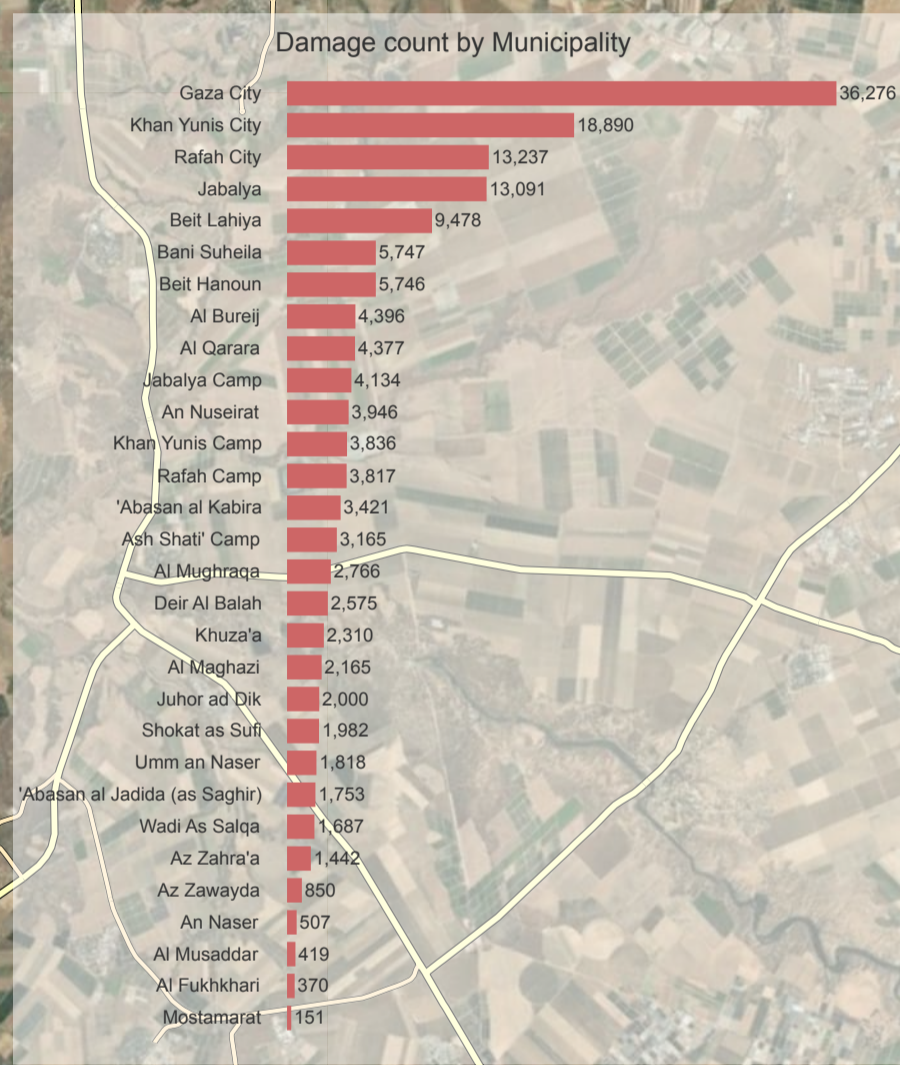
This map illustrates a satellite imagery-based comprehensive assessment of damage and destruction to structures within the area of interest in the Gaza Strip, Occupied Palestinian Territory, based on images collected on 1 May 2023, 10 May 2023, 18 September 2023, 15 October 2023, 7 November 2023, 26 November 2023, 6-7 January 2024, 29 February 2024, 31 March - 1 April 2024, and 3 May 2024. According to satellite imagery analysis, UNOSAT identified 46,223 destroyed structures, 18,478 severely damaged structures, 55,954 moderately damaged structures, and 35,754 possibly damaged structures for a total of 156,409 structures. These correspond to around 63% of the total structures in the Gaza Strip and a total of 215,137 estimated damaged housing units. The governorates of North Gaza and Rafah have experienced the highest rise in damage compared to the 3 May 2024 analysis, with around 2,300 new structures damaged in North Gaza and around 15,030 in Rafah. Within Rafah, Rafah City municipality had the highest number of newly damaged structures, totalling almost 10,100. This is a preliminary analysis and has not yet been validated in the field.
