# NIGERIA

## MOKWA TOWN, NIGER LOCAL GOVERNMENT AREA, NIGER STATE

IMAGERY ANALYSIS: 02/06/2025 PUBLISHED 03/06/2025 V1.

### Flood impact assessment in Mokwa Town, Niger Local Government Area, Niger State, Nigeria as of 2 June 2025

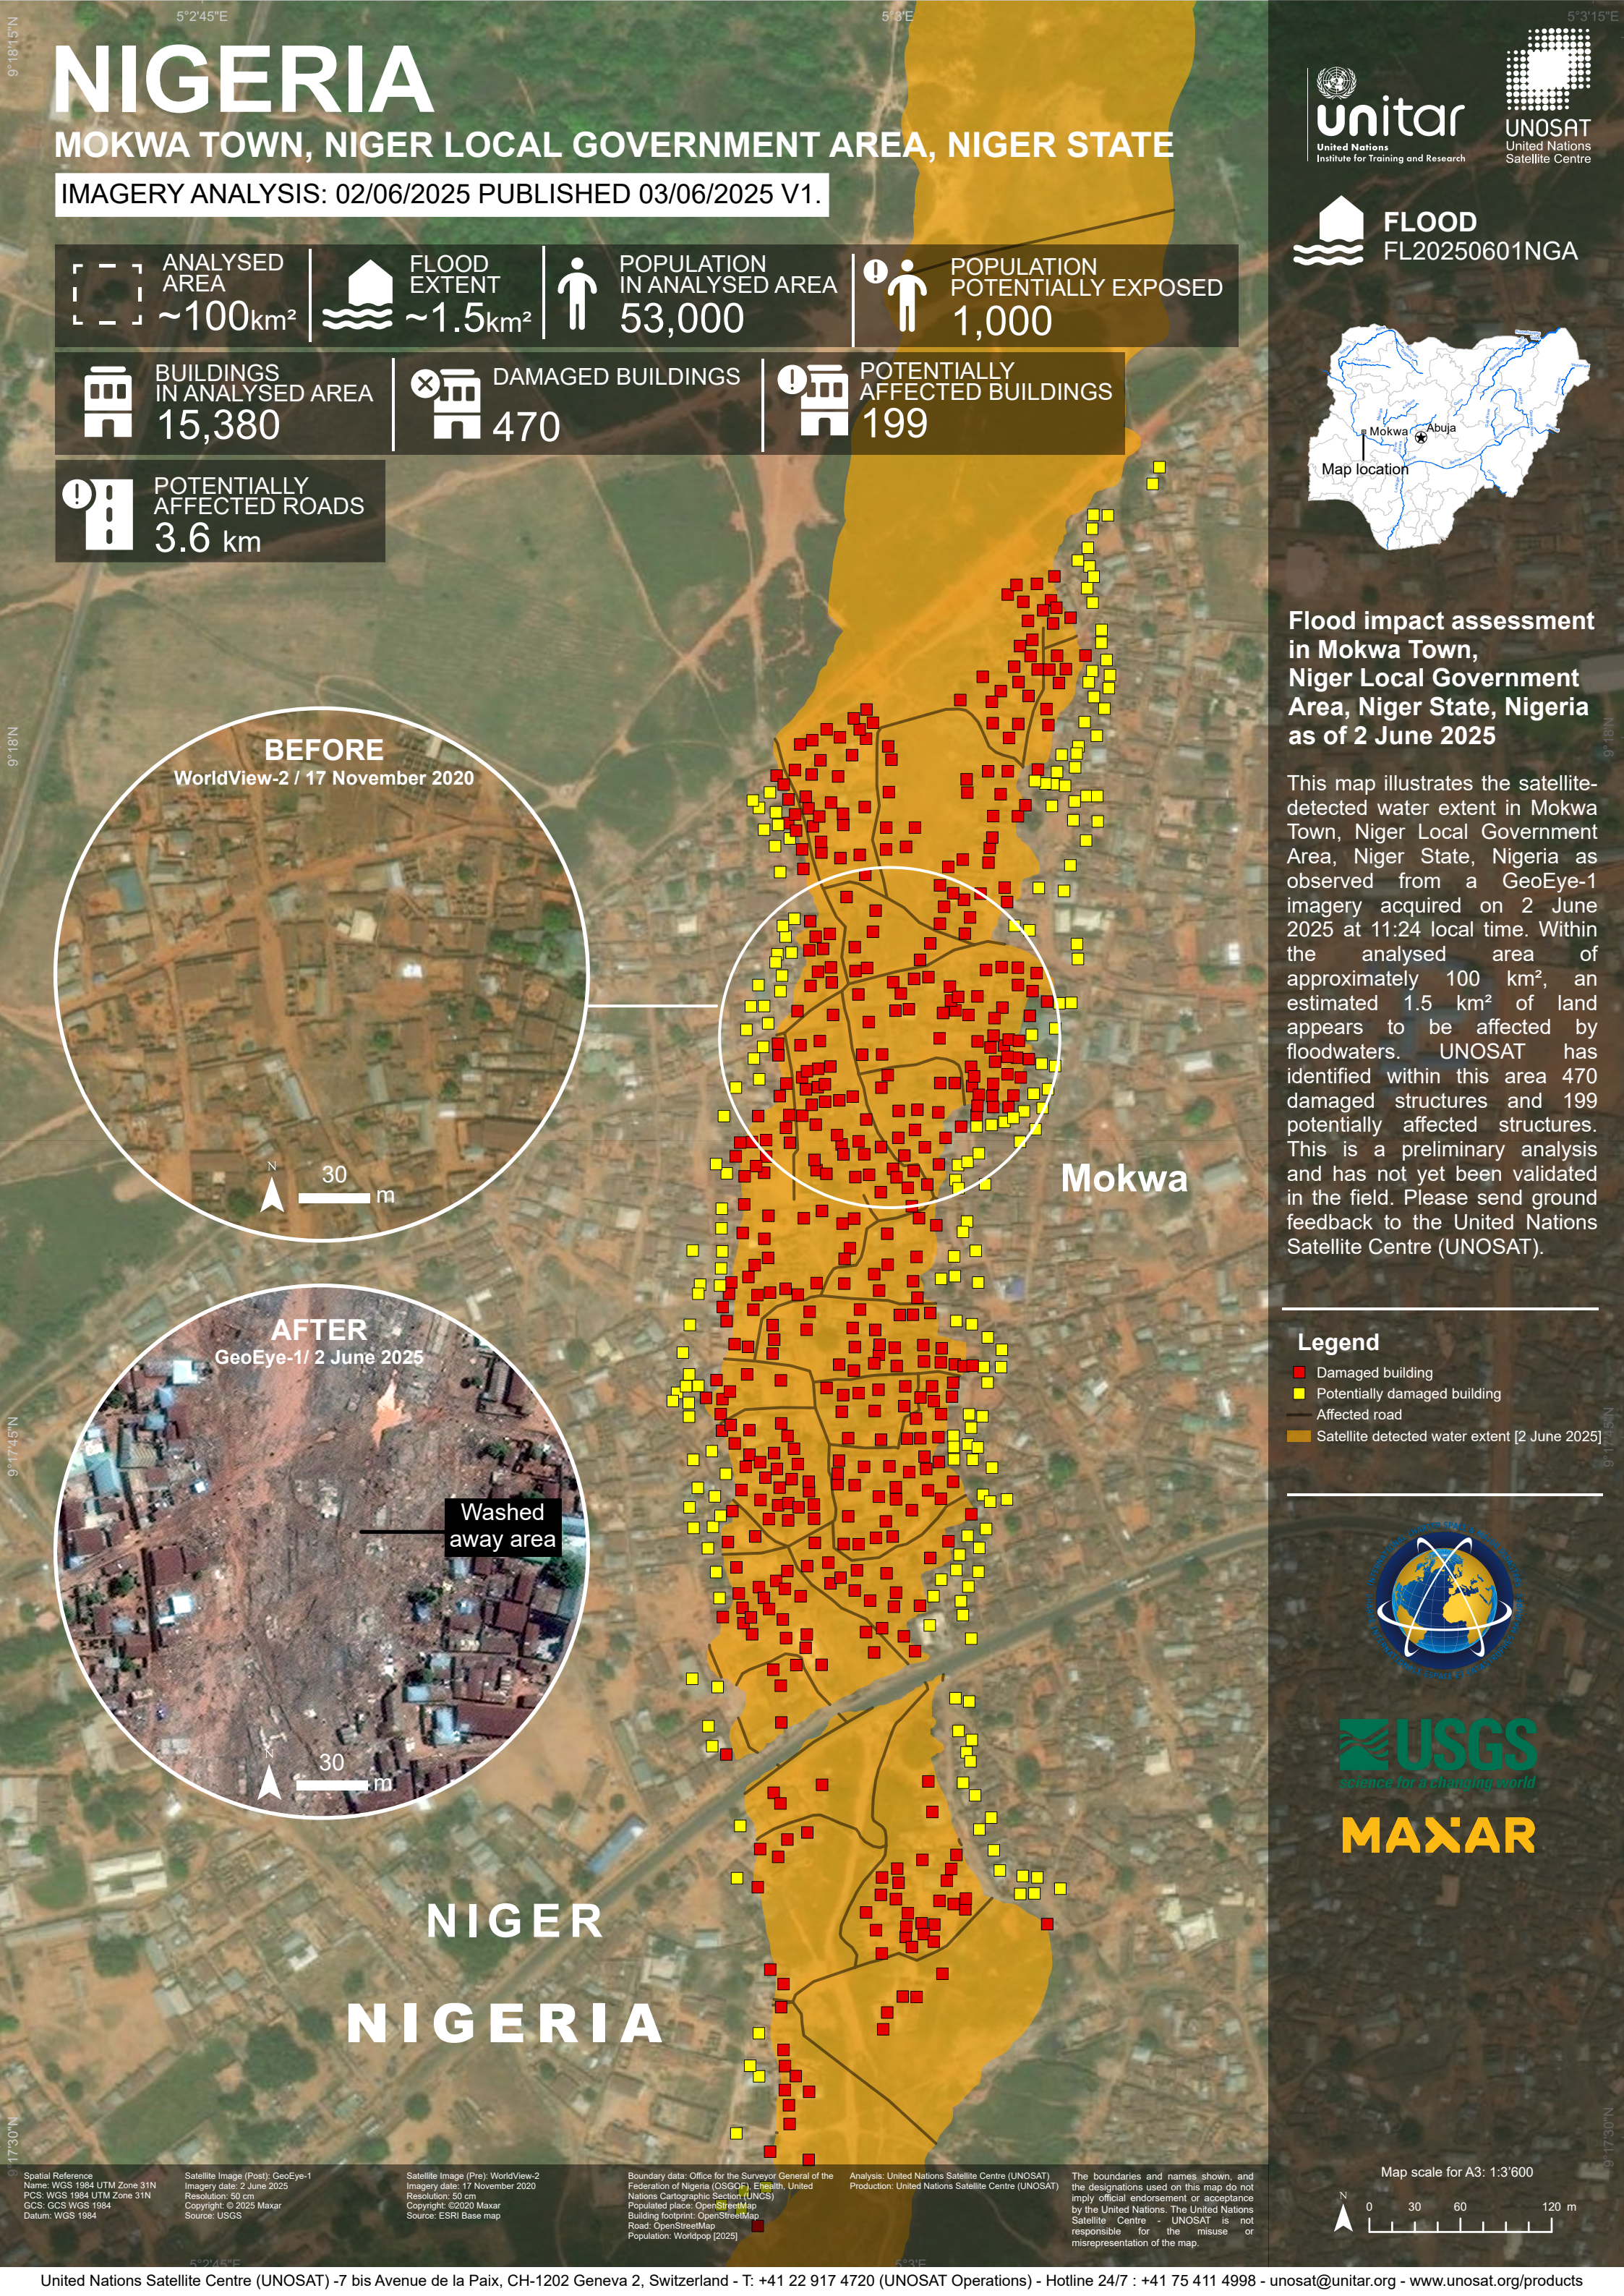
ANALYSED AREA ~100km <sup>2</sup>	FLOOD EXTENT ~1.5km <sup>2</sup>	POPULATION IN ANALYSED AREA 53,000	POPULATION POTENTIALLY EXPOSED 1,000
BUILDINGS IN ANALYSED AREA 15,380	DAMAGED BUILDINGS 470	POTENTIALLY AFFECTED BUILDINGS 199	
POTENTIALLY AFFECTED ROADS 3.6 km

This map illustrates the satellite-detected water extent in Mokwa Town, Niger Local Government Area, Niger State, Nigeria as observed from a GeoEye-1 imagery acquired on 2 June 2025 at 11:24 local time. Within the analysed area of approximately 100 km<sup>2</sup>, an estimated 1.5 km<sup>2</sup> of land appears to be affected by floodwaters. UNOSAT has identified within this area 470 damaged structures and 199 potentially affected structures. This is a preliminary analysis and has not yet been validated in the field. Please send ground feedback to the United Nations Satellite Centre (UNOSAT).
