17 July 2025

United Nations Office for the Coordination of Humanitarian Affairs - UNOCHA

UNOSAT Comprehensive Damage Assessment and Security Analysis
of Tulkarm, Nur Shams and Jenin Refugee Camps in Tulkarm and
Jenin Governorates, West Bank, Occupied Palestinian Territory

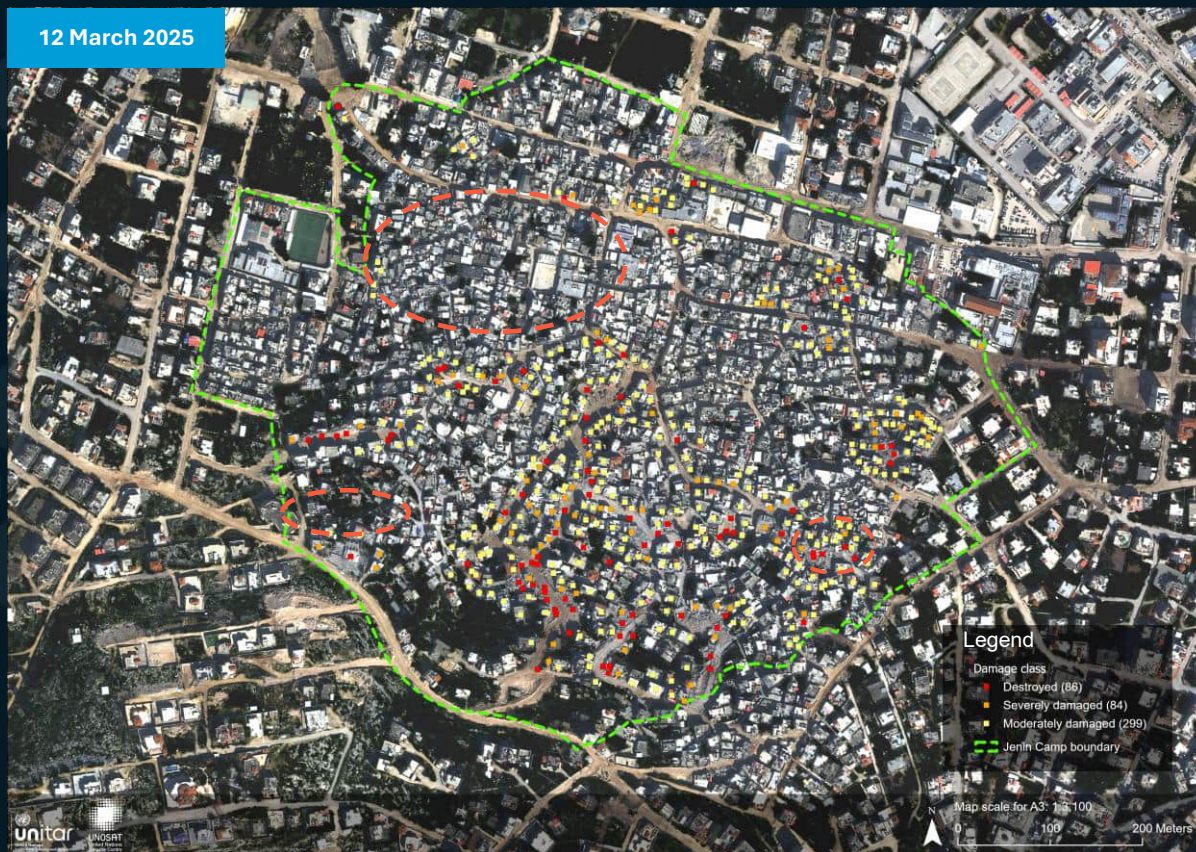
Comprehensive damage assessment Jenin Camp

UNOSAT acquired two Pleiades NEO satellite images of Jenin Camp, Jenin Governorate, West Bank, Occupied Palestinian Territory, collected on 21 May 2025 and 12 March 2025. As of 21 May 2025, when compared to 12 March 2025, new damaged and destroyed buildings were visible, and the total count of damaged and destroyed structures identified in Jenin Camp increased from 469 to 548.

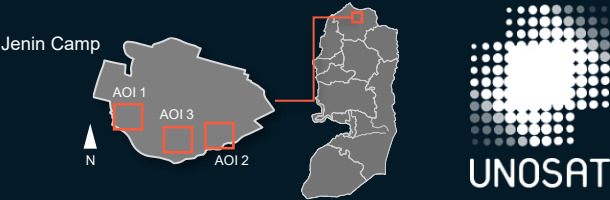
Comprehensive damage assessment Jenin Camp – AOI 1, 2 and 3

Changes observed

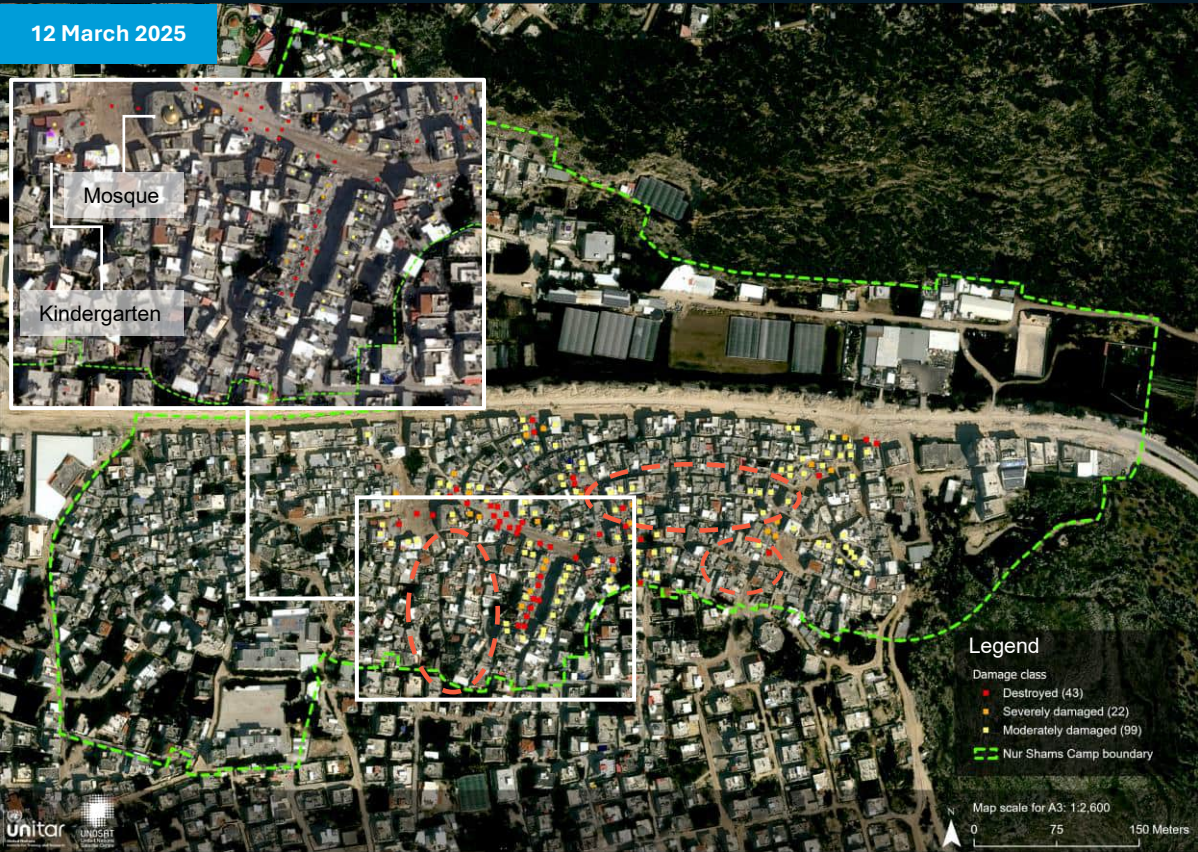
Comprehensive damage assessment

UNOSAT acquired two Pleiades NEO satellite images of Nur Shams Camp, Tulkarem Governorate, West Bank, Occupied Palestinian Territory, collected on 21 May 2025 and 12 March 2025. As of 21 May 2025, when compared to 12 March 2025, new damaged and destroyed buildings were visible, and the total count of damaged and destroyed structures identified in Nur Shams Camp increased from 164 to 280.

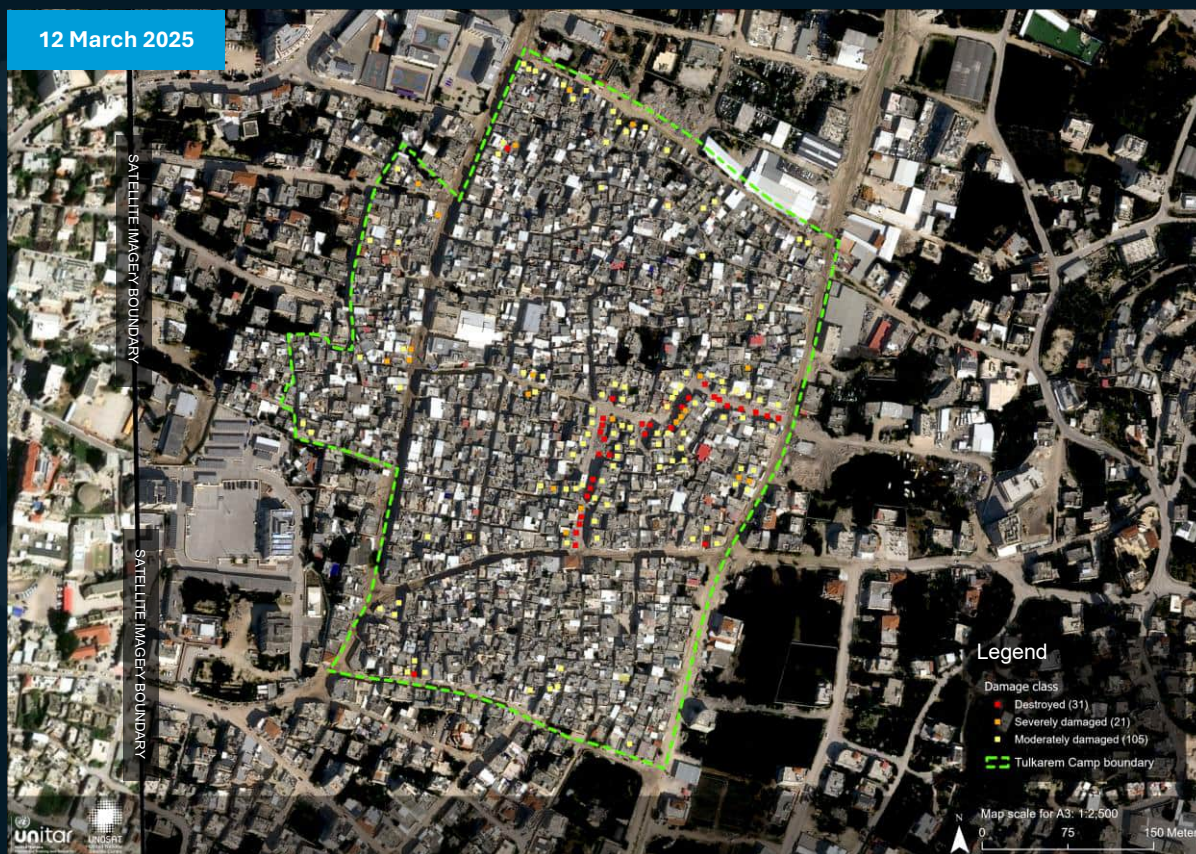
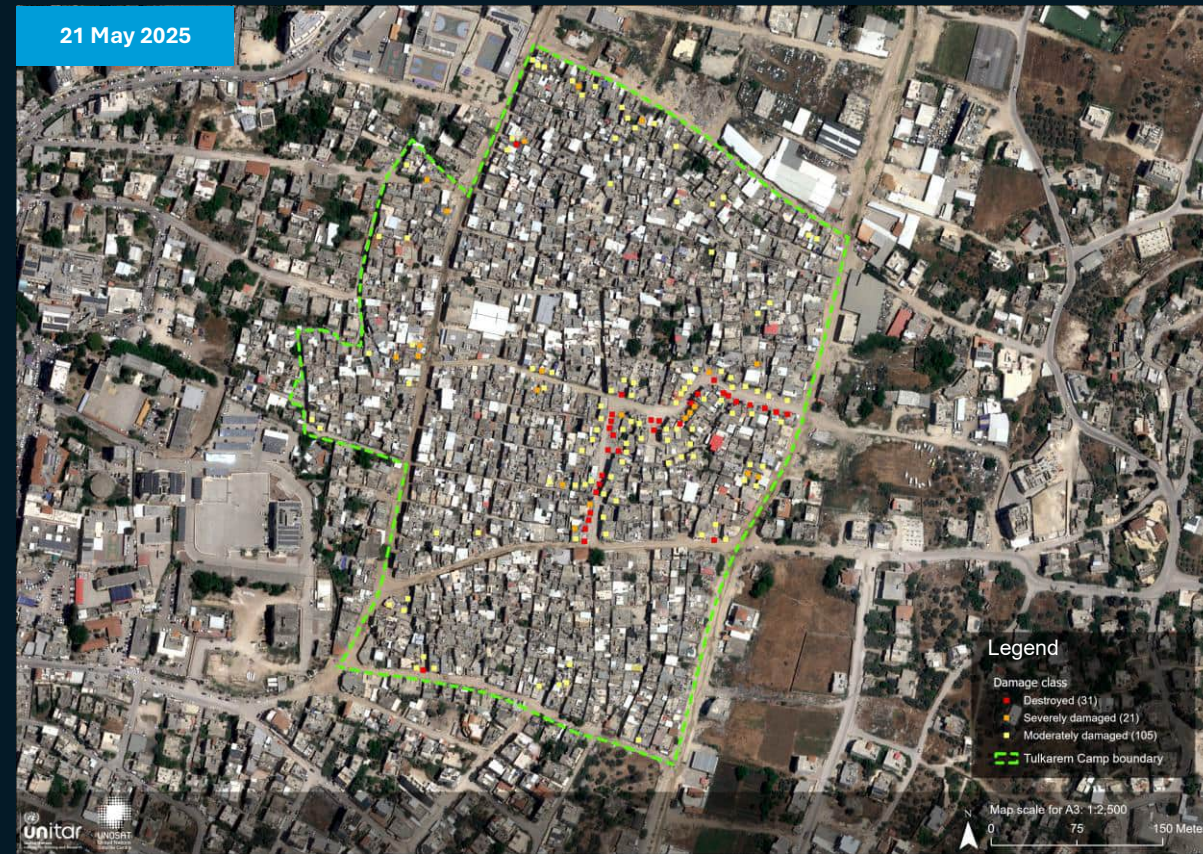
Comprehensive damage assessment Tulkarem Camp

UNOSAT acquired two Pleiades NEO satellite images of Tulkarem Camp, Tulkarem Governorate, West Bank, Occupied Palestinian Territory, collected on 21 May 2025 and 12 March 2025. As of 21 May 2025, when compared to 12 March 2025, no new damaged building was observed, and the total count of damaged and destroyed structures identified in Tulkarem Camp remains at 157.

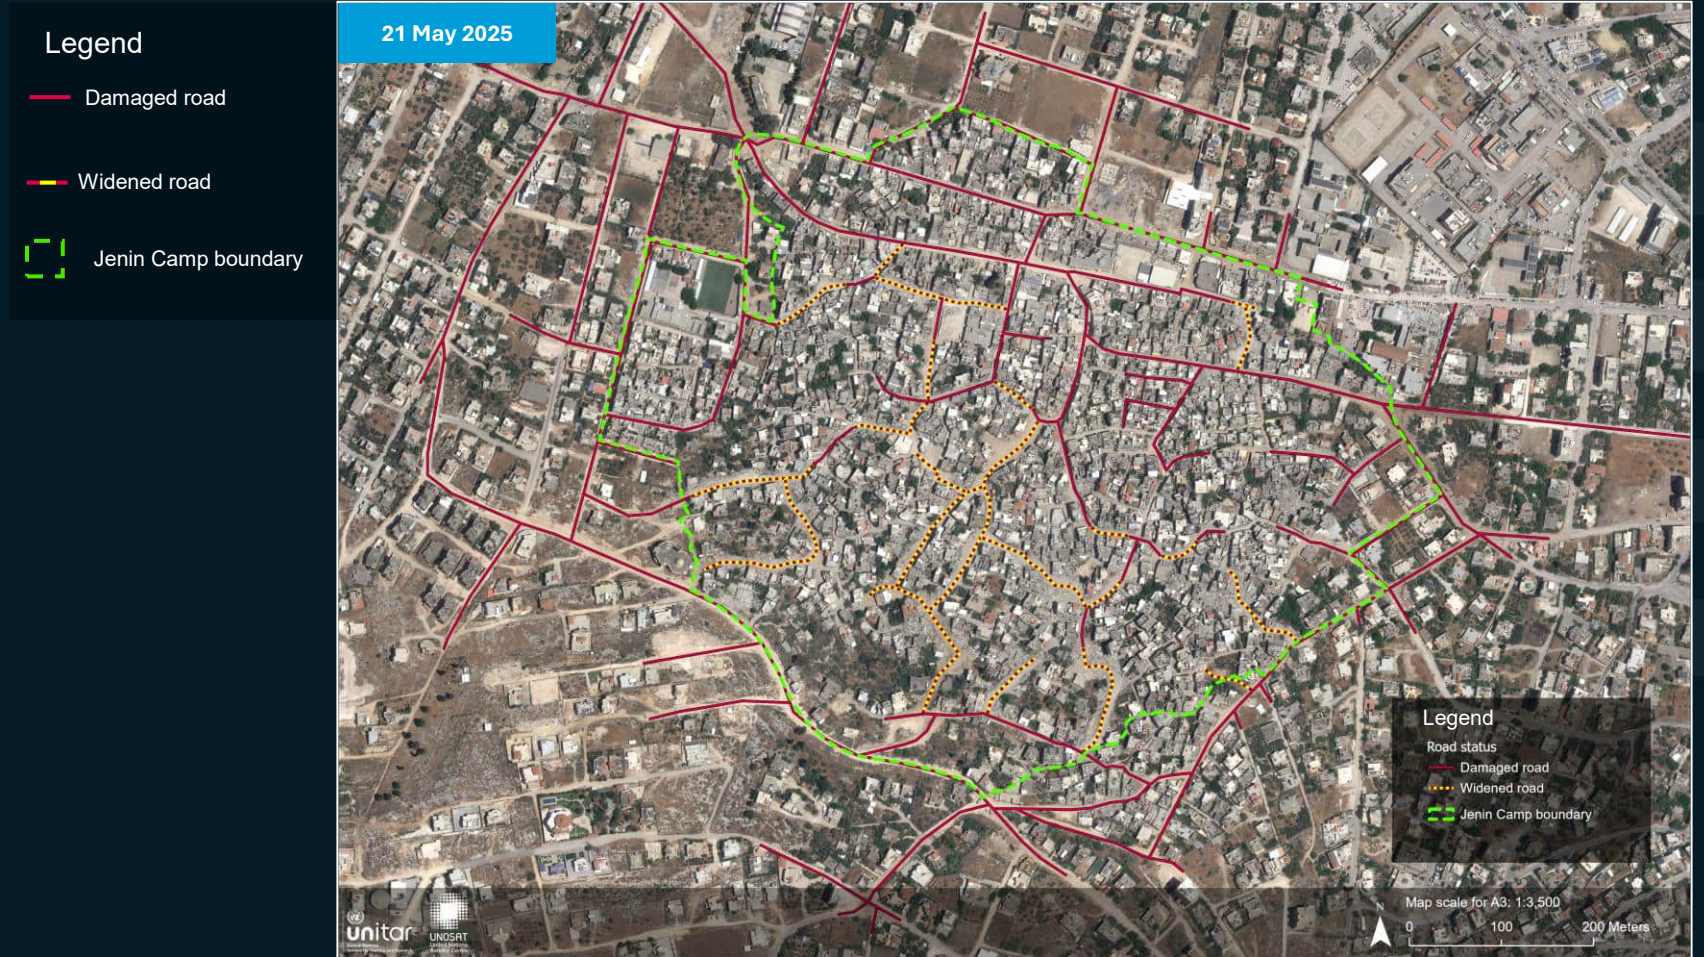
Road damage assessment Jenin Camp

This map illustrates a UNOSAT satellite imagery-based comprehensive assessment of damage to roads within Jenin Camp, Jenin Governorate, West Bank, Occupied Palestinian Territory, based on images collected on 21 May 2025 when compared to an image collected on 12 March 2025.

According to the satellite imagery analysis, UNOSAT identified several damaged roads and widened roads, in the vicinity of Jenin Camp, as of 21 May 2025.

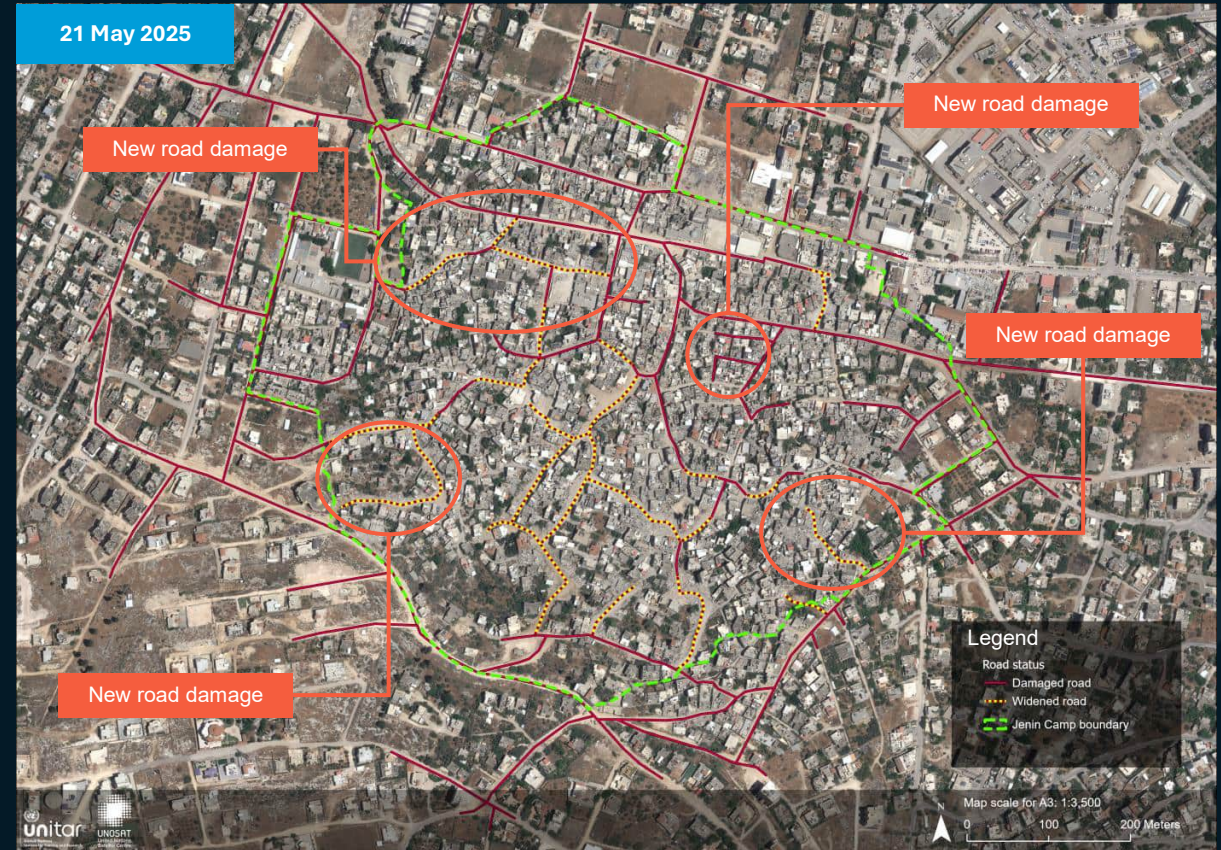
Road damage assessment Jenin Camp

UNOSAT acquired two Pleiades NEO satellite images of Jenin Camp, Jenin Governorate, West Bank, Occupied Palestinian Territory, collected on 21 May 2025 and 12 March 2025. As of 12 March 2025, significant sections of roads in the vicinity of Jenin Camp appeared damaged or widened, making the vehicular access for civilian vehicles extremely difficult or even impossible. Along the widened roads, buildings appeared damaged or destroyed. As of 21 May 2025, when compared to 12 March 2025, new sections of roads appeared damaged or widened.

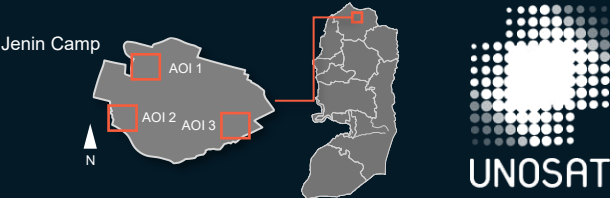
Road damage assessment Jenin Camp – AOI 1, 2 and 3

Changes observed

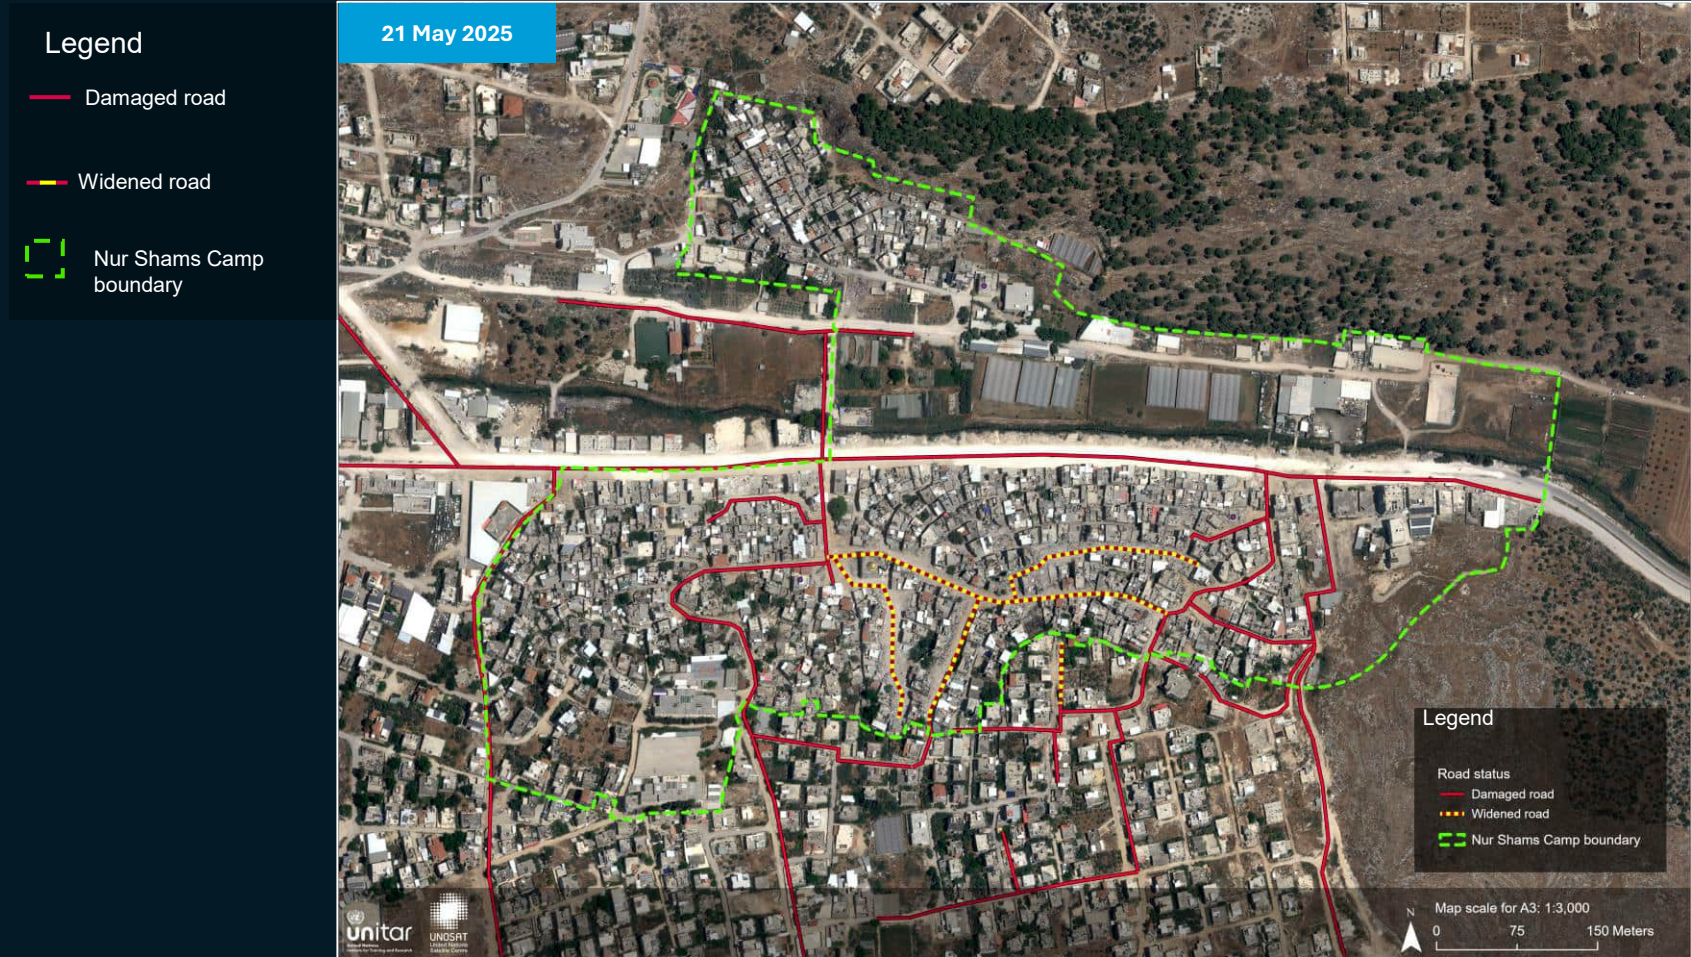
Road damage assessment Nur Shams Camp

This map illustrates a UNOSAT satellite imagery-based comprehensive assessment of damage to roads within Nur Shams Camp, Tulkarem Governorate, West Bank, Occupied Palestinian Territory, based on images collected on 21 May 2025 when compared to an image collected on 12 March 2025.

According to the satellite imagery analysis, UNOSAT identified several damaged roads and widened roads, in the vicinity of Nur Shams Camp, as of 21 May 2025.

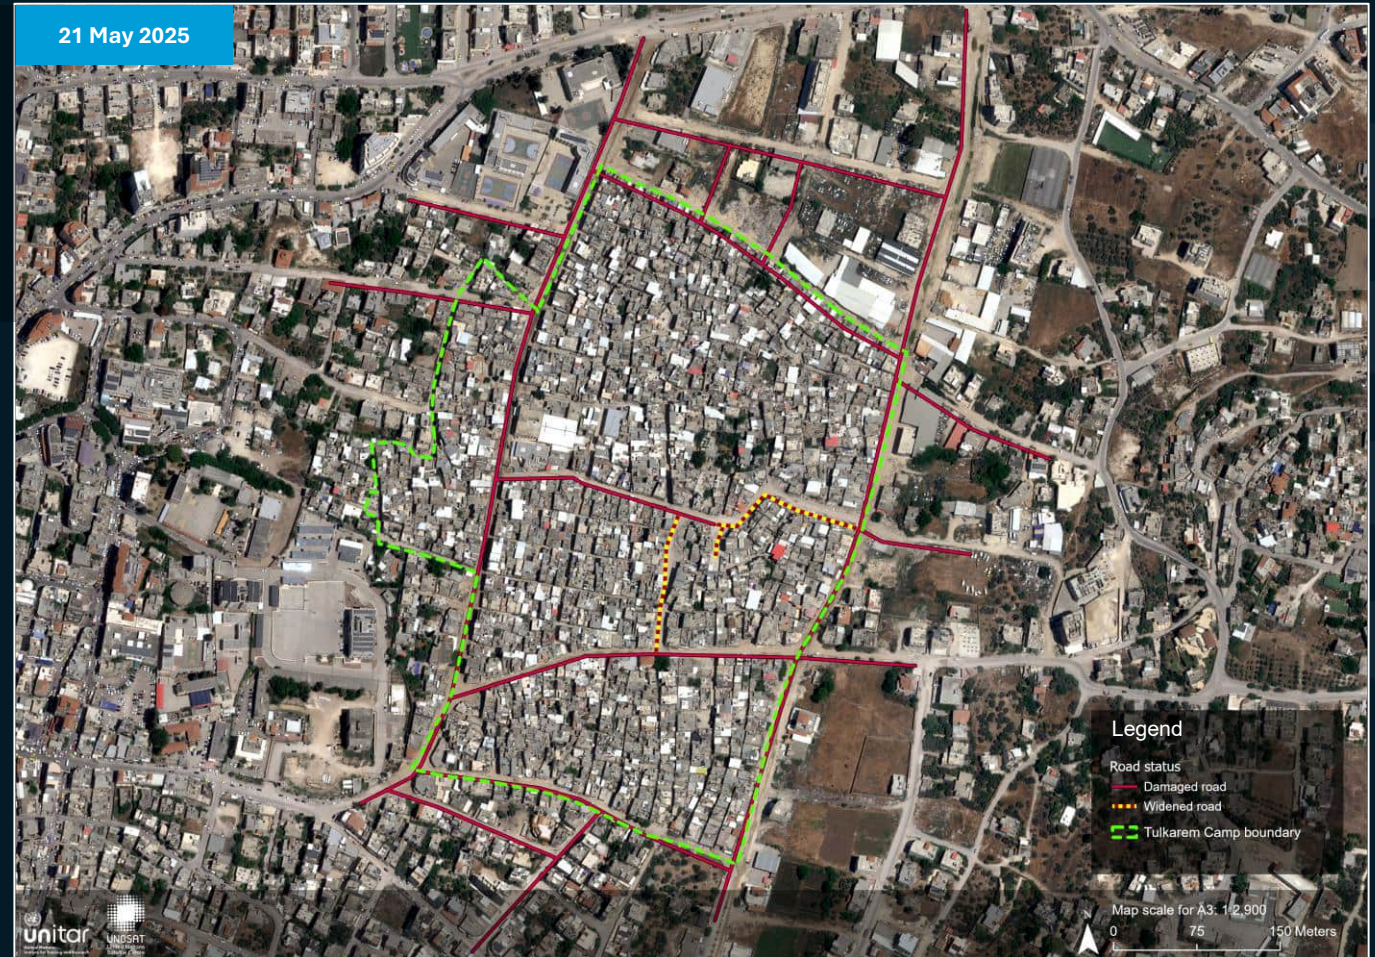
Road damage assessment Tulkarem Camp

This map illustrates a UNOSAT satellite imagery-based comprehensive assessment of damage to roads within Tulkarem Camp, Tulkarem Governorate, West Bank, Occupied Palestinian Territory, based on images collected on 21 May 2025 when compared to an image collected on 12 March 2025.

According to the satellite imagery analysis, UNOSAT has not observed any changes, compared to 12 March 2025, and identified several damaged roads and widened roads, in the vicinity of Tulkarem Camp, as of 21 May 2025.

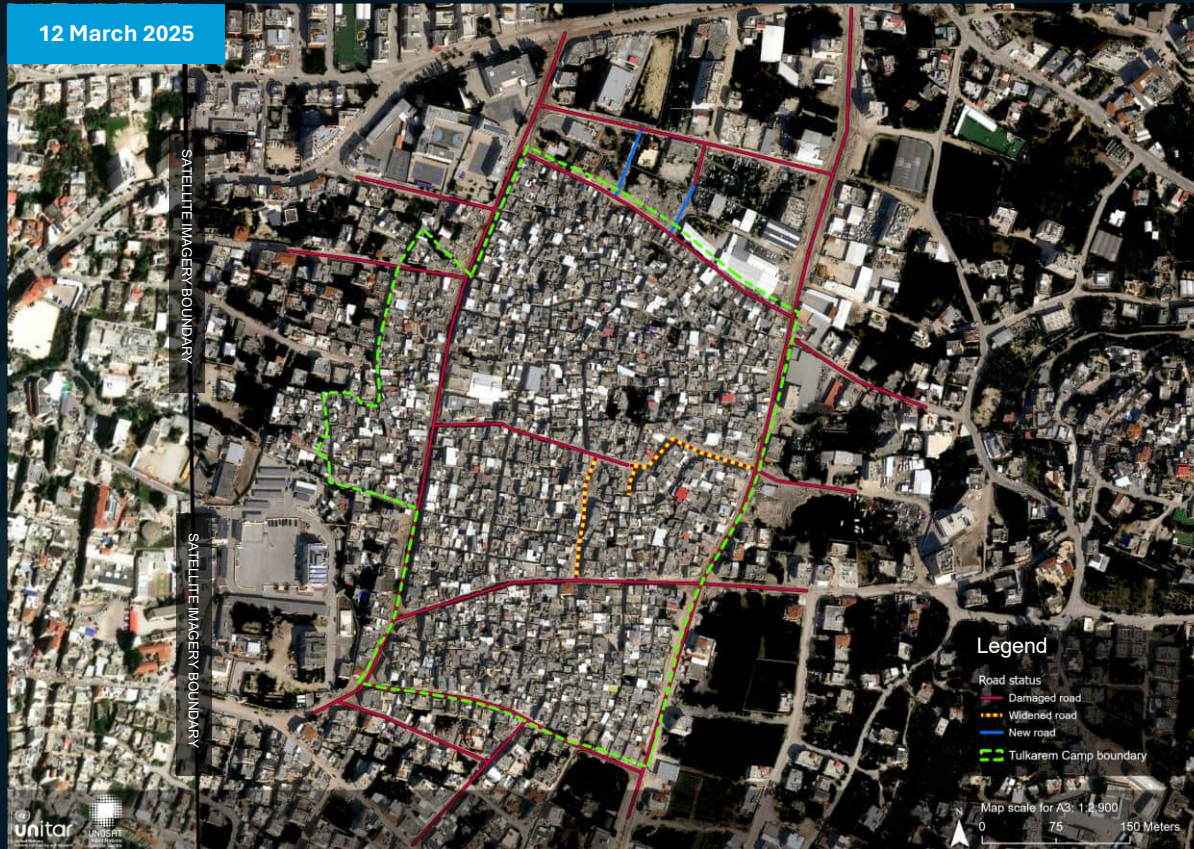
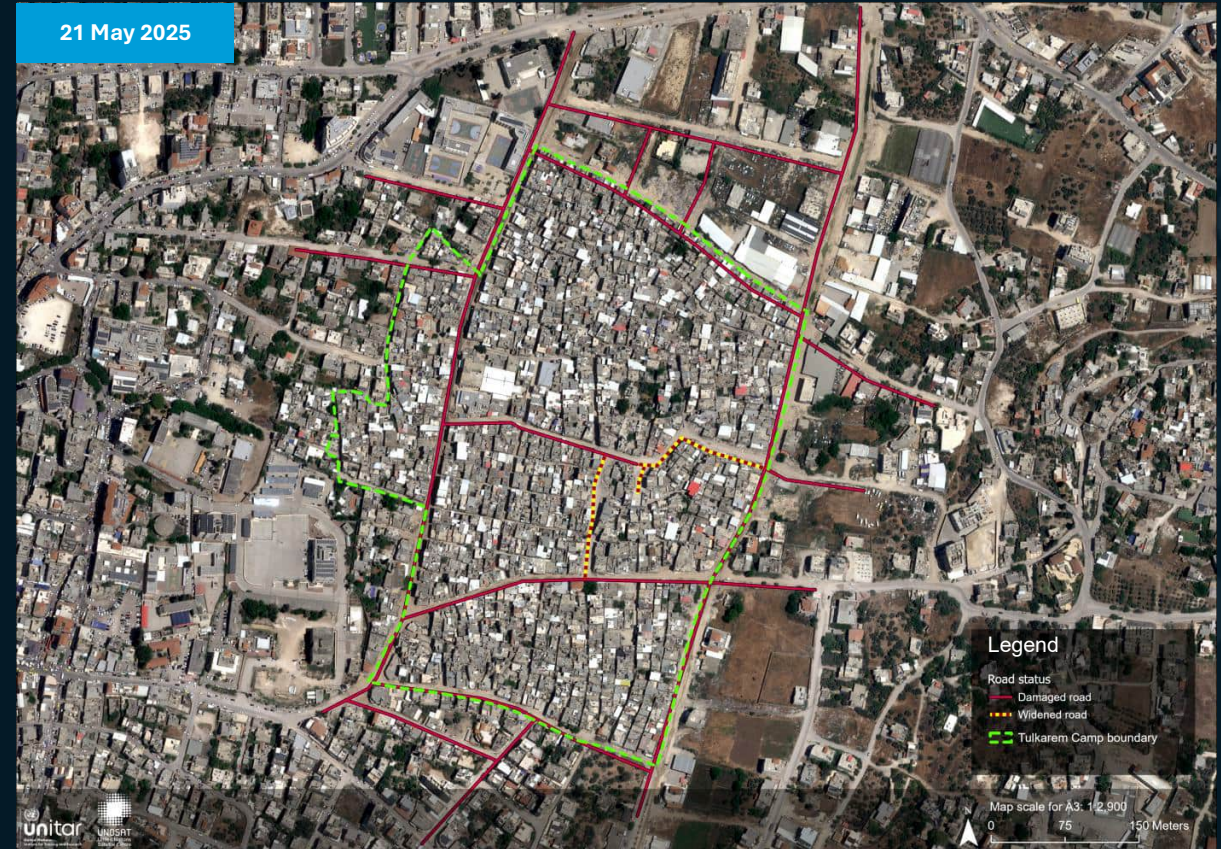
Road damage assessment Tulkarem Camp

UNOSAT acquired two Pleiades NEO satellite images of Tulkarem Camp, Tulkarem Governorate, West Bank, Occupied Palestinian Territory, collected on 21 May 2025 and 12 March 2025. . As of 12 March 2025, sections of roads in the vicinity of Tulkarem Camp appeared damaged or widened, making the vehicular access for civilian vehicles extremely difficult or even impossible. Along the widened roads, buildings appeared damaged or destroyed. As of 21 May 2025, when compared to 12 March 2025, no new damaged road was observed.

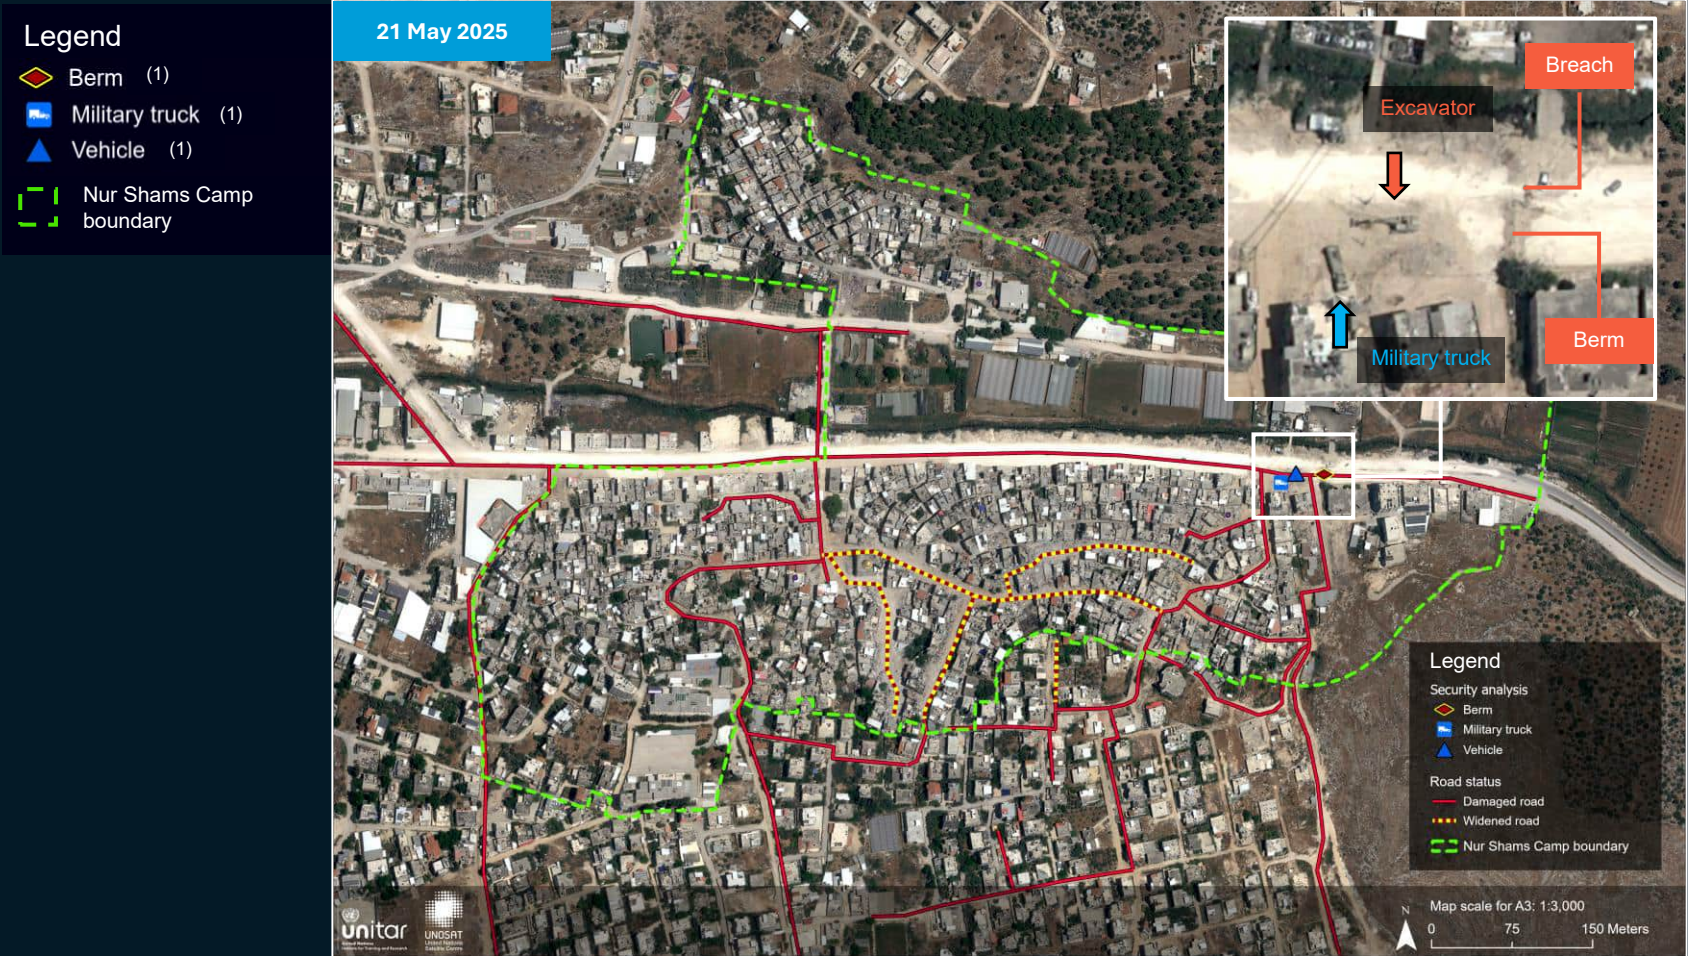
Security assessment Nur Shams Camp

This map illustrates a UNOSAT satellite imagery-based security assessment of Nur Shams Camp, Tulkarem Governorate, West Bank, Occupied Palestinian Territory, based on images collected on 21 May 2025 when compared to an image collected on 12 March 2025.

According to the satellite imagery analysis, UNOSAT identified 1 breached berm, 1 military truck and 1 excavator on the main damaged road crossing the Nur Shams Camp.

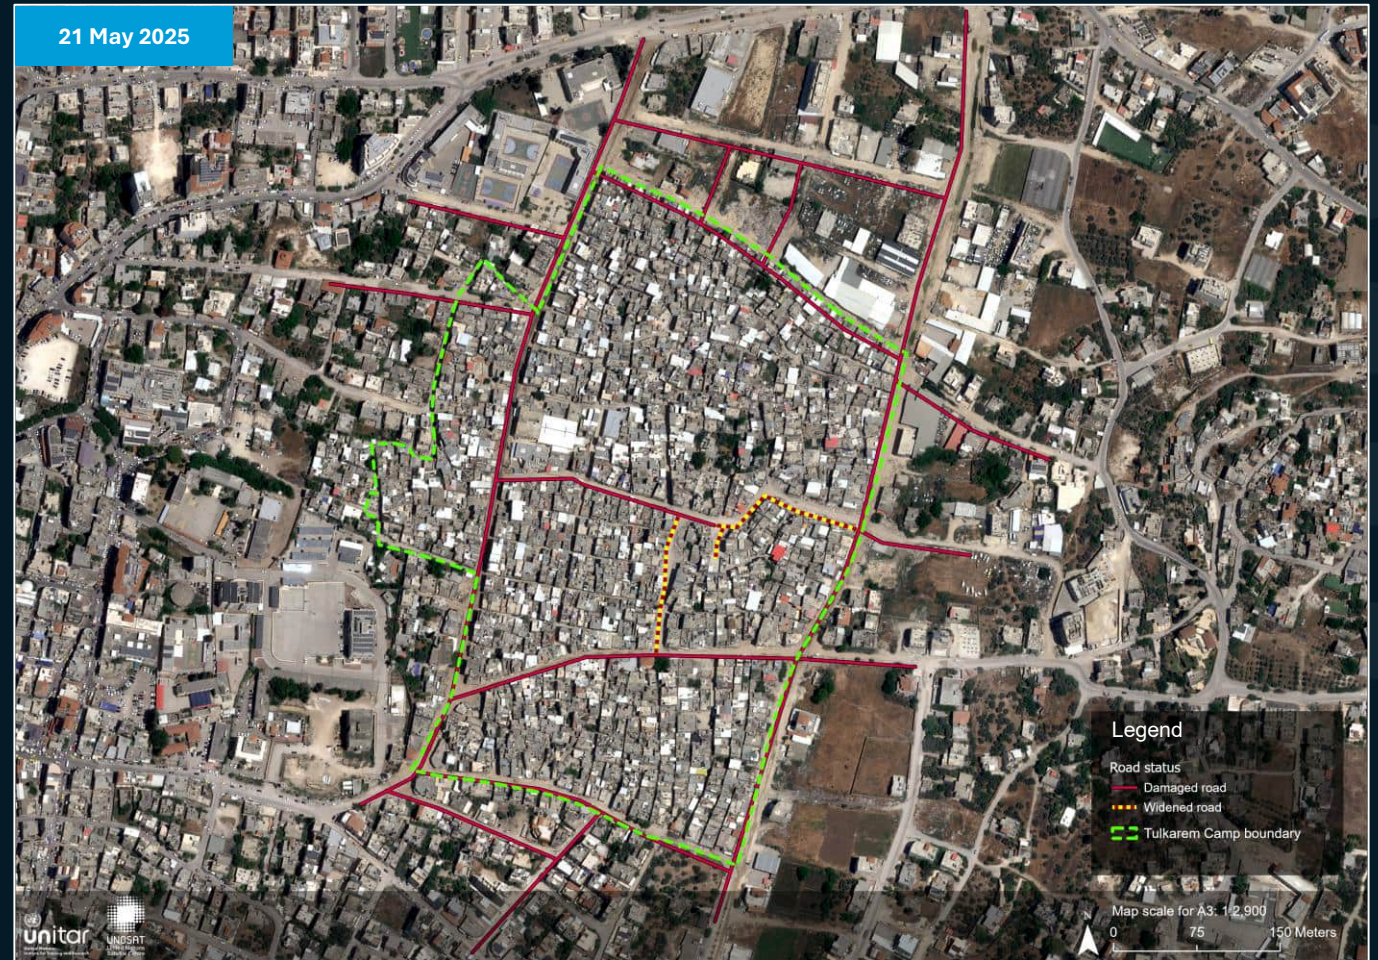
Security assessment Tulkarem Camp

This map illustrates a UNOSAT satellite imagery-based security assessment of Tulkarem Camp, Tulkarem Governorate, West Bank, Occupied Palestinian Territory, based on images collected on 21 May 2025 when compared to an image collected on 12 March 2025.

According to the satellite imagery analysis, No military activity was observed on 21 May 2025 and 12 March 2025, excepted the damage on roads.
