# **United Nations Office for the Coordination of Humanitarian Affairs - UNOCHA**

UNOSAT Comprehensive Damage Assessment and Security Analysis  
of Tulkarm, Nur Shams and Jenin Refugee Camps in Tulkarm and  
Jenin Governorates, West Bank, Occupied Palestinian Territory

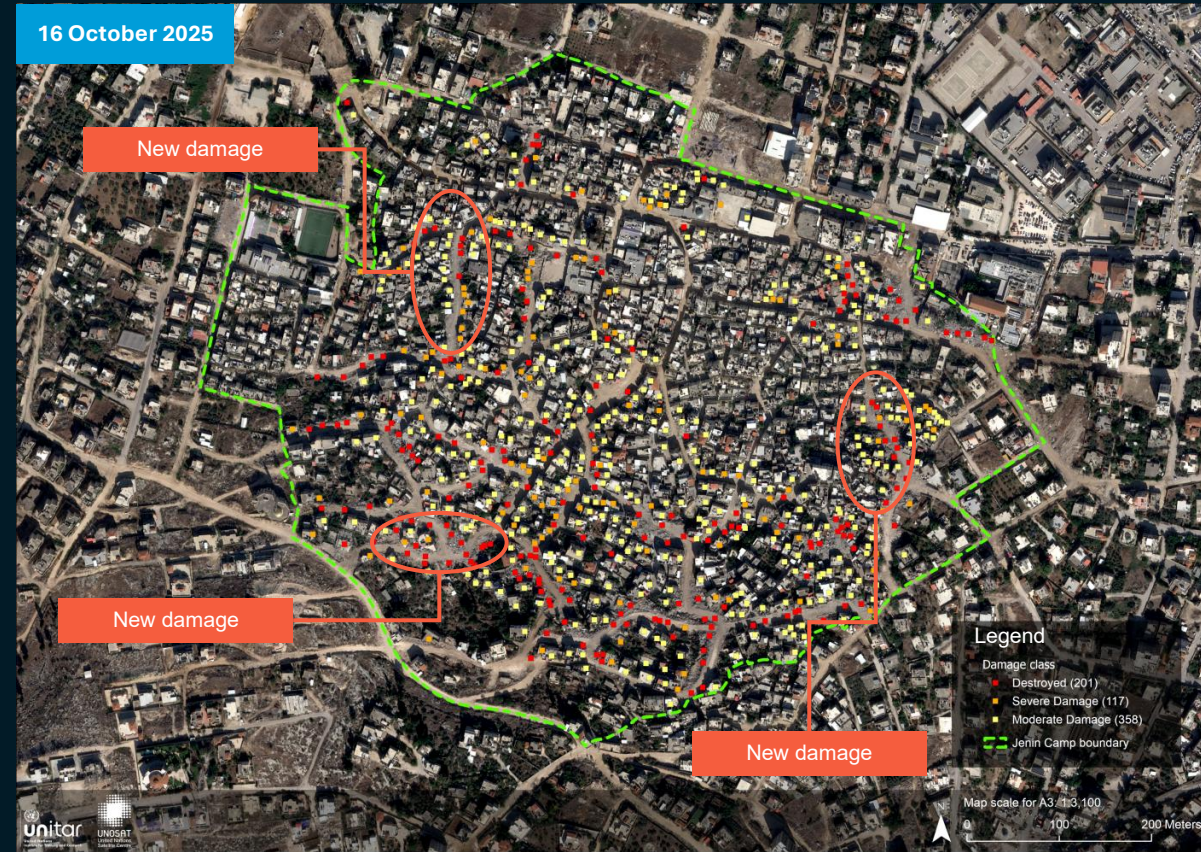
# Comprehensive damage assessment Jenin Camp

UNOSAT acquired two Pleiades NEO satellite images of Jenin Camp, Jenin Governorate, West Bank, Occupied Palestinian Territory, collected on 21 May 2025 and 16 October 2025. As of 16 October 2025, compared to 21 May 2025, additional damaged and destroyed buildings were observed, increasing the total number of affected structures in Jenin Camp from 548 to 676.

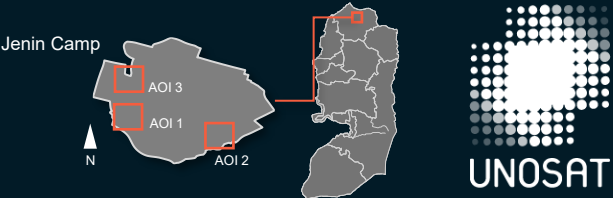
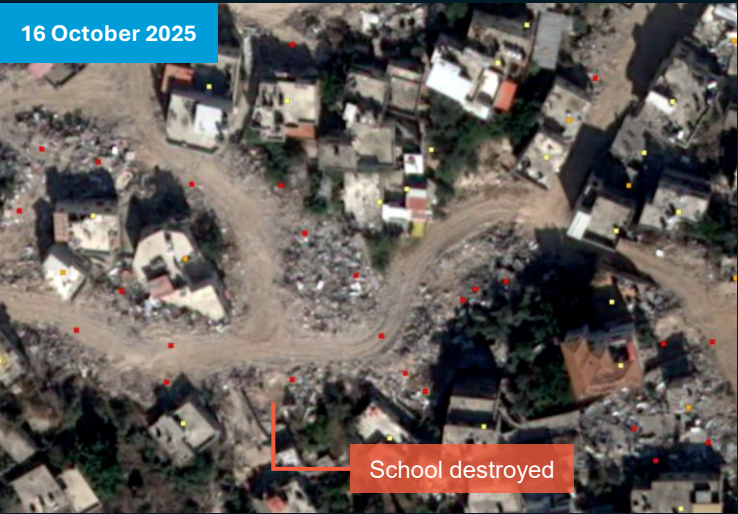
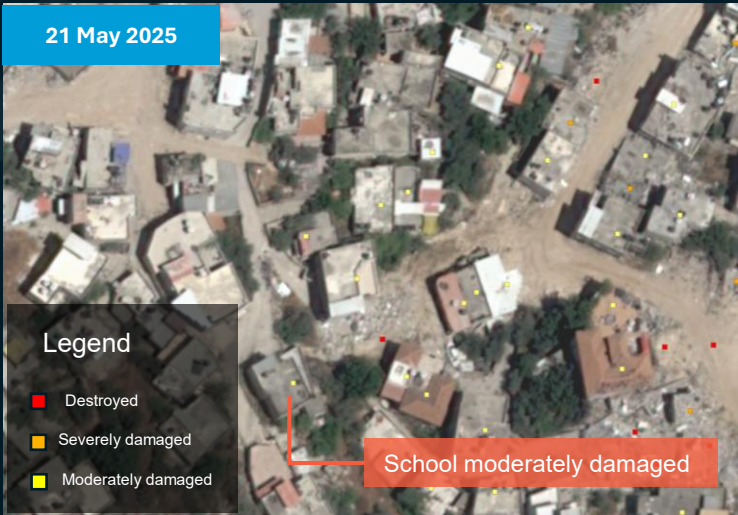
AOI 1

Changes observed

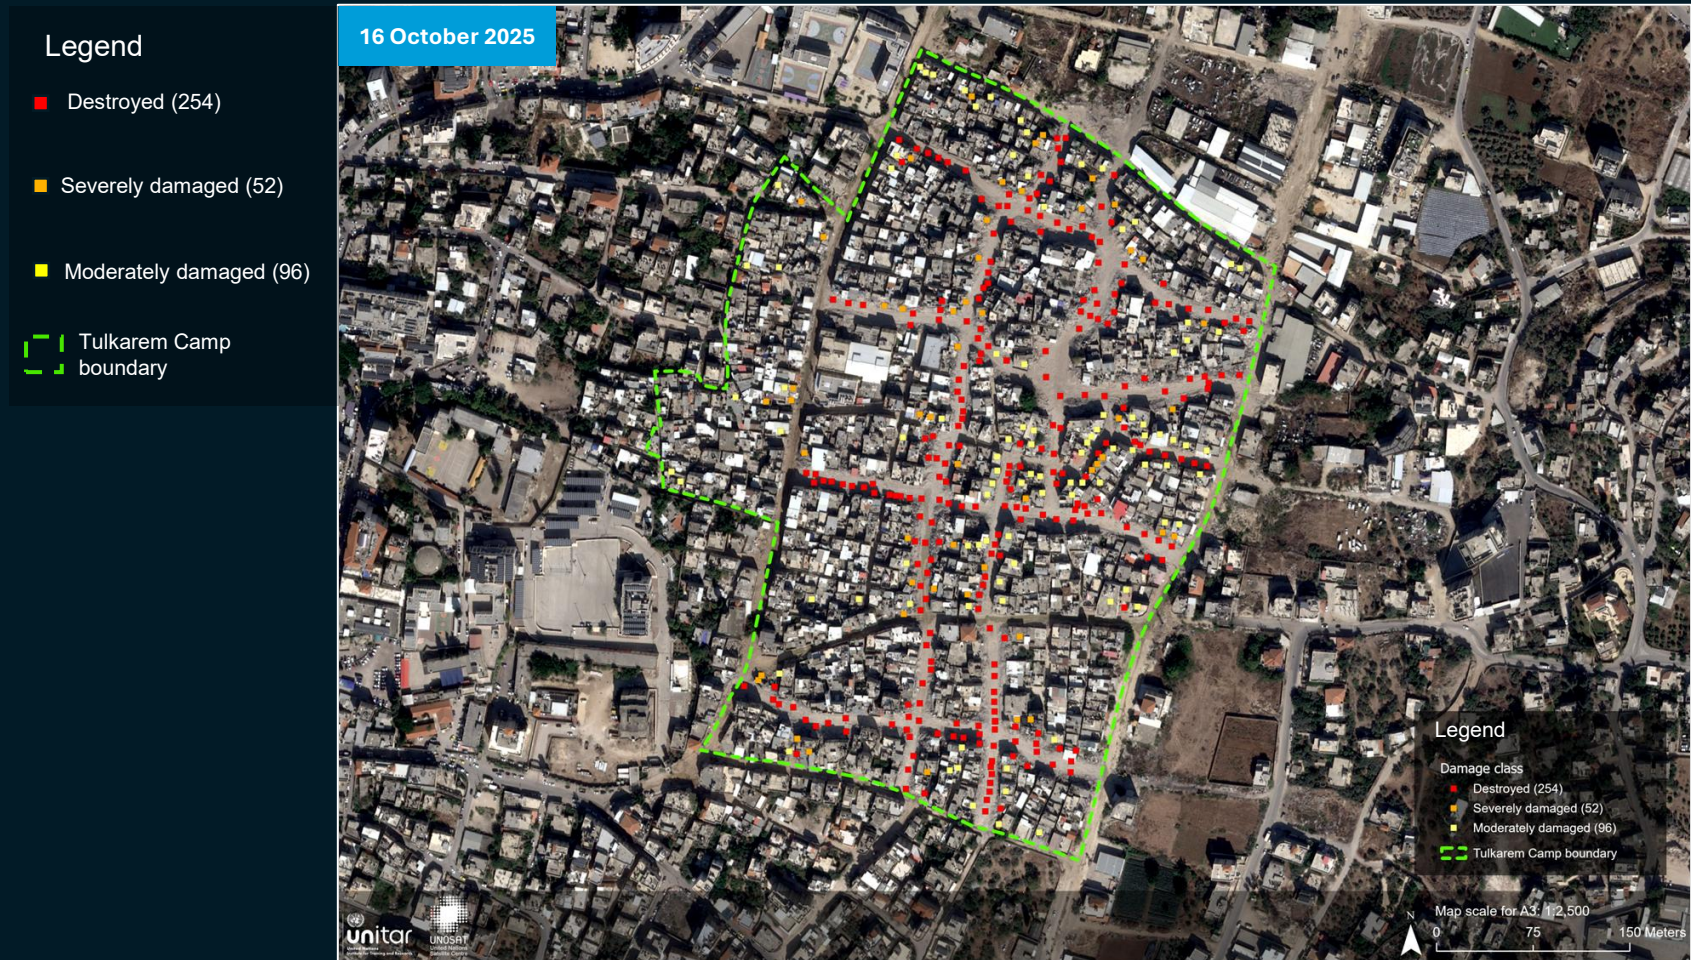
# Comprehensive damage assessment Tulkarem Camp

This map illustrates a UNOSAT satellite imagery-based comprehensive assessment of damage and destruction to structures within Tulkarem Camp, Tulkarem Governorate, West Bank, Occupied Palestinian Territory, based on images collected on 16 October 2025 when compared to an image collected on 21 May 2025.

According to the satellite imagery analysis, UNOSAT identified 254 destroyed structures, 52 severely damaged structures, and 96 moderately damaged structures for a total of 402 structures. These correspond to around 36% of the total 1105 structures found in Tulkarem Camp. This is a preliminary analysis and has not yet been validated in the field.

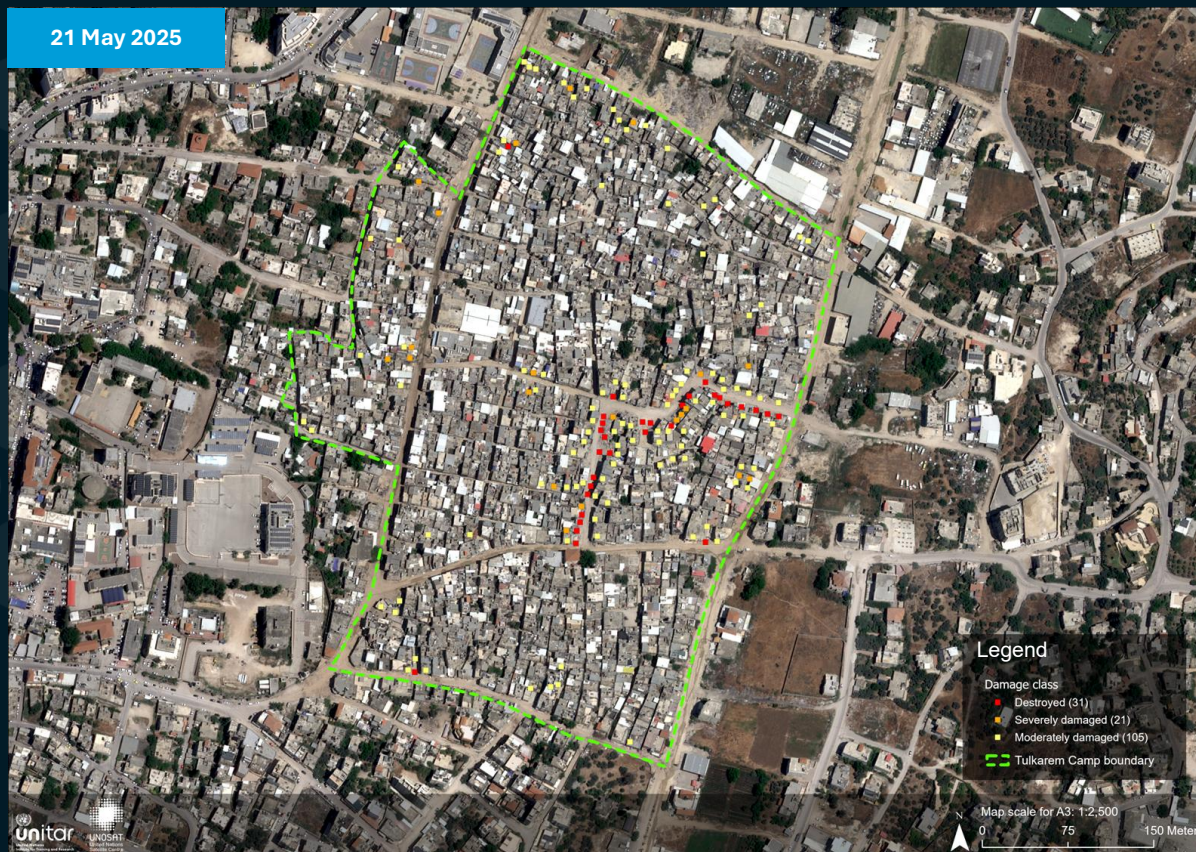
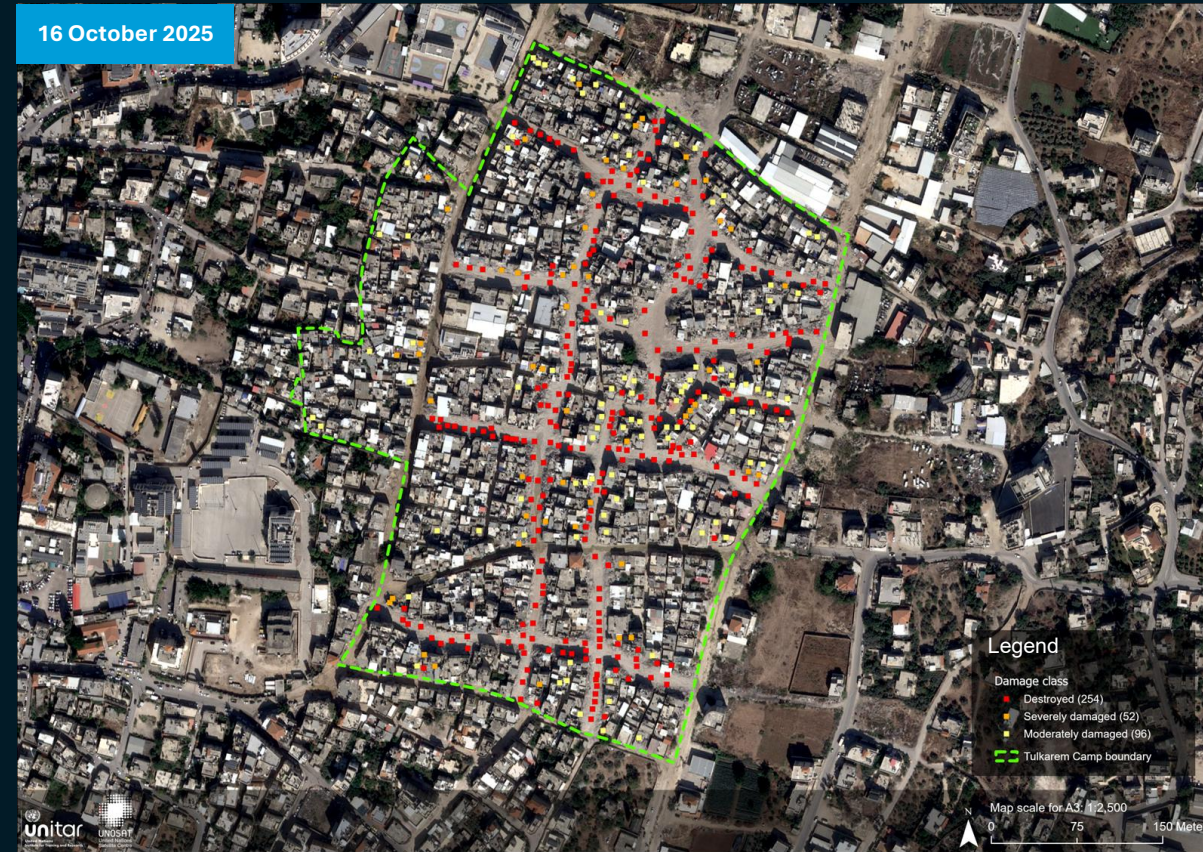
# Comprehensive damage assessment Tulkarem Camp

UNOSAT acquired two Pleiades NEO satellite images of Tulkarem Camp, Tulkarem Governorate, West Bank, Occupied Palestinian Territory, collected on 16 October 2025 and 21 May 2025. As of 16 October 2025, when compared to 21 May 2025, new damaged and destroyed buildings were visible, and the total count of damaged and destroyed structures identified in Tulkarem Camp increased from 157 to 402.

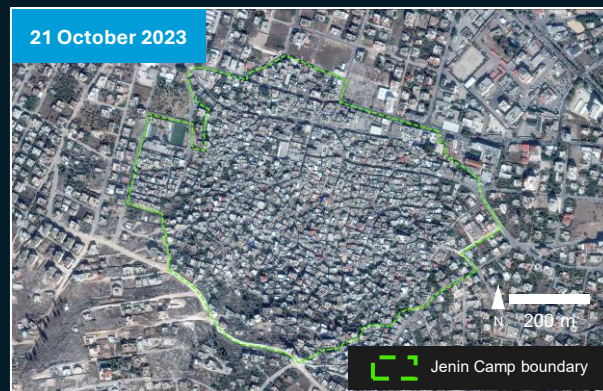
This map illustrates a UNOSAT satellite imagery-based comprehensive assessment of damage to roads within Jenin Camp, Jenin Governorate, West Bank, Occupied Palestinian Territory, based on images collected on 16 October 2025 when compared to an image collected on 21 May 2025.

According to the satellite imagery analysis, UNOSAT identified new damaged roads and widened roads, in the vicinity of Jenin Camp, as of 16 October 2025.

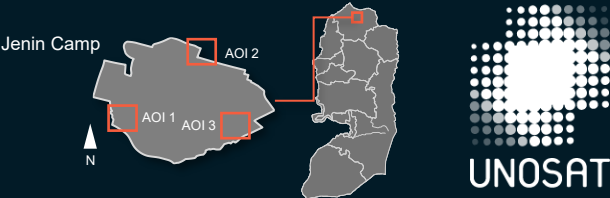
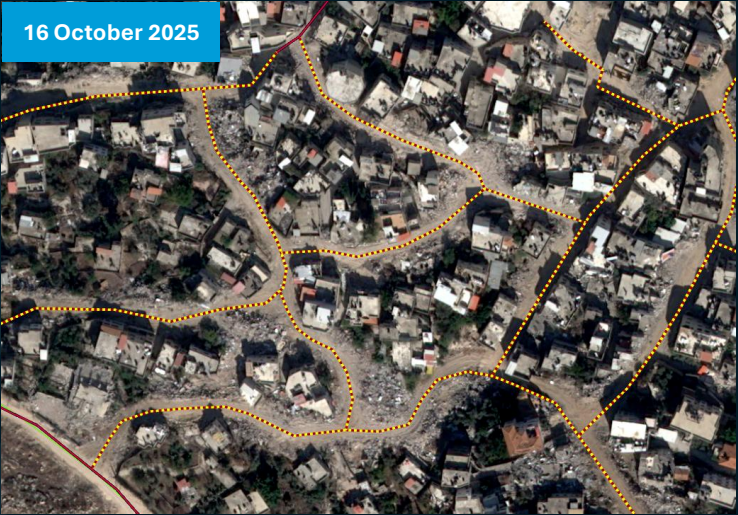
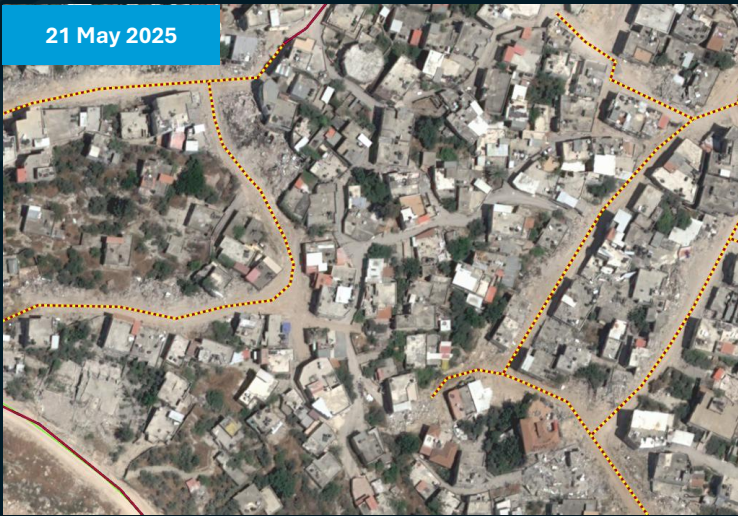
AOI 1

UNOSAT acquired two Pleiades NEO satellite images of Jenin Camp, Jenin Governorate, West Bank, Occupied Palestinian Territory, collected on 21 May 2025 and on 16 October 2025. As of 16 October 2025, new widened roads were visible inside the camp, often connecting to the camp boundary. Along these widened roads, buildings appeared damaged or destroyed.

Changes observed

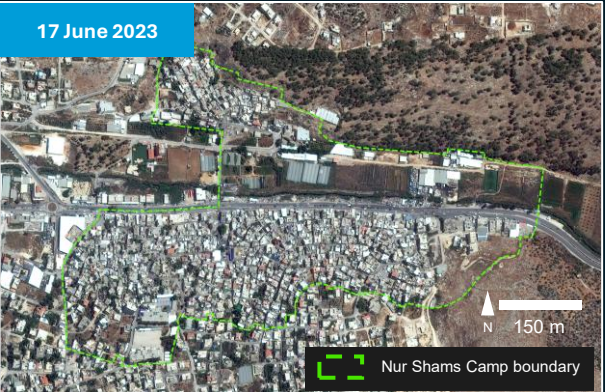
This map illustrates a UNOSAT satellite imagery-based comprehensive assessment of damage to roads within Nur Shams Camp, Tulkarem Governorate, West Bank, Occupied Palestinian Territory, based on images collected on 16 October 2025 when compared to an image collected on 21 May 2025.

According to the satellite imagery analysis, UNOSAT identified several damaged roads and widened roads, in the vicinity of Nur Shams Camp, as of 16 October 2025.

UNOSAT acquired two Pleiades NEO satellite images of Nur Shams Camp, Tulkarem Governorate, West Bank, Occupied Palestinian Territory, collected on 21 May 2025 and 16 October 2025. As of 16 October 2025, new sections of widened were visible. Along the widened roads, buildings were destroyed or damaged.

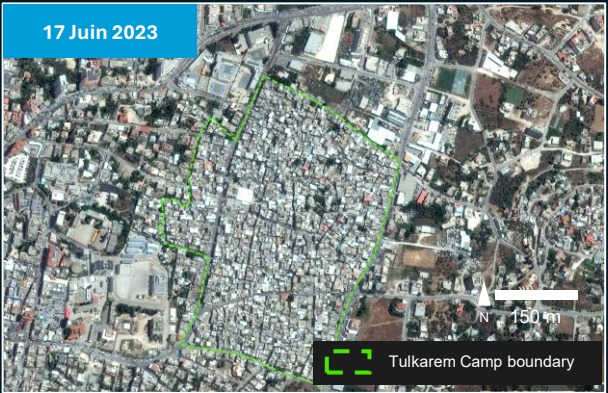
This map illustrates a UNOSAT satellite imagery-based comprehensive assessment of damage to roads within Tulkarem Camp, Tulkarem Governorate, West Bank, Occupied Palestinian Territory, based on images collected on 16 October 2025 when compared to an image collected on 21 May 2025.

According to the satellite imagery analysis, UNOSAT identified several new widened roads, in the vicinity of Tulkarem Camp, as of 16 October 2025.

UNOSAT acquired two Pleiades NEO satellite images of Tulkarem Camp, Tulkarem Governorate, West Bank, Occupied Palestinian Territory, collected on 16 October 2025 and 21 May 2025. As of 16 October 2025, when compared to 21 May 2025, several new sections of roads in the vicinity of Tulkarem Camp appeared widened. Along the widened roads, buildings appeared damaged or destroyed.

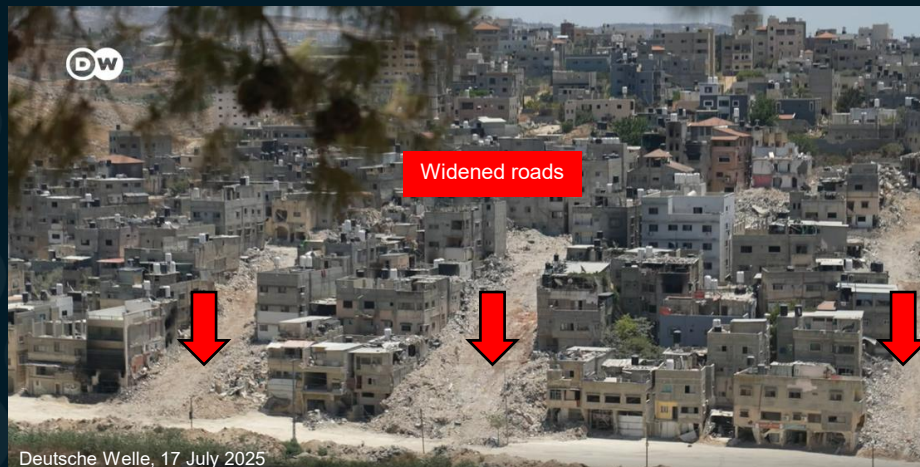
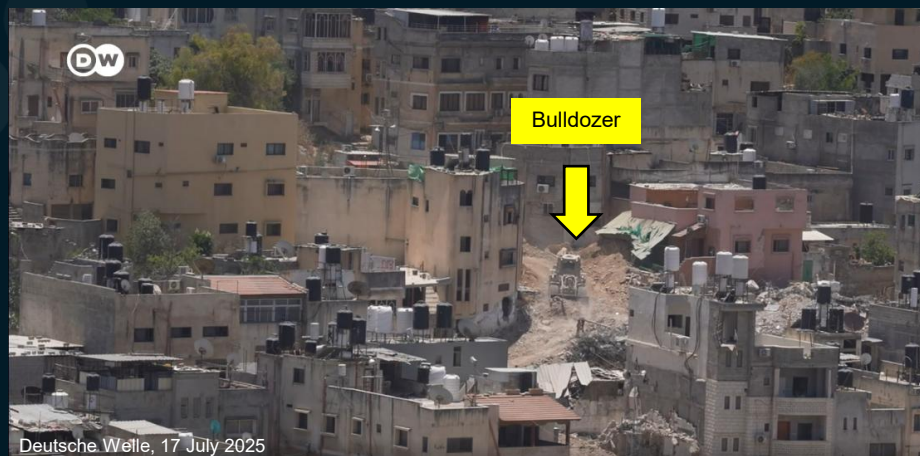
This map illustrates a UNOSAT satellite imagery-based security assessment of Nur Shams Camp, Tulkarem Governorate, West Bank, Occupied Palestinian Territory, based on images collected on 16 October 2025 when compared to an image collected on 21 May 2025.

According to satellite imagery analysis, UNOSAT identified one breached berm, one berm, and two roadblocks on the main damaged road crossing Nur Shams Camp, restricting access to the camp, as well as one berm within the camp compound.
