23 February 2026

# **United Nations Office for the Coordination of Humanitarian Affairs - Occupied Palestinian Territory**

UNOSAT Comprehensive Damage Assessment and Security Analysis of  
Tulkarm, Nur Shams and Jenin Refugee Camps in  
Tulkarm and Jenin Governorates, West Bank, Occupied Palestinian Territory

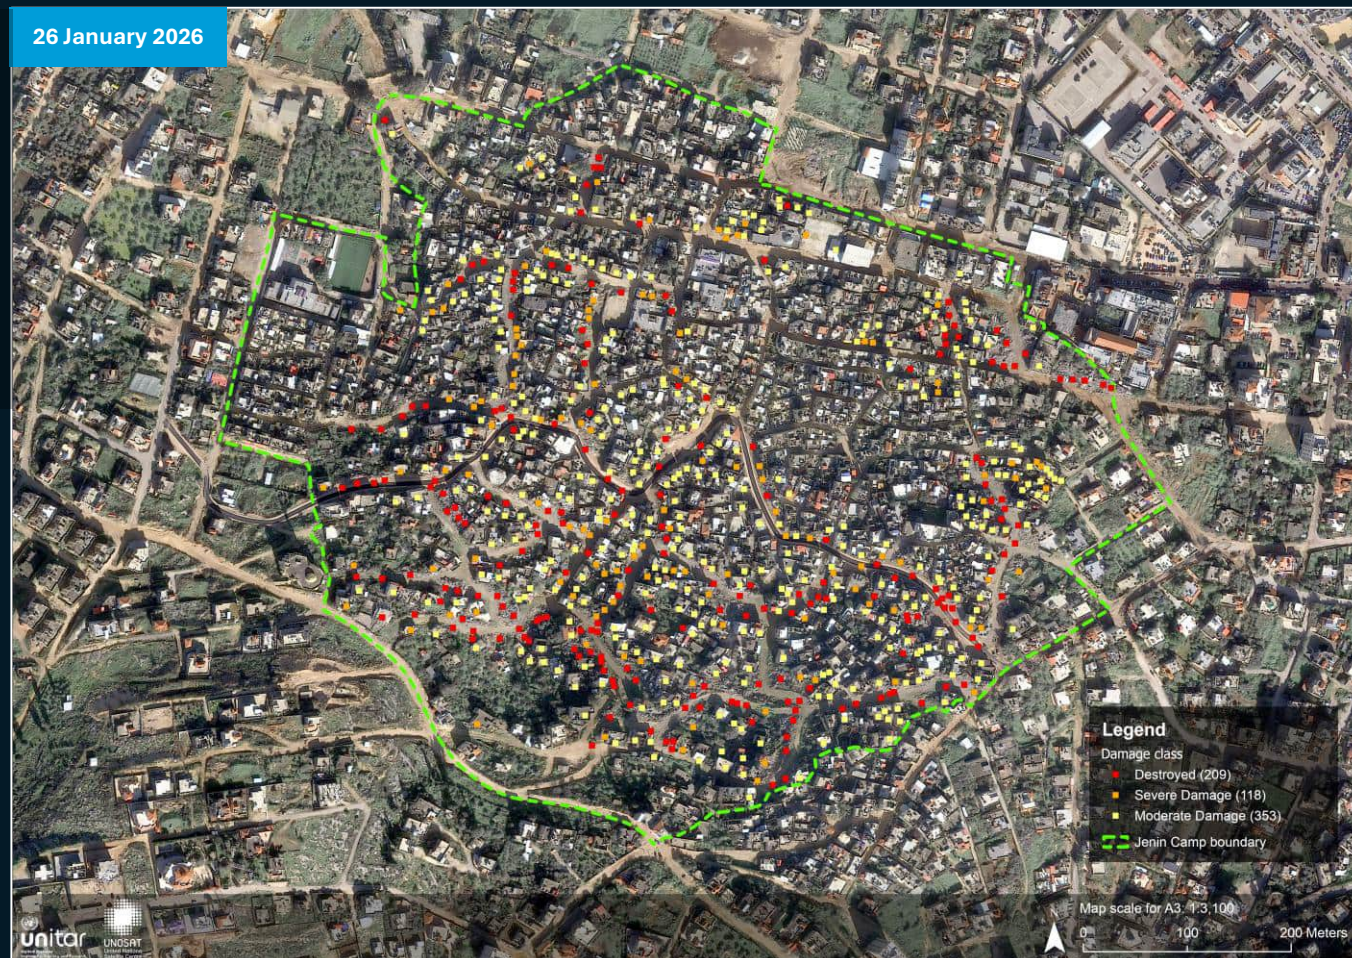
This map illustrates a UNOSAT satellite imagery-based comprehensive assessment of damage and destruction to structures within Jenin Camp, Jenin Governorate, West Bank, Occupied Palestinian Territory, based on images collected on 26 January 2026 when compared to an image collected on 16 October 2025.

According to the satellite imagery analysis, UNOSAT identified 209 destroyed structures, 118 severely damaged structures, and 353 moderately damaged structures for a total of 680 structures. These correspond to around 53% of the total structures that have been damaged in Jenin Camp. This is a preliminary analysis and has not yet been validated in the field.

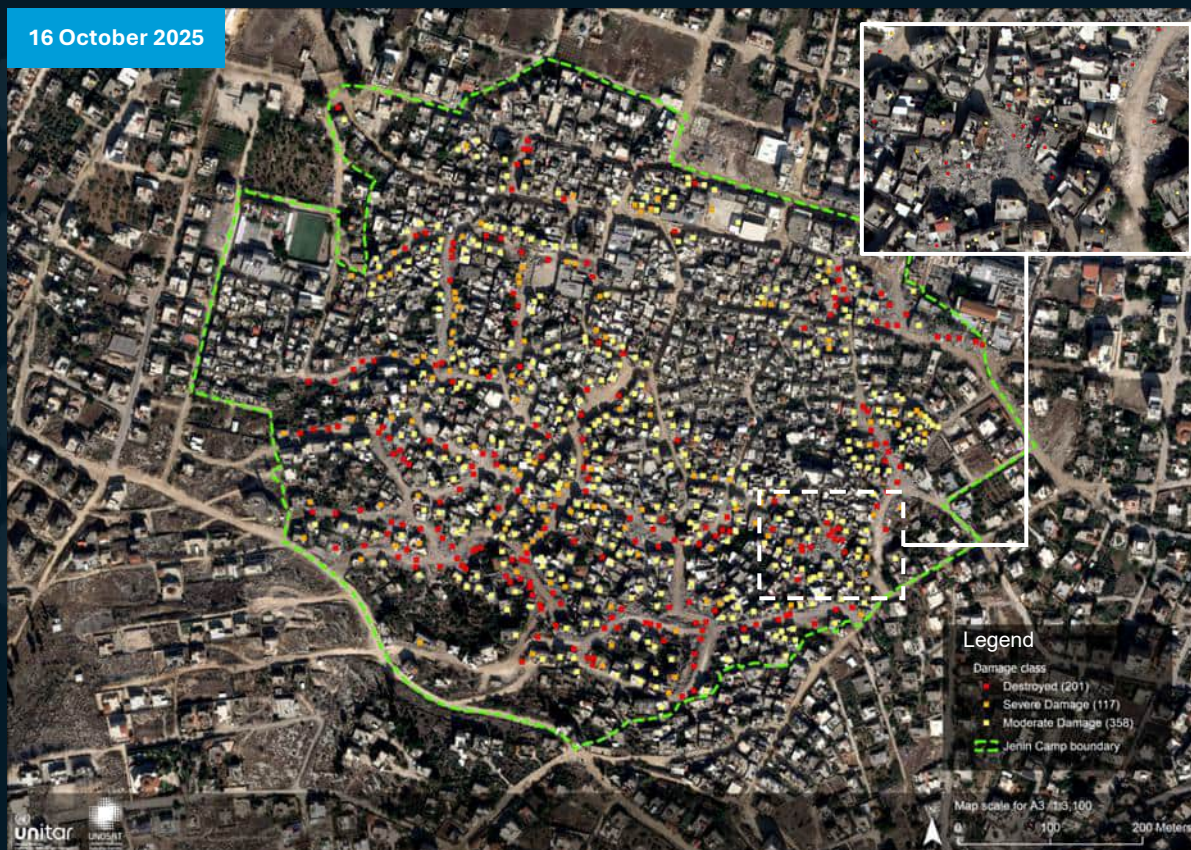
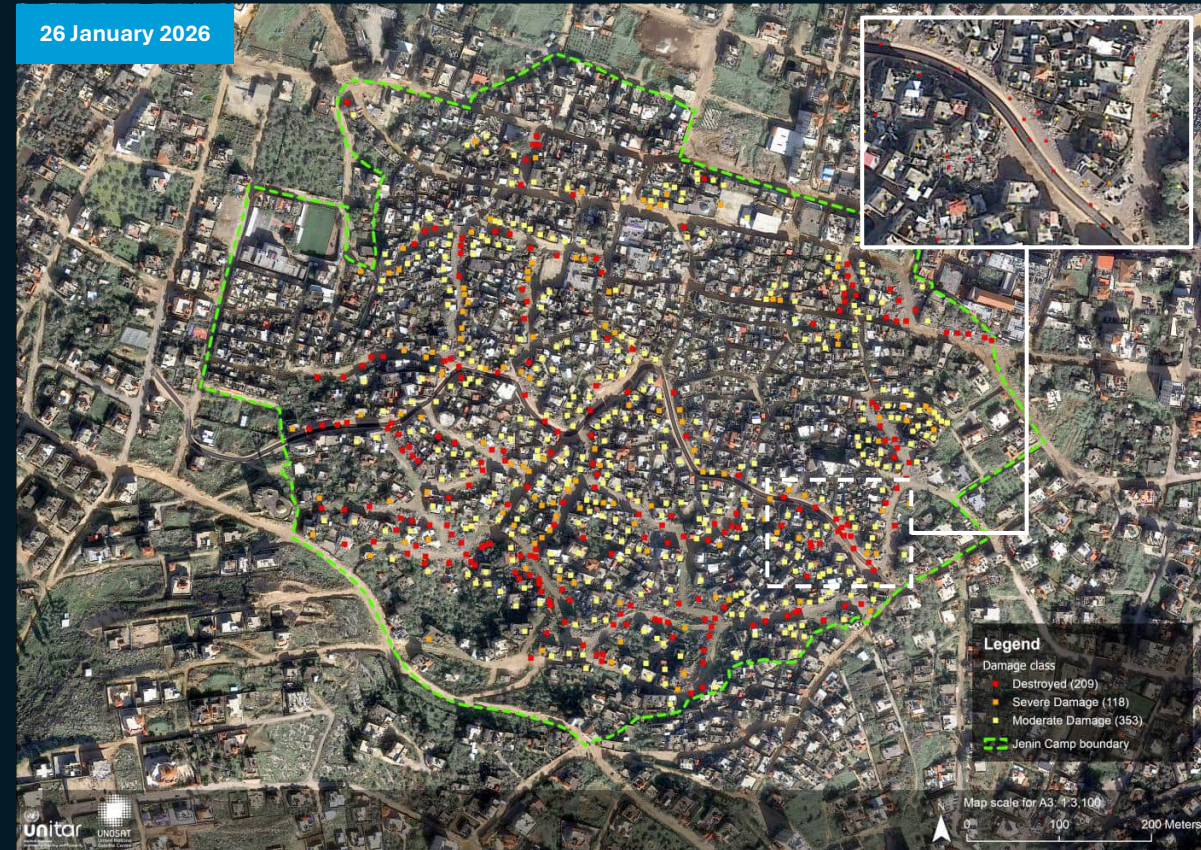
UNOSAT acquired two Pleiades NEO satellite images of Jenin Camp, Jenin Governorate, West Bank, Occupied Palestinian Territory, collected on 16 October 2025 and 26 January 2026. As of 26 January 2026, compared to 16 October 2025, increase in damage level on buildings, additional damaged and destroyed buildings were observed, increasing the total number of affected structures in Jenin Camp from 676 to 680. These damaged and destroyed buildings were mainly observed along a new paved road (highlighted in slide 13), crossing the camp.

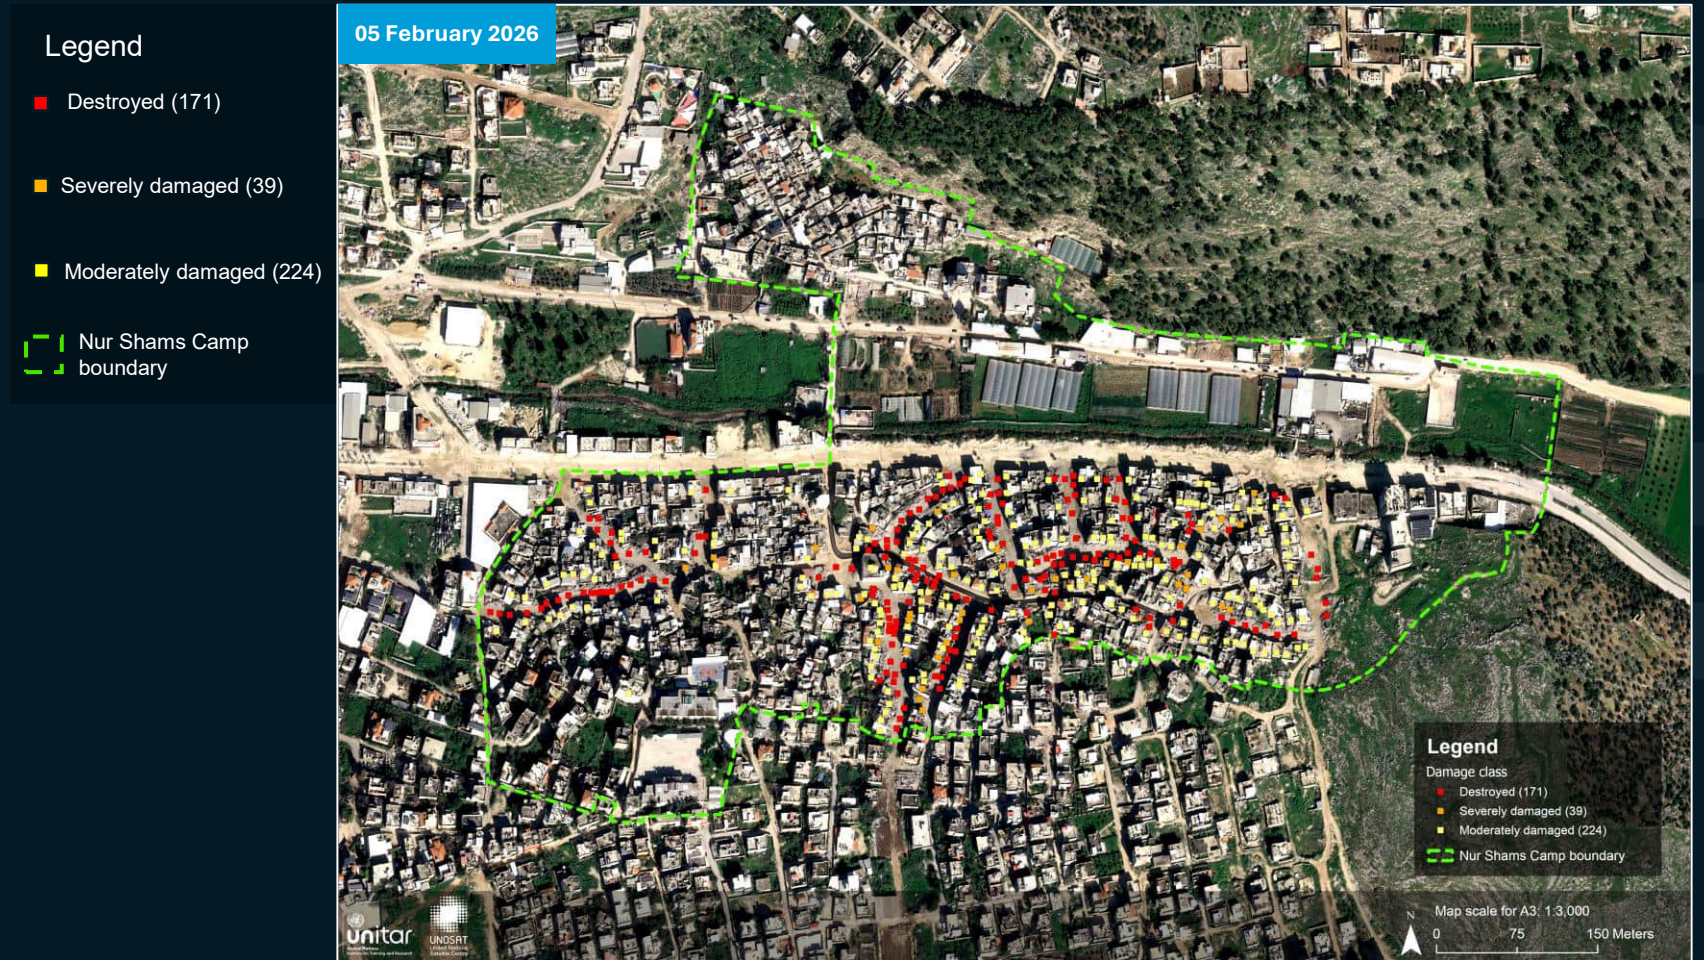
This map illustrates a UNOSAT satellite imagery-based comprehensive assessment of damage and destruction to structures within Nur Shams Camp, Tulkarem Governorate, West Bank, Occupied Palestinian Territory, based on images collected on 05 February 2026 when compared to an image collected on 16 October 2025.

According to the satellite imagery analysis, UNOSAT identified 171 destroyed structures, 39 severely damaged structures, and 224 moderately damaged structures for a total of 434 structures. These correspond to around 55% of the total structures in Nur Shams Camp. This is a preliminary analysis and has not yet been validated in the field.

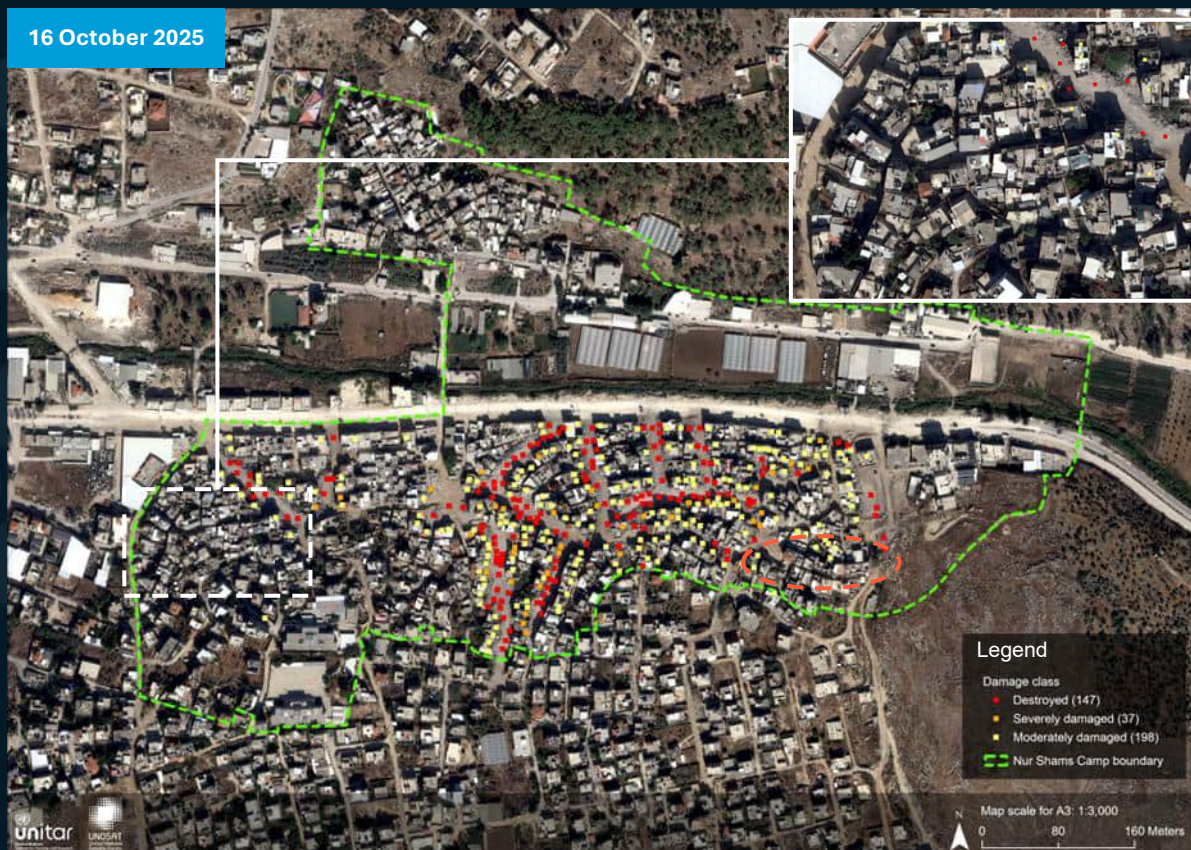
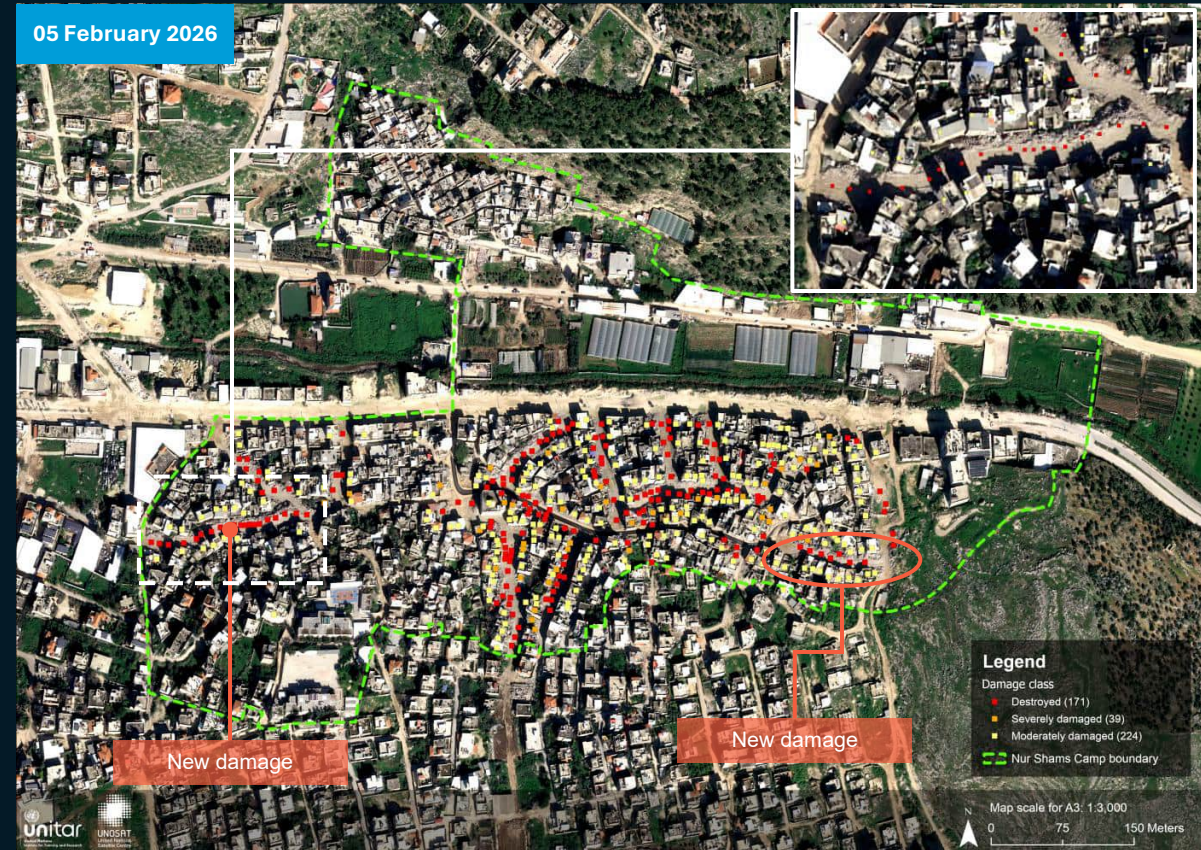
UNOSAT acquired two Pleiades NEO satellite images of Nur Shams Camp, Tulkarem Governorate, West Bank, Occupied Palestinian Territory, collected on 16 October 2025 and 05 February 2026. As of 05 February 2026, compared to 16 October 2025, additional damaged and destroyed buildings were observed, where new widened pathways have been carved, and increasing the total number of affected structures in Nur Shams Camp from 382 to 434.

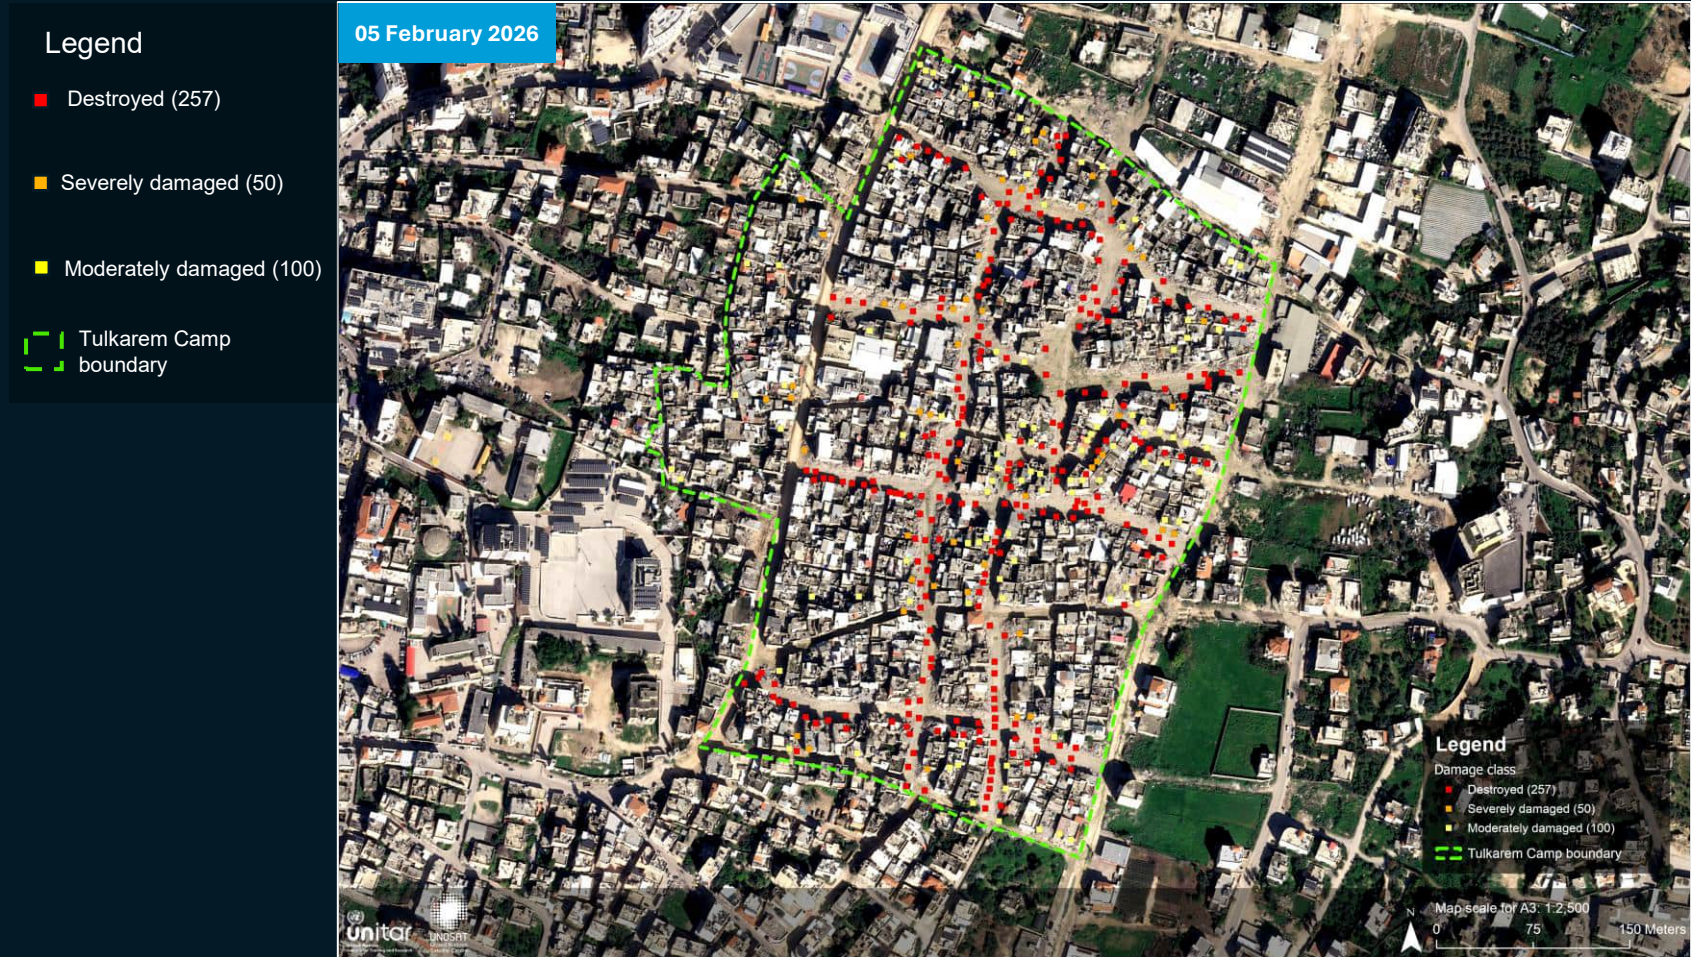
This map illustrates a UNOSAT satellite imagery-based comprehensive assessment of damage and destruction to structures within Tulkarem Camp, Tulkarem Governorate, West Bank, Occupied Palestinian Territory, based on images collected on 05 February 2026 when compared to an image collected on 16 October 2025.

According to the satellite imagery analysis, UNOSAT identified 257 destroyed structures, 50 severely damaged structures, and 100 moderately damaged structures for a total of 407 structures. These correspond to around 37% of the total 1105 structures found in Tulkarem Camp. This is a preliminary analysis and has not yet been validated in the field.

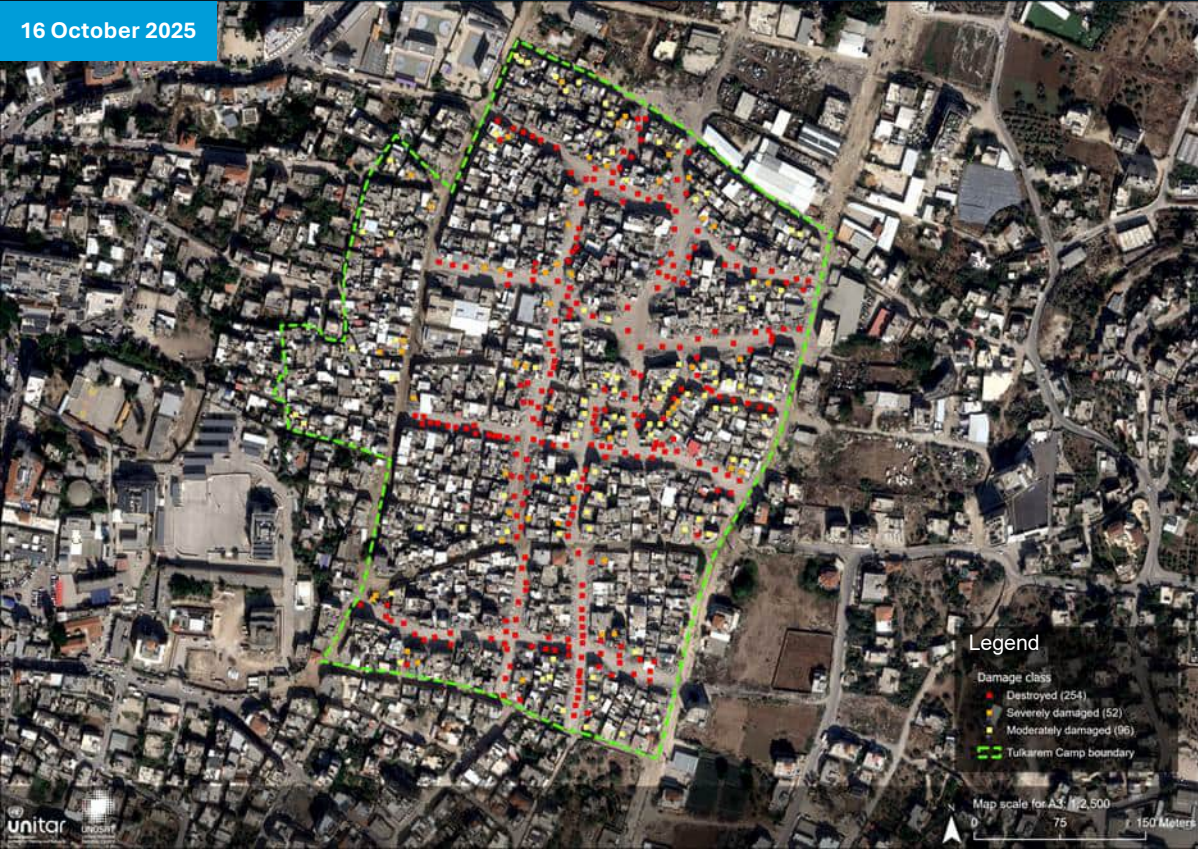
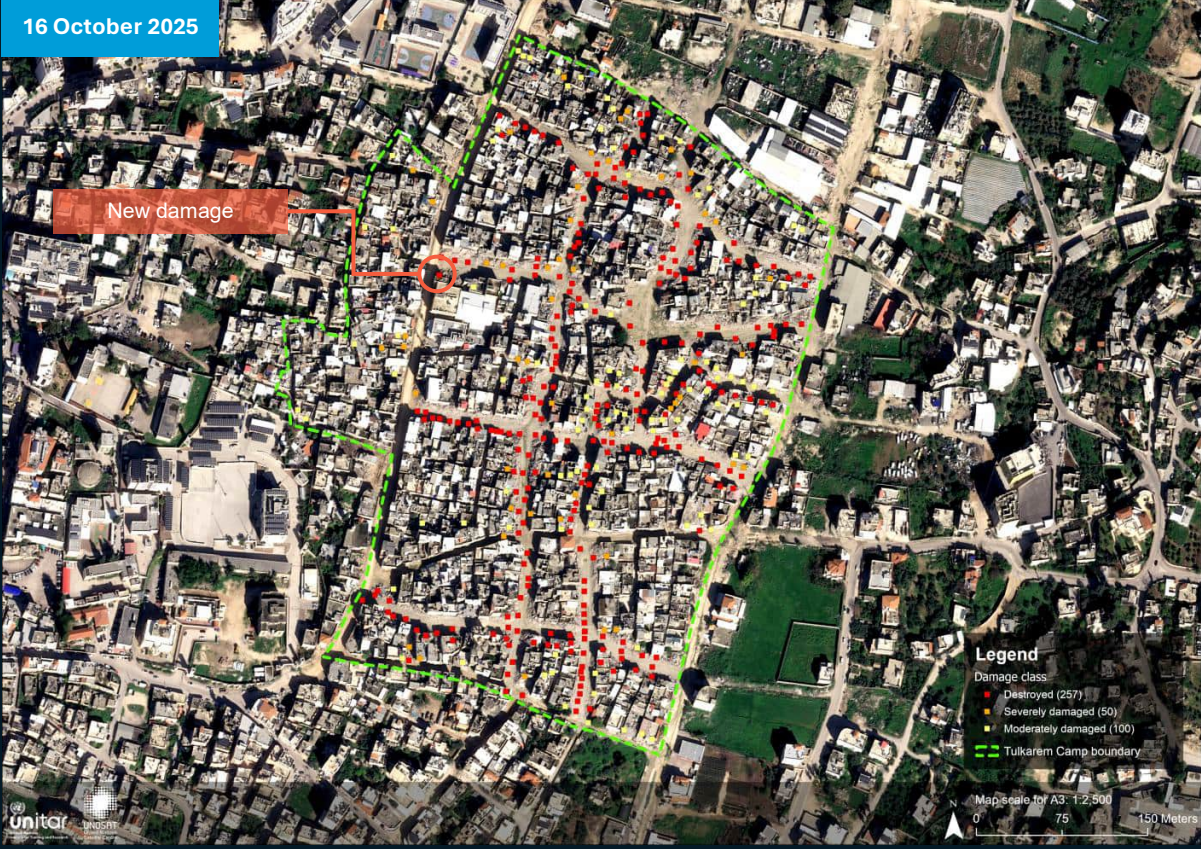
UNOSAT acquired two Pleiades NEO satellite images of Tulkarem Camp, Tulkarem Governorate, West Bank, Occupied Palestinian Territory, collected on 05 February 2026 and 16 October 2025. As of 05 February 2026, when compared to 16 October 2025, new damaged and destroyed buildings were visible, and the total count of damaged and destroyed structures identified in Tulkarem Camp increased from 402 to 407.

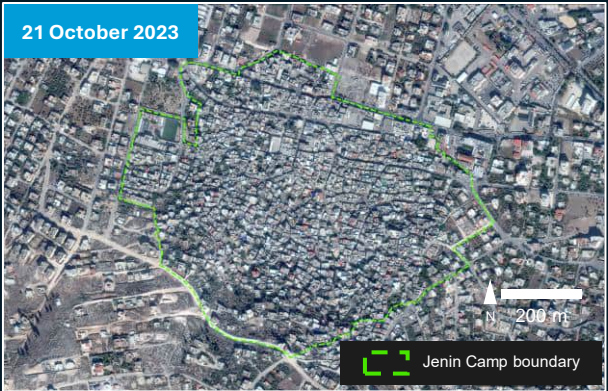
This map illustrates a UNOSAT satellite imagery-based comprehensive assessment of damage to roads within Jenin Camp, Jenin Governorate, West Bank, Occupied Palestinian Territory, based on images collected on 26 January 2026 when compared to an image collected on 16 October 2025.

According to the satellite imagery analysis, UNOSAT identified a new paved road (blue line, on the right hand-side map) crossing Jenin Camp, and increasing the level of damaged buildings in this area, as of 26 January 2026. This new road connects the western boundary and the western boundary of the camp.

UNOSAT acquired two Pleiades NEO satellite images of Jenin Camp, Jenin Governorate, West Bank, Occupied Palestinian Territory, collected on 16 October 2025 and on 26 January 2026. As of 26 January 2026, a new paved road was visible inside, connecting the western boundary and the eastern boundary of the camp. Along the new paved road, buildings appeared damaged or destroyed (see red squares, in map inset).

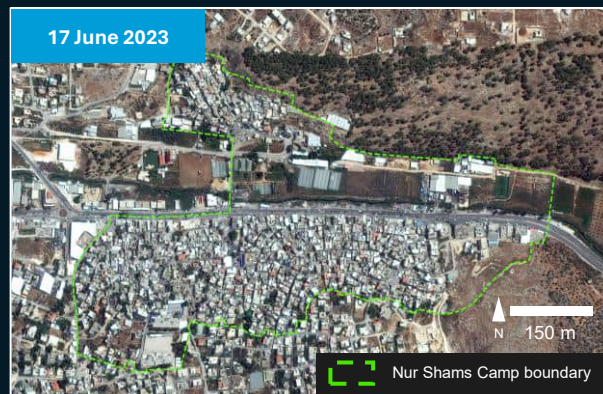
This map illustrates a UNOSAT satellite imagery-based comprehensive assessment of damage to roads within Nur Shams Camp, Tulkarem Governorate, West Bank, Occupied Palestinian Territory, based on images collected on 05 February 2026 when compared to an image collected on 16 October 2025.

According to the satellite imagery analysis, UNOSAT identified new widened roads and a new paved road (blue line, on the right hand-side map), in the vicinity of Nur Shams Camp, as of 05 February 2026.

UNOSAT acquired two Pleiades NEO satellite images of Nur Shams Camp, Tulkarem Governorate, West Bank, Occupied Palestinian Territory, collected on 16 October 2025 and 05 February 2026. As of 05 February 2026, new sections of widened roads and a new paved road were visible, in the vicinity of the camp. Along the widened roads, buildings were destroyed or damaged.

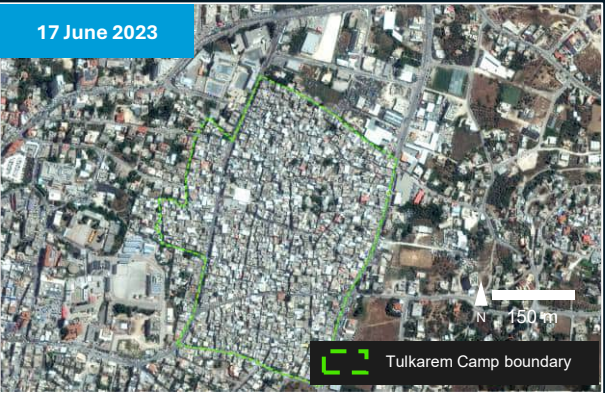
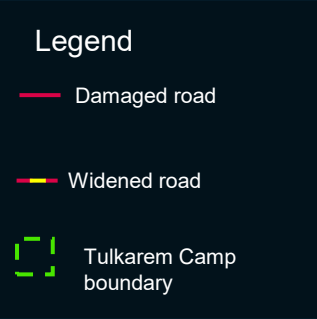
This map illustrates a UNOSAT satellite imagery-based comprehensive assessment of damage to roads within Tulkarem Camp, Tulkarem Governorate, West Bank, Occupied Palestinian Territory, based on images collected on 05 February 2026 when compared to an image collected on 16 October 2025.

According to the satellite imagery analysis, UNOSAT an additional section of a road have been damaged, outside the Tulkarem Camp boundary, as of 05 February 2026.

UNOSAT acquired two Pleiades NEO satellite images of Tulkarem Camp, Tulkarem Governorate, West Bank, Occupied Palestinian Territory, collected on 05 February 2026 and 16 October 2025. As of 05 February 2026, when compared to 16 October 2025, a new section of a road, outside the camp boundary of Tulkarem Camp, appeared damaged.

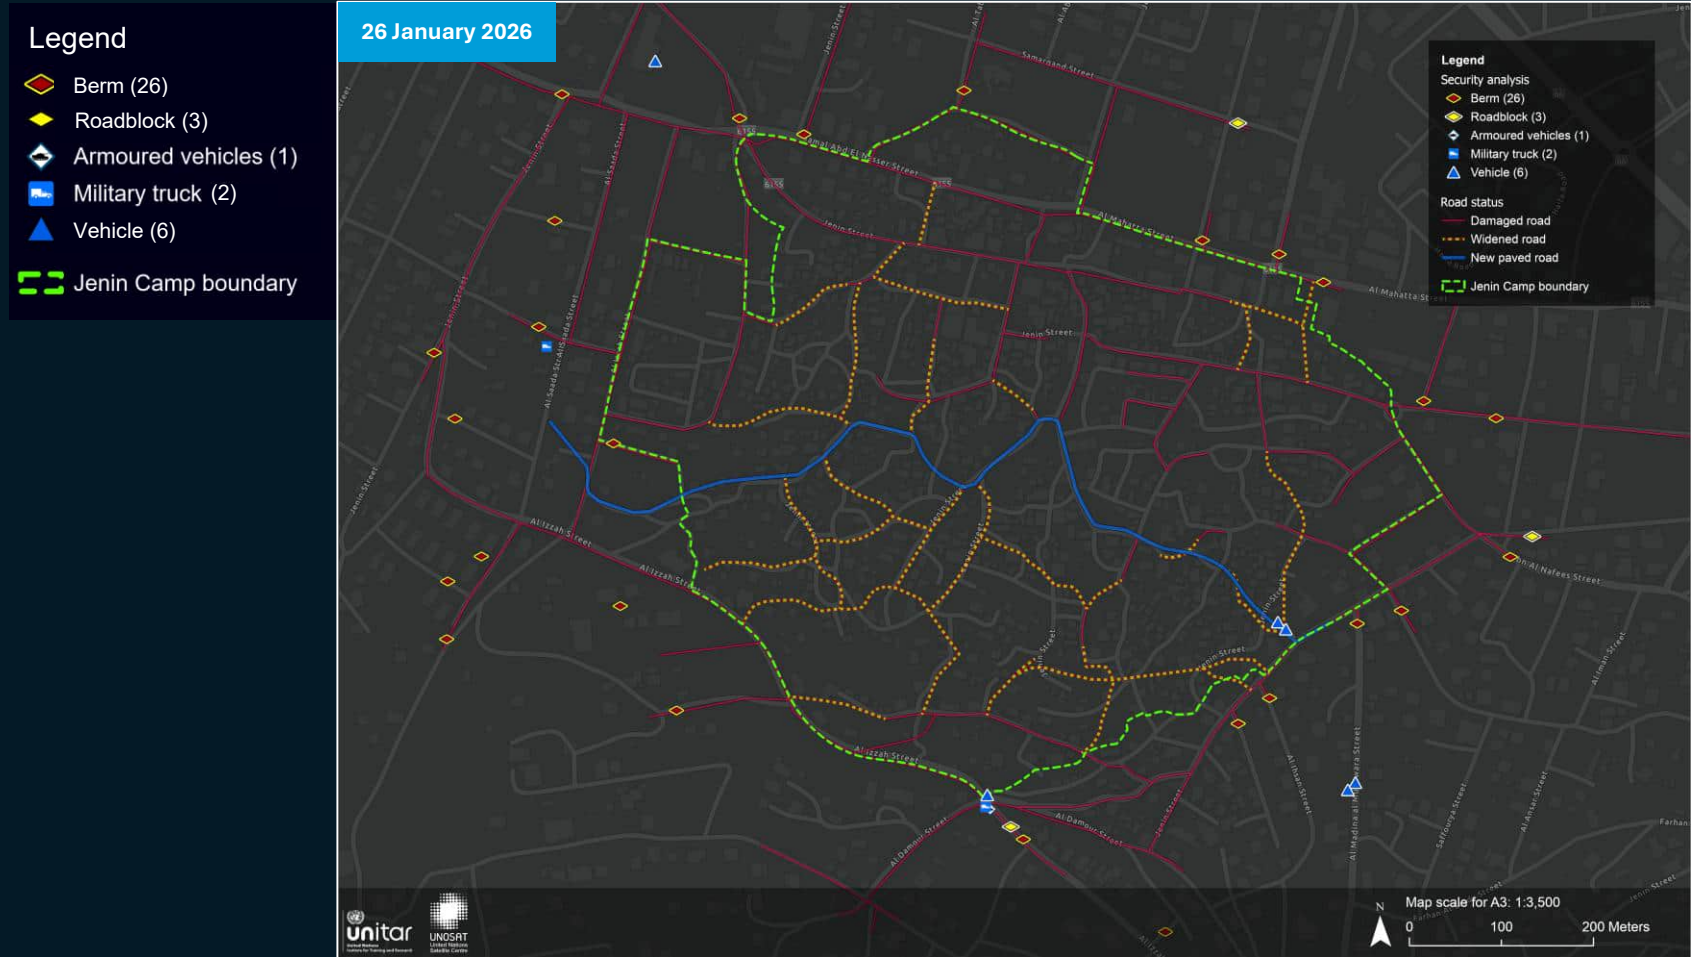
According to satellite imagery analysis, UNOSAT identified 26 berms and 3 roadblocks surrounding the camp and restricting civilian vehicular access to the camp. These berms are mainly located on damaged road sections.

A total of 1 probable armoured vehicle, 1 probable bulldozer, 2 military trucks, and 2 probable construction trucks were overserved in the vicinity of the camp.

In addition to the imagery-based assessment, an overview map without a satellite imagery background has been produced to clearly visualise the spatial distribution of berms and roadblocks surrounding the camp. The removal of the imagery basemap reduces visual clutter and allows for improved identification of access restrictions, thereby providing a clearer representation of the prevailing security configuration affecting Jenin Camp.

UNOSAT acquired two Pleiades NEO satellite images of Jenin Camp, Jenin Governorate, West Bank, Occupied Palestinian Territory, collected on 16 October 2025 and 26 January 2026. As of 26 January 2026, military vehicles were observed outside and inside the camp boundary, as well as berms and roadblocks on damaged roads around the camp, restricting its access. Military vehicles and construction vehicles were also visible outside and inside the camp, indicating ongoing activity.

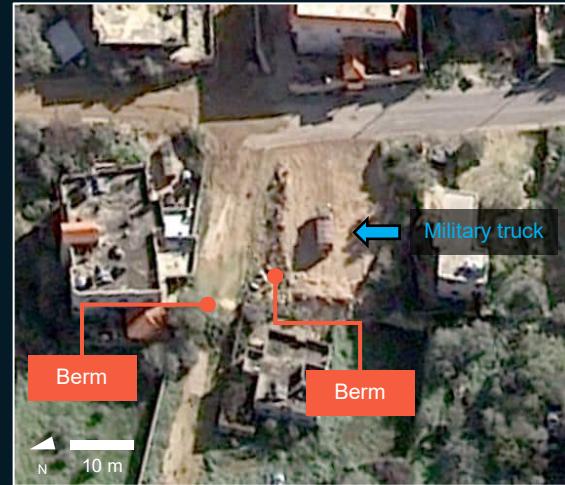
AOI 1

AOI 1: A military truck positioned outside the eastern area of the camp.

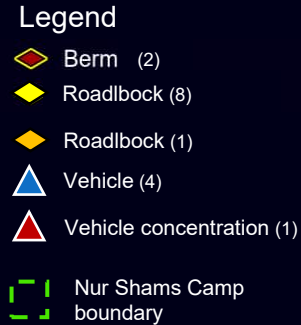
According to satellite imagery analysis, UNOSAT identified one checkpoint and five roadblock along the main damaged road crossing Nur Shams Camp, restricting the access to the camp. Three other roadblocks were visible around the camp as well. A total of three bulldozers and one military vehicle were visible southward from the camp. A concentration of vehicles parked on a field, at approximately 280 metres southwest from the camp border was visible, as of 05 February 2026.

In addition to the imagery-based assessment, an overview map without a satellite imagery background has been produced to clearly visualise the spatial distribution of berms and roadblocks surrounding the camp. The removal of the imagery basemap reduces visual clutter and allows for improved identification of access restrictions, thereby providing a clearer representation of the prevailing security configuration affecting Nur Shams Camp.

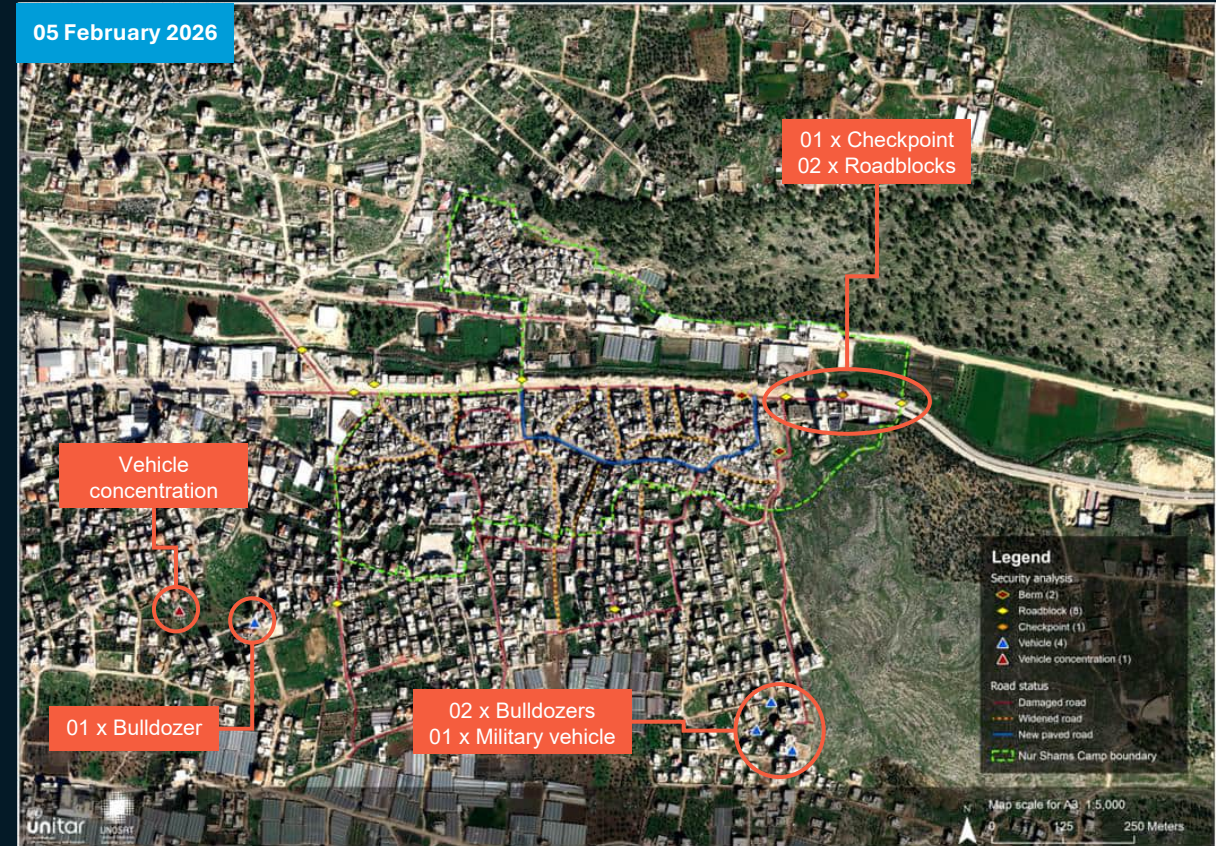
05 February 2026

UNOSAT acquired two Pleiades NEO satellite images of Nur Shams Camp, Tulkarem Governorate, West Bank, Occupied Palestinian Territory, collected on 16 October 2025 and 05 February 2026. As of 05 February 2026, a military vehicle, a concentration of vehicles and 3 bulldozer were observed outside the camp boundary, on the southern area. A checkpoint, berms and roadblocks on damaged roads were also visible inside and outside the camp, restricting its access.

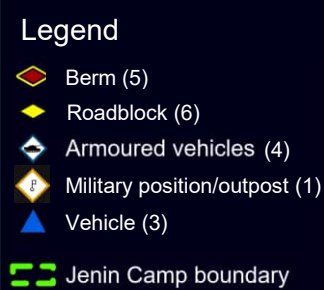
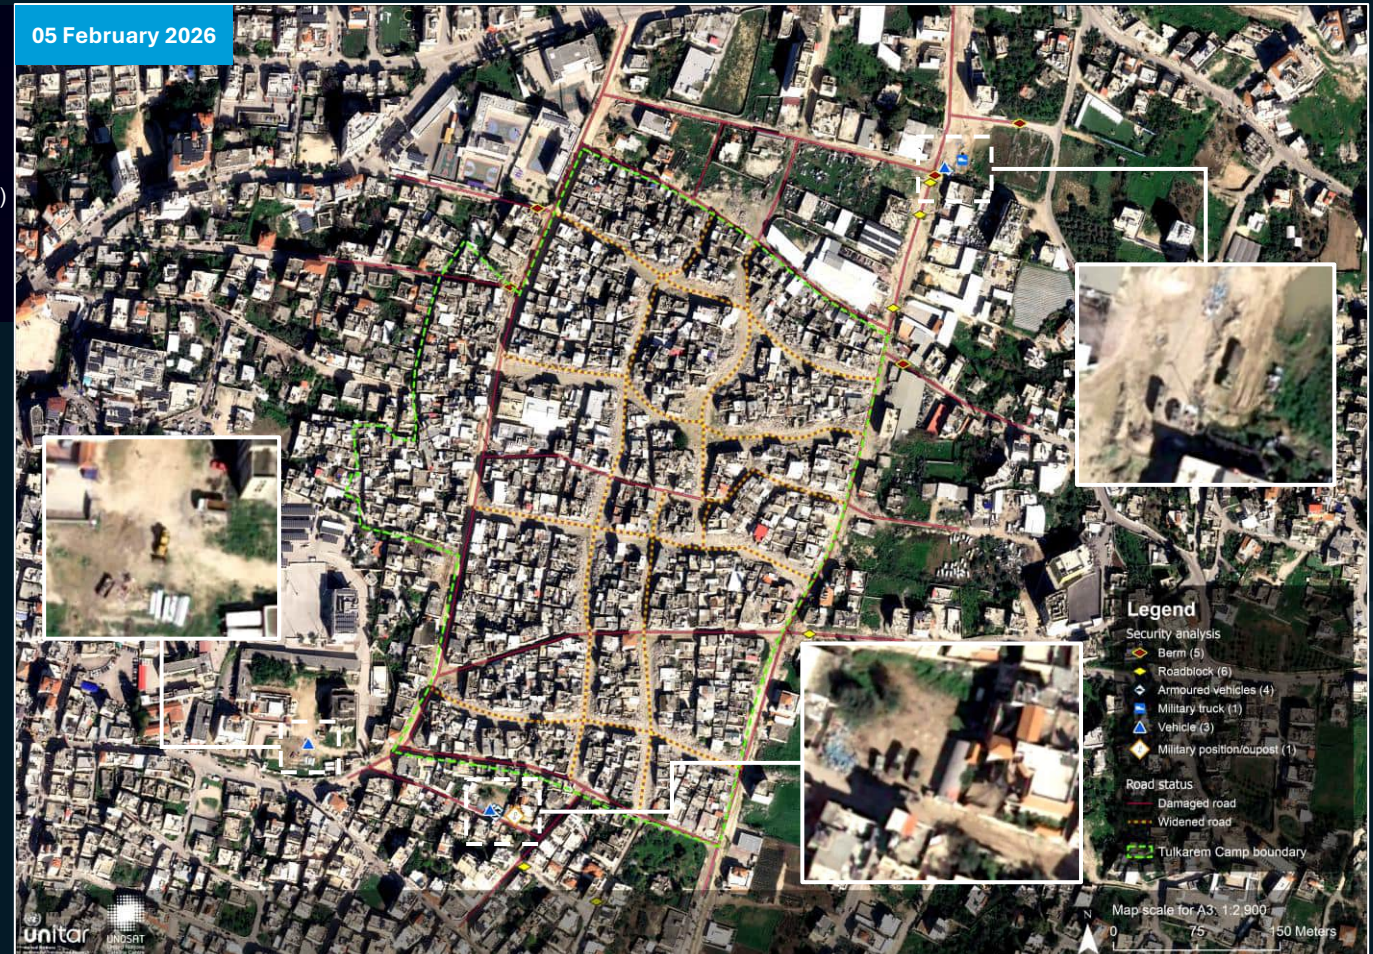
This map illustrates a UNOSAT satellite imagery-based security assessment of Tulkarem Camp, Tulkarem Governorate, West Bank, Occupied Palestinian Territory, based on images collected on 05 February 2026 when compared to an image collected on 16 October 2025.

According to satellite imagery analysis, UNOSAT identified five berms and six roadblocks surrounding the camp, possibly blocking civilian vehicular access. A bulldozer was visible outside the camp, approx. 75 meters from the southwestern camp boundary. At approx. 160 meters from the northeastern camp boundary, a military truck, military vehicle and a probable armored vehicle were visible. At approximately 40 meters from the southern border of the camp, two probable armoured personnel carrier (APC), one armoured vehicle and a military vehicle were visible, next to a possible temporary military outpost.
