Satellite-Detected Flood Waters Along the Prut River, Cahul and Vulcanesti

Heavy Rainfall & Flooding

29 July 2010 Version 1.0

Glide No: FL-2010-000130-MDA

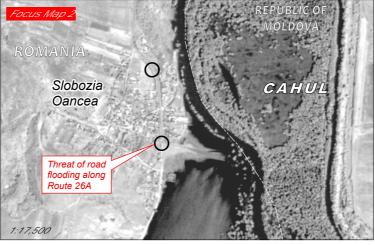
Potential flooding in limited eastern edges of Slobozia Oancea, however significant threat of road flooding along multiple points of Route 26A

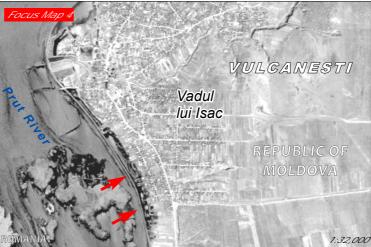
Vadul lui Isac, some likely flooding in south-western section of town, encroaching on cluster of residential buildings immediately west of route A283
