Production Date: 10/17/2014

## ***SITUATION UPDATE FOR KOBANI, ALEPPO GOVERNORATE, SYRIAN ARAB REPUBLIC***

*Based on satellite imagery acquired 15 October 2014*

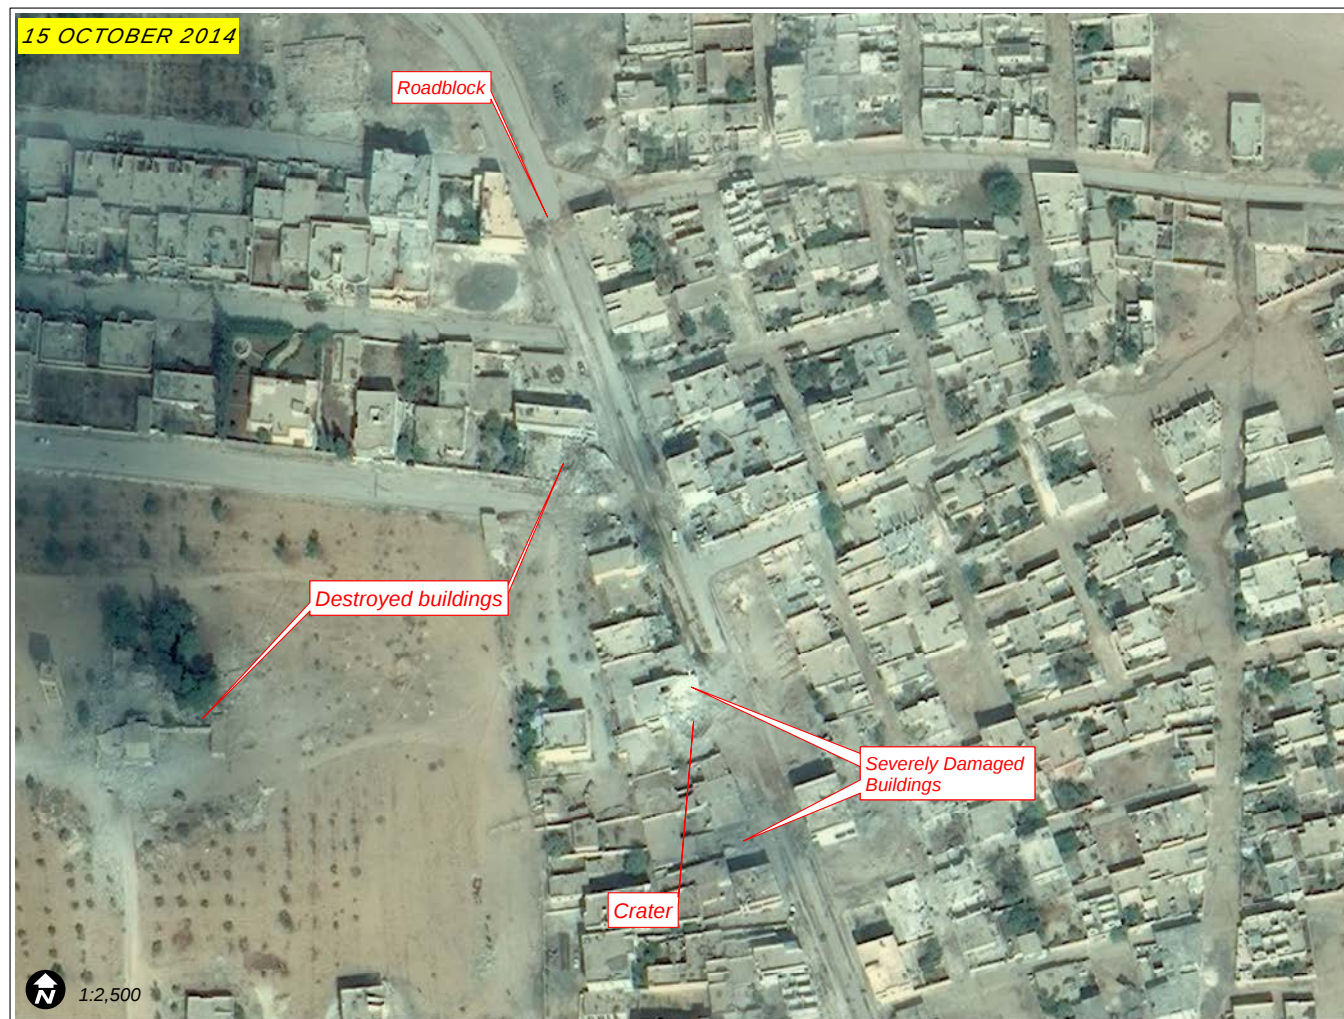
*The image shows destruction at the eastern part of the city of Kobani. Several buildings appear destroyed or heavily damaged; craters and roadblocks are also visible.*

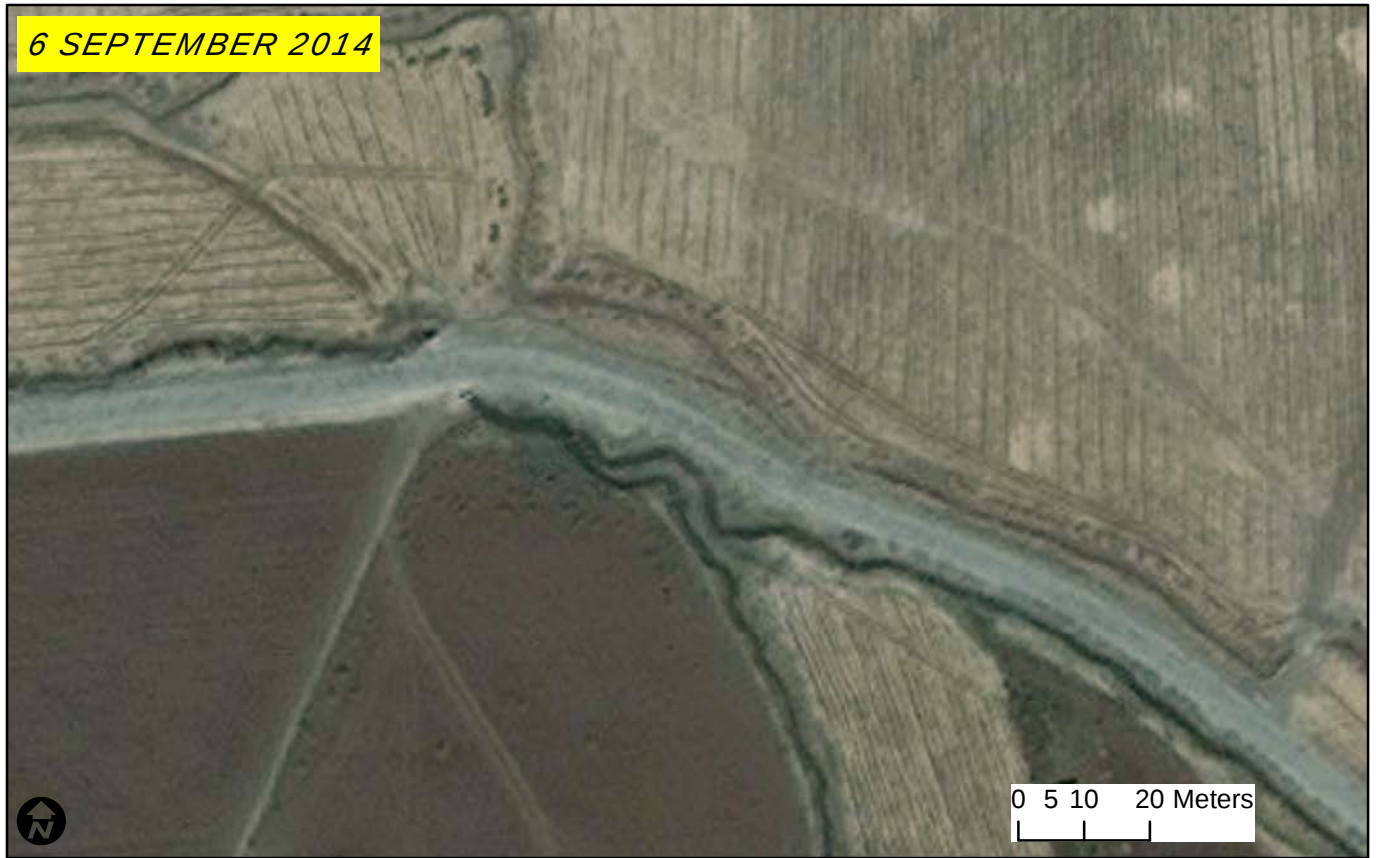
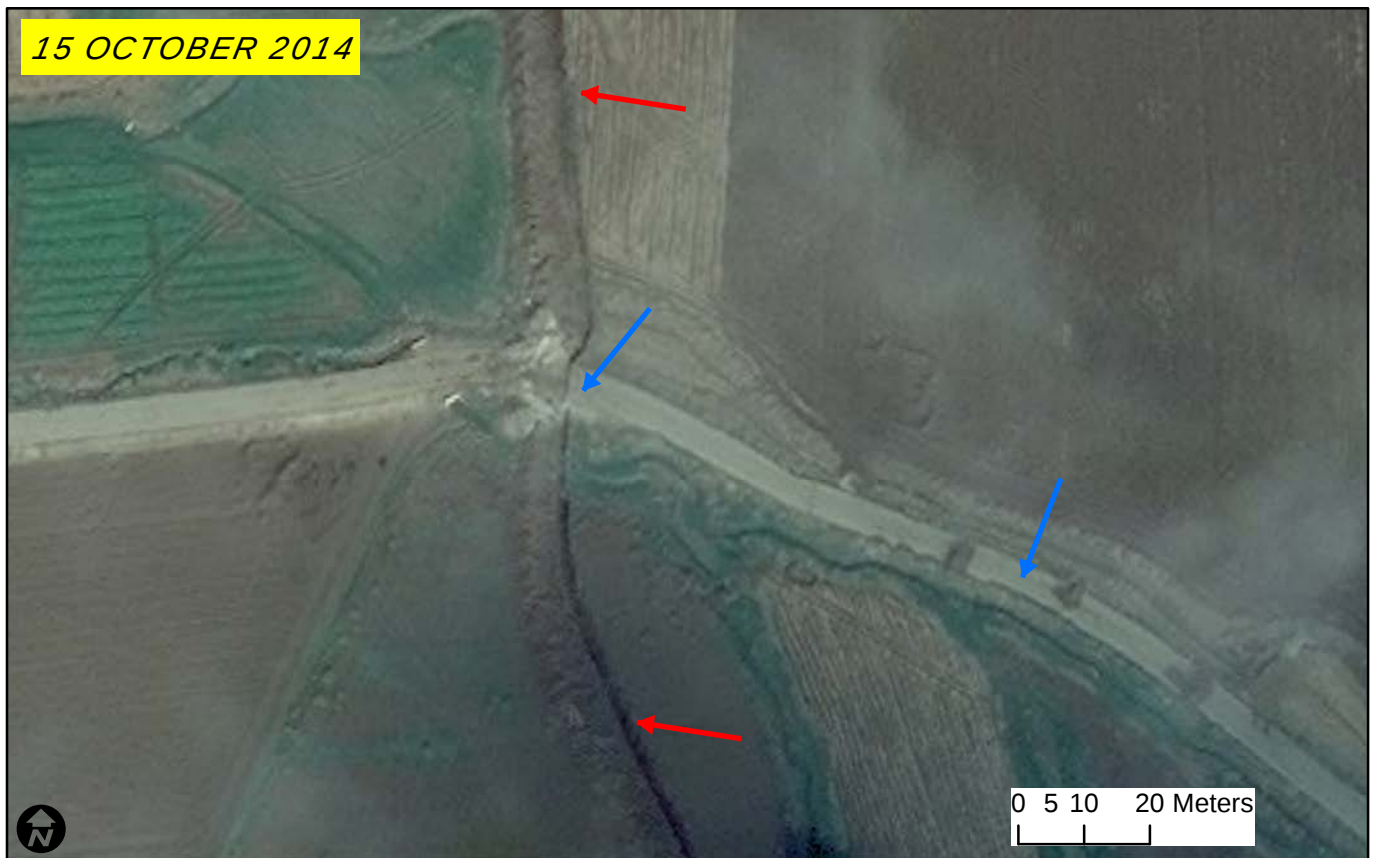
*Figure 2: Roadblocks and fortified fighting line*

Imagery shows roadblocks and access control points placed along the roads preventing access to the town (blue arrows). A probable fortified fighting line is also visible in the imagery (red arrow). Images copyright 2014 DigitalGlobe.

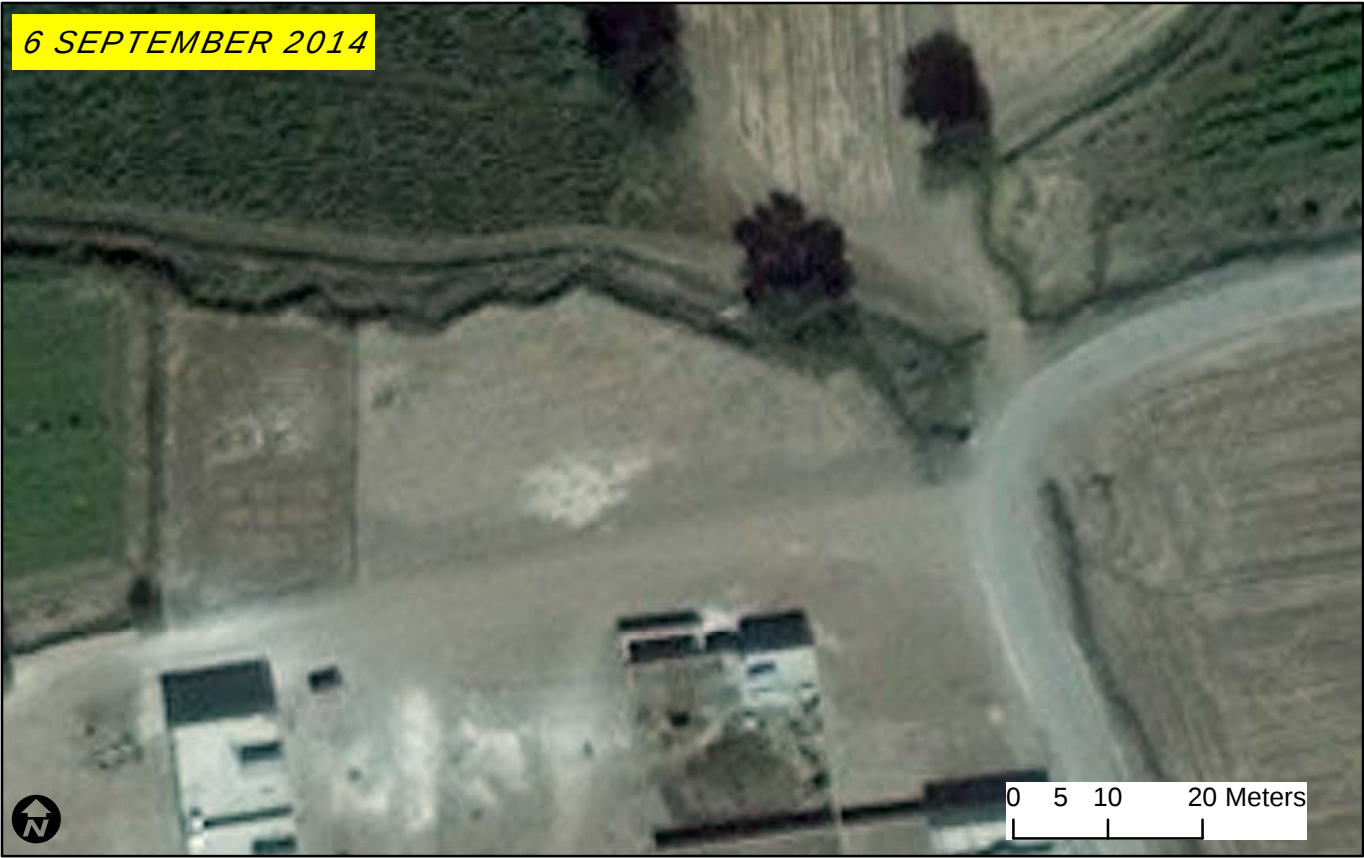
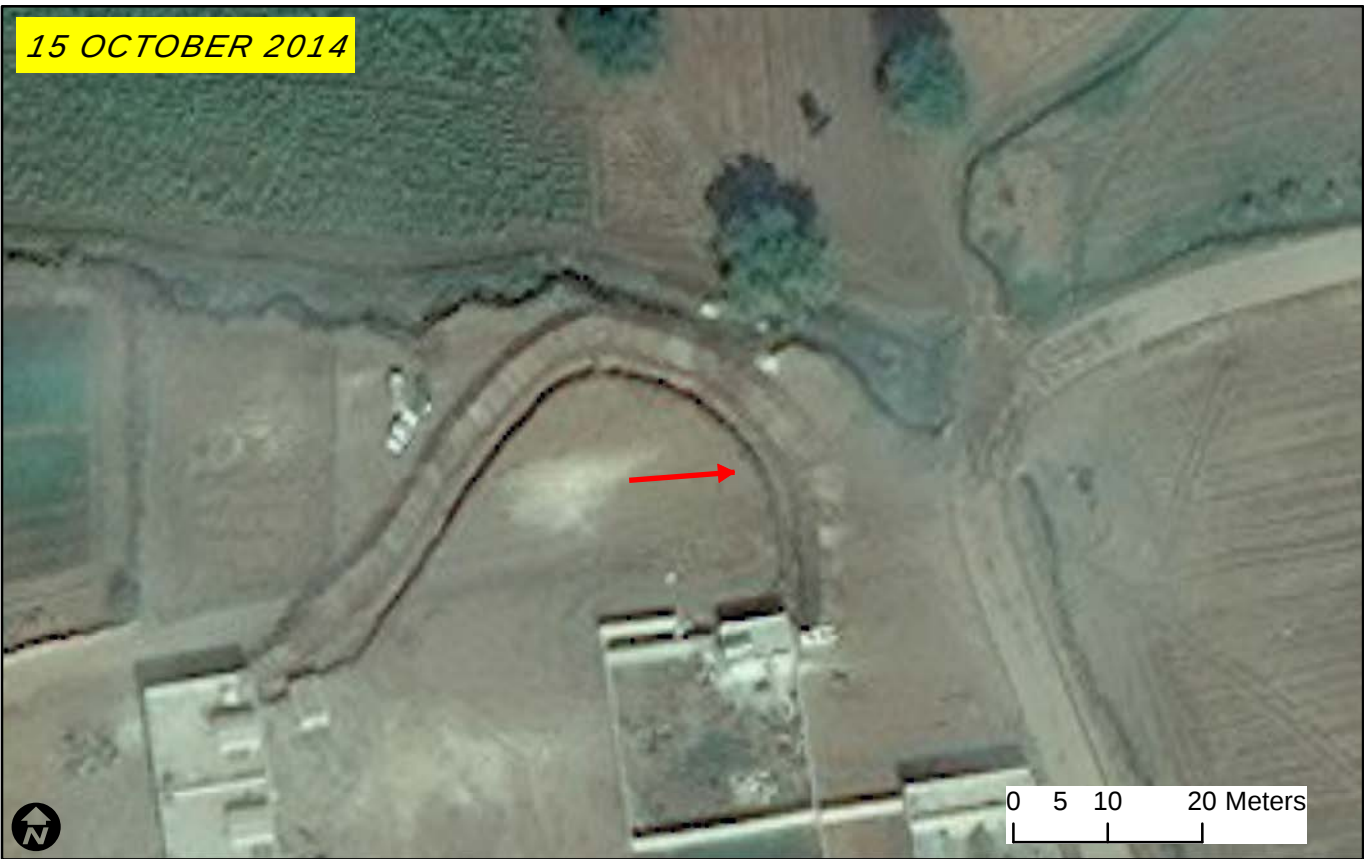
*Figure 4: Fortified fighting position*

*A fortified fighting position is visible inside of the town (red arrow) in the proximity of an access road with restricted access. Images copyright 2014 DigitalGlobe.*

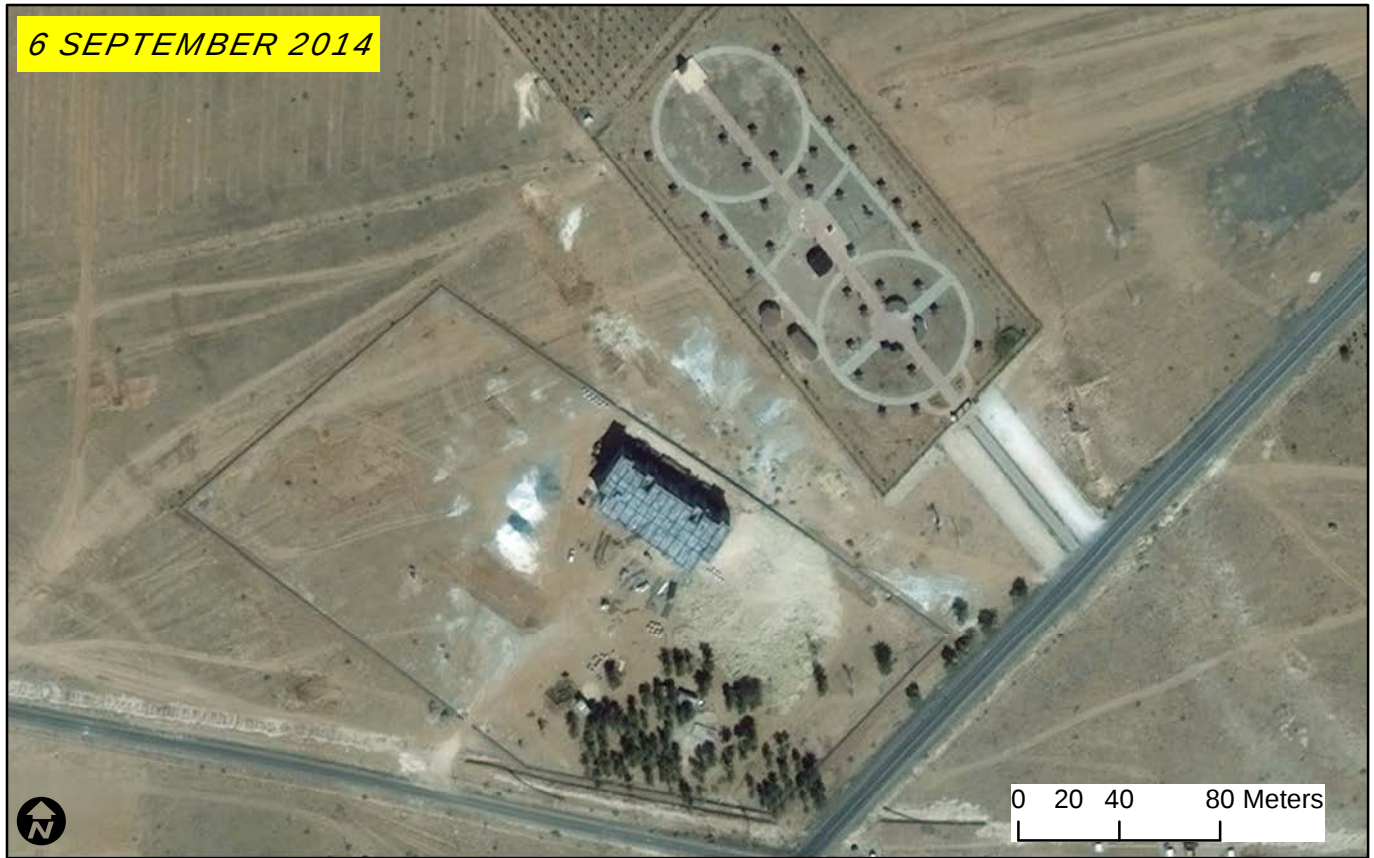
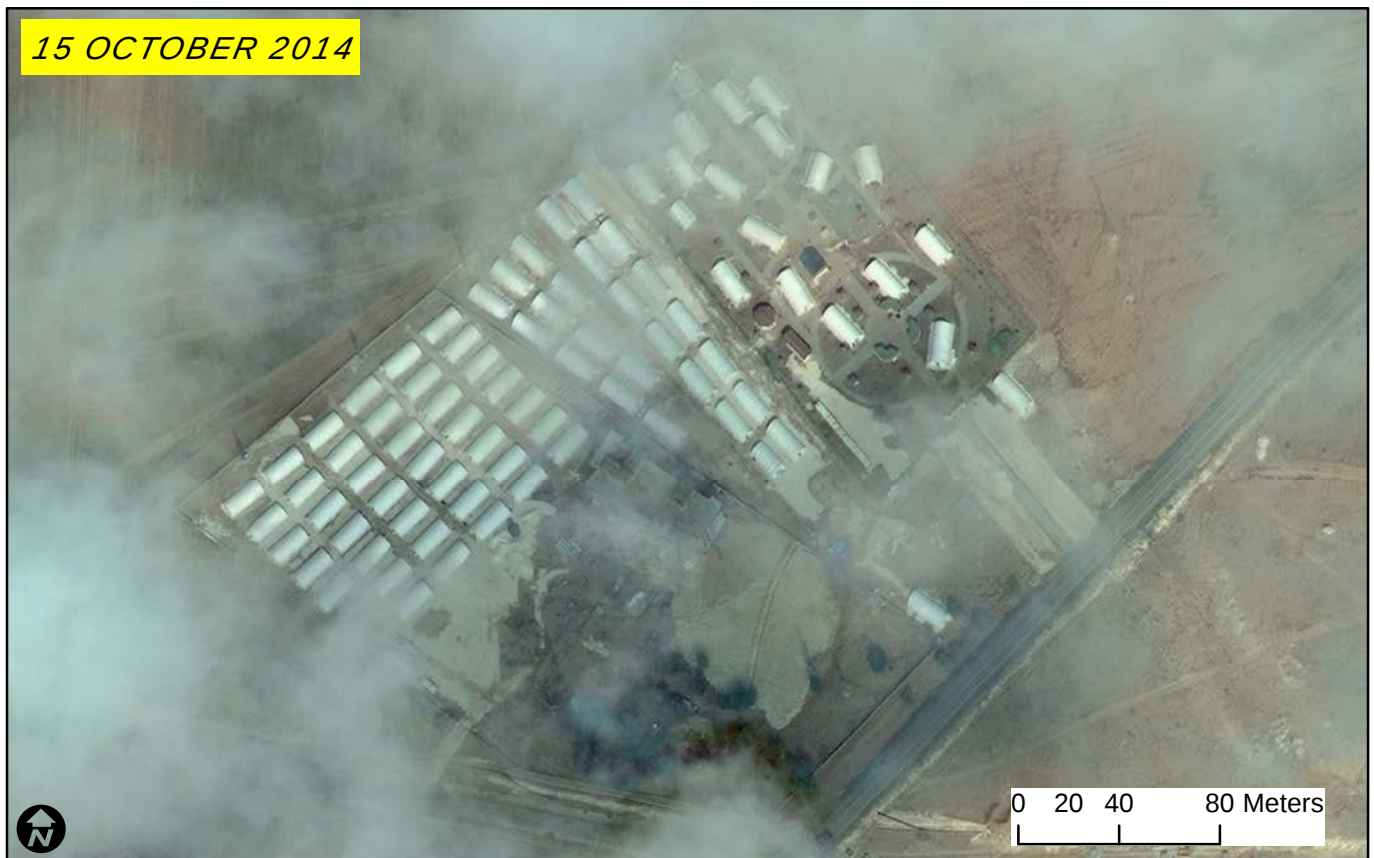
*Figure 6: Newly constructed refugee settlement*

Close to the border, on the Turkish side a refugee camp has been created in order to accommodate increased number of refugees fleeing Kobani. Images copyright 2014 DigitalGlobe.
