UNOSAT

Impact of the 2014 Conflict in the Gaza Strip

UNOSAT Satellite Derived
Geospatial Analysis

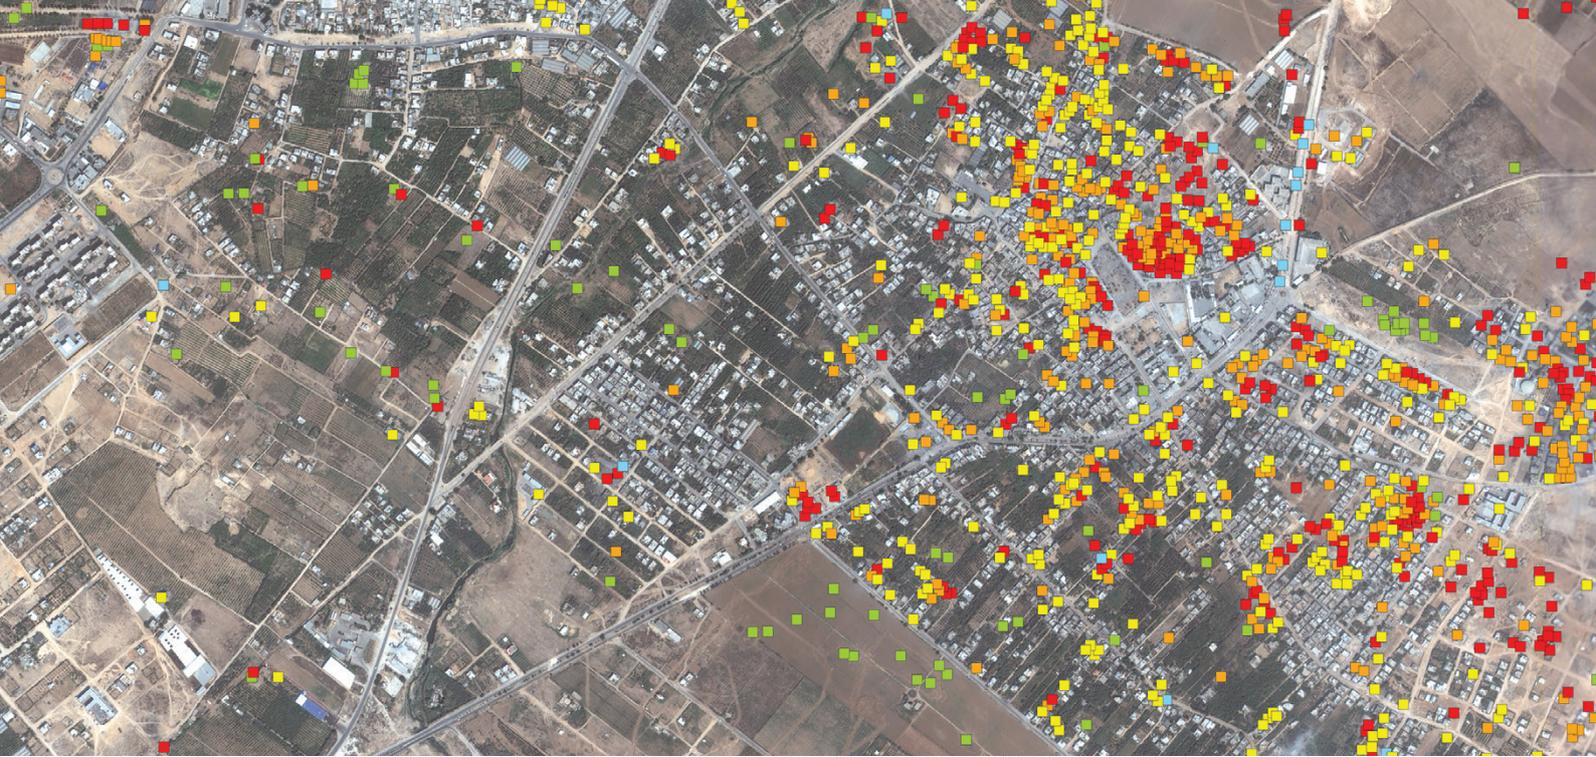
UNOSAT DAMAGE ASSESSMENT:

The image above shows a small part of the UNOSAT damage assessment using the 28 August 2014 imagery.

- Destroyed
- Severe Damage
- Moderate Damage
- Crater on Road
- Crater in Field

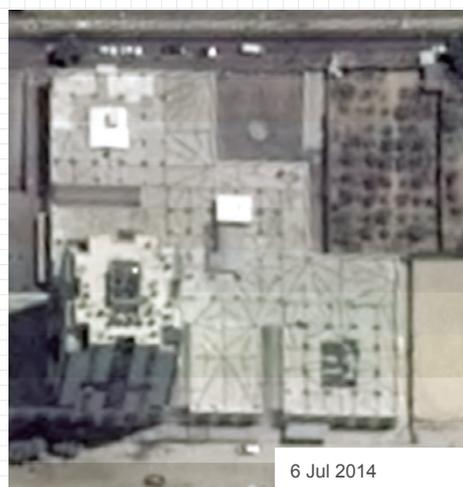
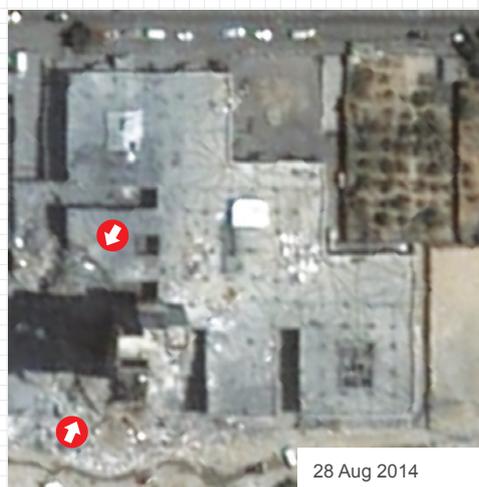
Beit Hanoun is a neighbourhood inside the North Gaza Governorate, in the northeast edge of the Gaza Strip. Imagery from 28 August 2014 as well as the UN-Asign photography show widespread damage to residential buildings across the Beit Hanoun neighbourhood. A total of 1,003 damage points were identified on imagery inside the neighbourhood boundary including 301 destroyed, 302 severely damaged and 350 moderately damaged buildings.

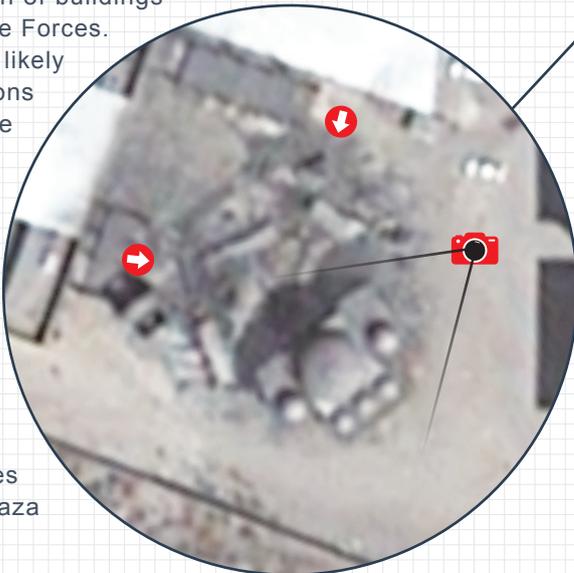
HAMZA MOSQUE, GAZA
Imagery from 28 August 2014 shows that the mosque has been severely damaged

➔ Severely damaged mosque

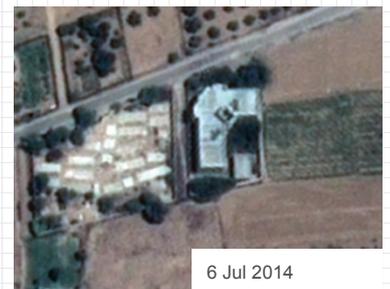
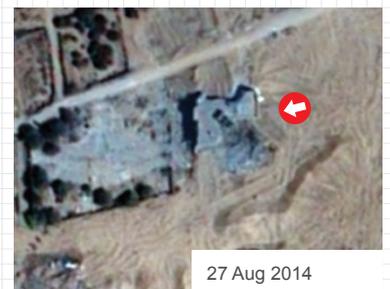
ABSSAN HEALTH CENTRE, KHAN YOUNIS

Imagery from 27 August 2014 shows severe damage to the main health center building. The southern wing of the building is completely destroyed and the remaining northern wing of the building is severely damaged.

Visibly destroyed buildings

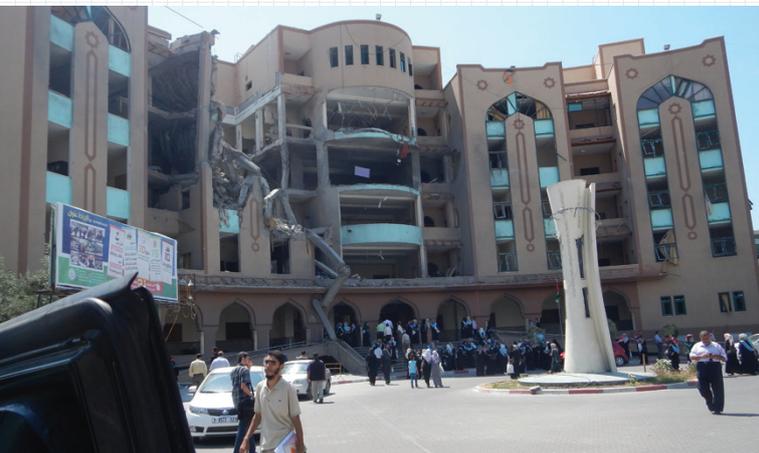
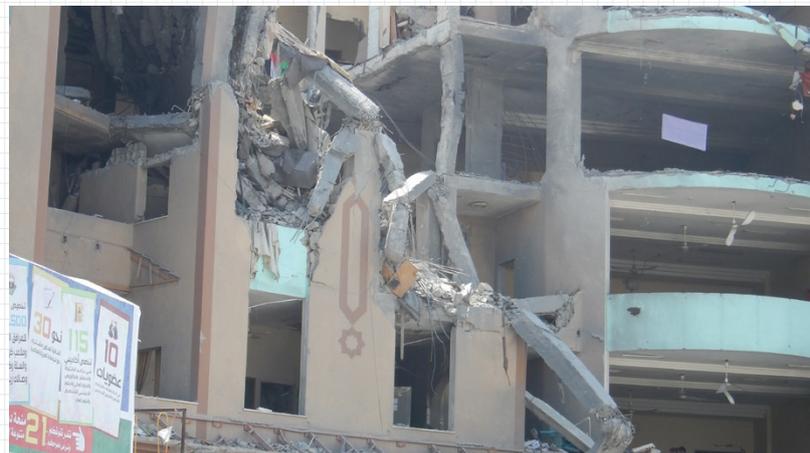
Imagery from 28 August 2014 shows severe damage to the main administration building of The Islamic University of Gaza, as highlighted on the image above and as seen on the UN-Assign pictures below, supporting reports from OCHA on 3 August 2014 stating that several buildings of the Islamic University in Gaza City sustained severe damage and are in need of repair.

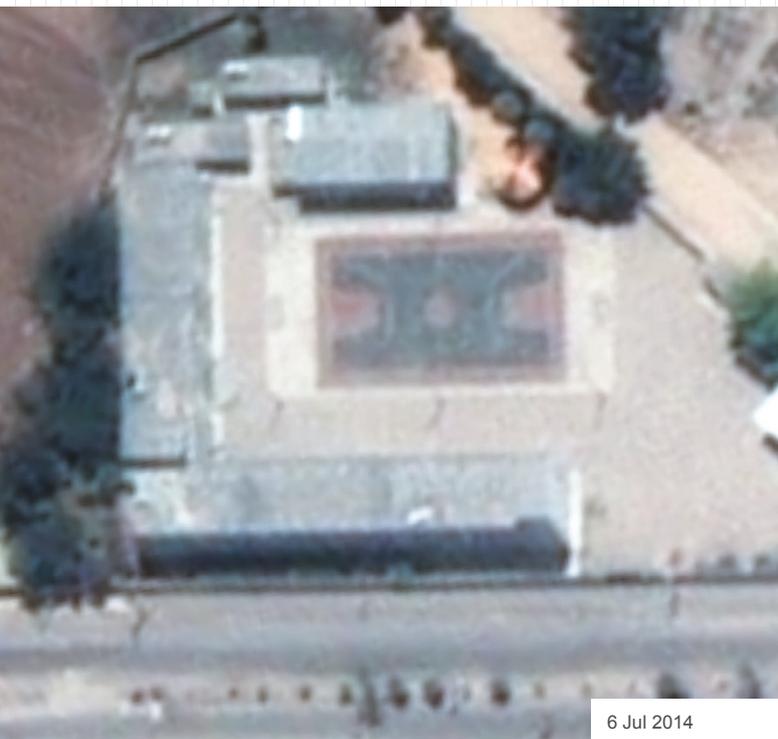
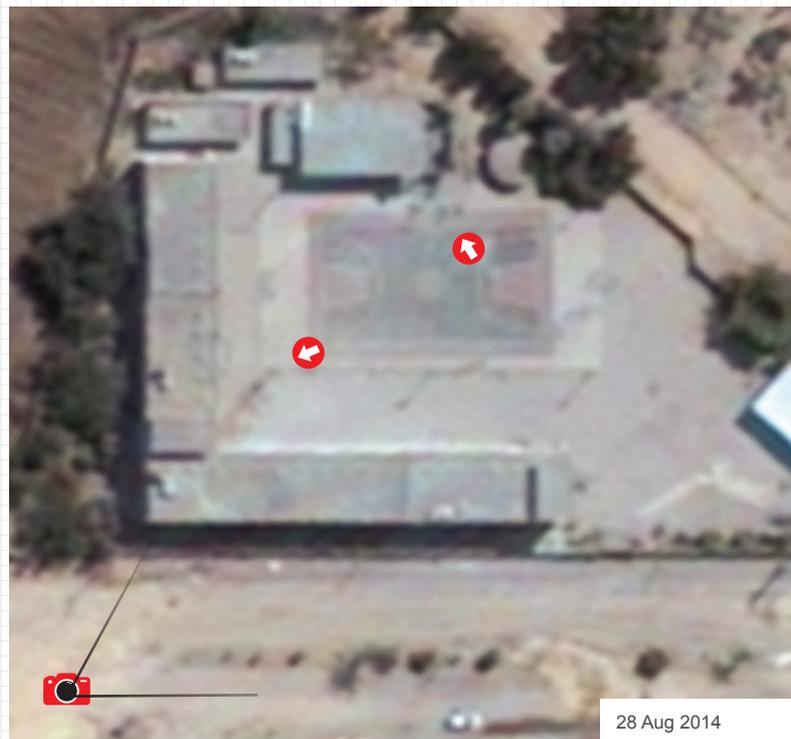
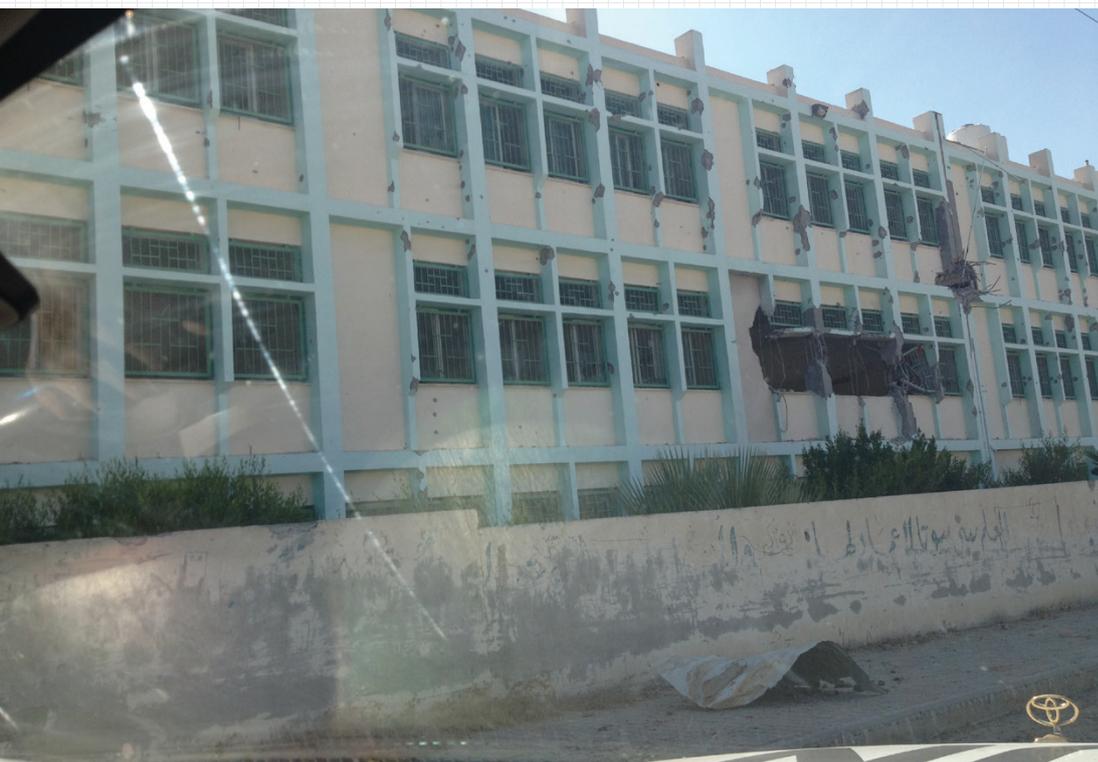
BEIT HANOUN SECONDARY SCHOOL FOR BOYS, NORTH GAZA

Sample images on these pages indicate significant combat activities in proximity to educational facilities. For example, the image showing the Beit Hanoun Secondary School for Boys indicates multiple debris areas around the school. Dirt spread across the road, and in piles in some areas, was likely one or more ad-hoc road blocks which were pushed aside by the IDF. Multiple buildings nearby are clearly destroyed, debris next to the school and some indentation of the school facade indicate damage. However, the Beit Hanoun school buildings are likely repairable and will not require complete reconstruction.

Imagery from 28 August 2014 shows possible moderate damage to the north section of the Beit Hanoun Secondary School for Boys building corroborated by UN-Assign ground photos taken 3 September 2014 and substantiated by an UNWRA report from 25 July 2014 stating that the attack on Beit Hanoun School followed three previous incidents in just the past four days of UNRWA shelters being hit by explosive projectiles.

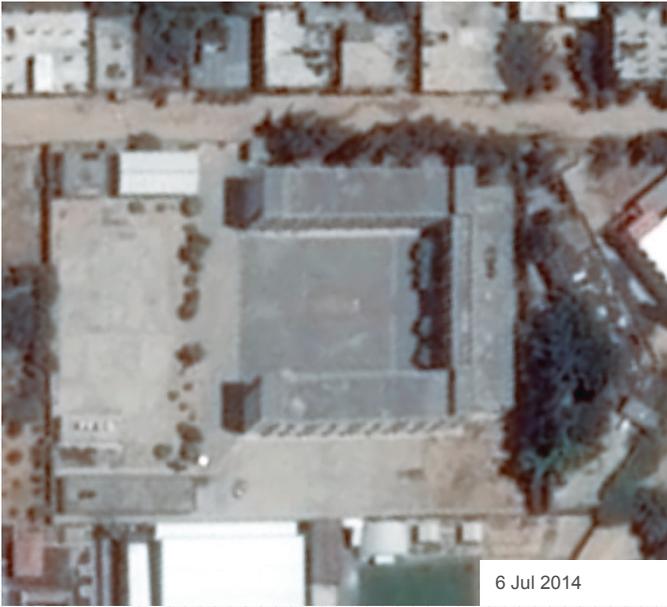
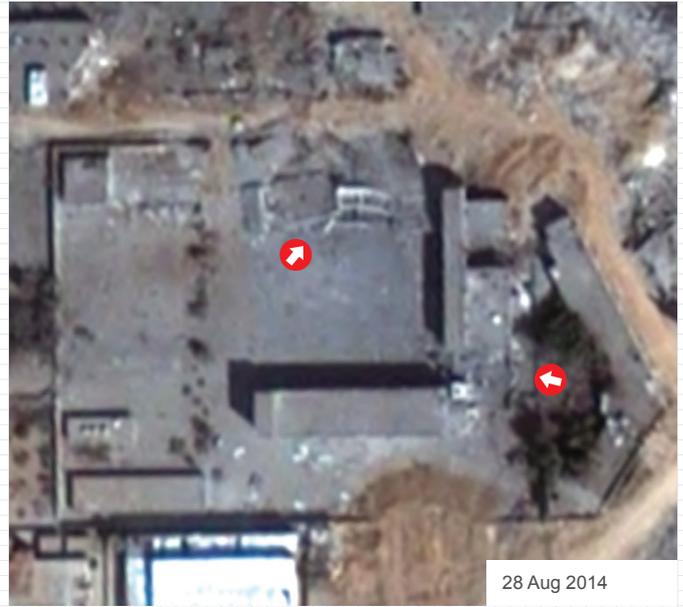
The Jamal Abd El-Nasser Secondary School was within an area razed by the IDF and thus likely experienced multiple munitions impacts from artillery, tank fire, and perhaps air strikes, completely destroying one building of the school and severely damaging others. These structures will need reconstruction after debris is cleared. Given the amount of damage in the area it is likely that even the structures remaining on the school grounds sustained significant damage and will need to be rebuilt.

Imagery from 28 August 2014 shows severe damage to the Jamal Abd El-Nasser Secondary School. Imagery shows the north wing of the school building completely destroyed and the east wing severely damaged. Additional damage to surrounding buildings and debris are visible as well.

Visibly destroyed buildings

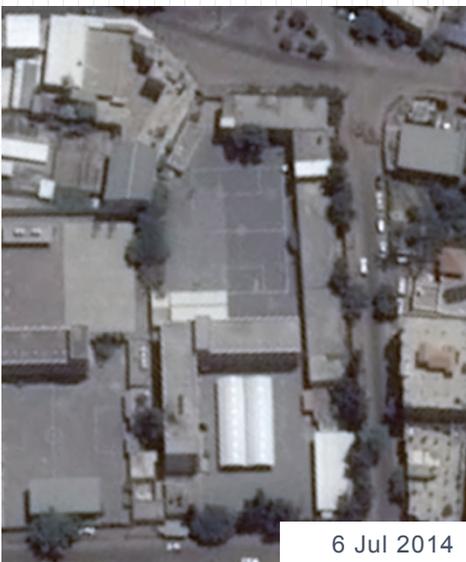
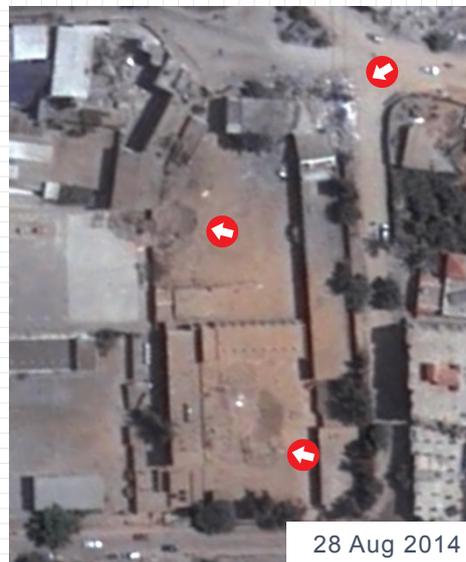
**AL-SHEJAE'IA SCHOOL,
GAZA**

The Al-Shejae'ia School was almost certainly the target of air strikes as large craters are visible on the school grounds. The munitions impacts spread debris across the school grounds and visibly damaged the northeast building. Shock waves from such explosions would have certainly caused damage to the facades and interiors of surrounding buildings but may or may not have degraded their structural integrity. While some structures certainly require demolition and reconstruction, other structures may be repairable.

Imagery from 28 August 2014 shows extensive severe damage to the male and female schools. Impact craters are clearly visible inside the school grounds and the northeast section of the school is severely damaged.

Craters and visible severe damage

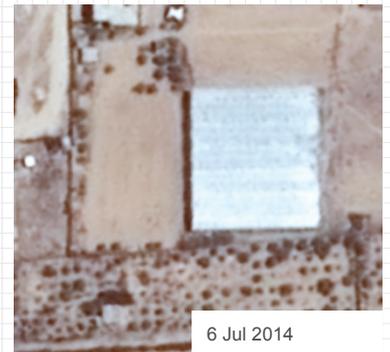
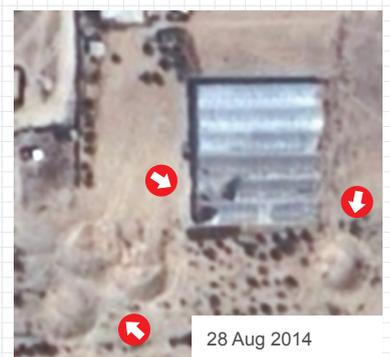
CRATER DAMAGE

Above is an example of moderate damage to a greenhouse with large craters in the close vicinity.

A total of 1,263 greenhouses were assessed to be damaged according to the most recent damage assessment using imagery from 27 and 28 August 2014. Imagery shows that 52 percent (or 657) of the total greenhouses found with some level of damage are completely destroyed (as seen on the image above), 17 percent (or 214) we found severely damaged and 31 percent (or 392) were seen with moderate damage (like the greenhouse on the left image).

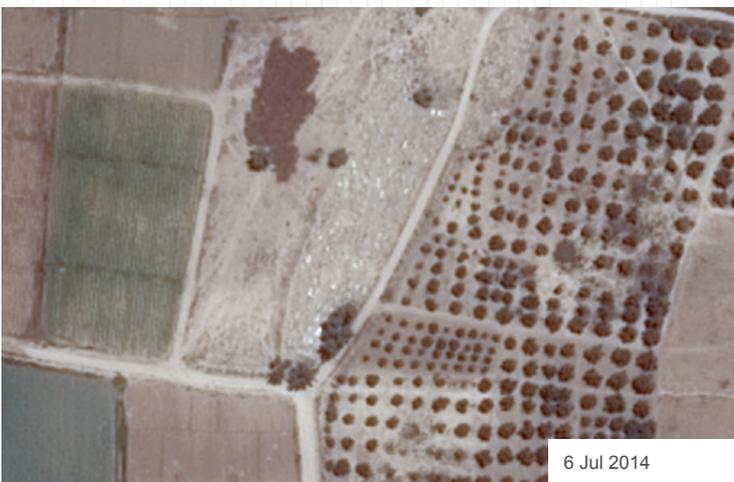
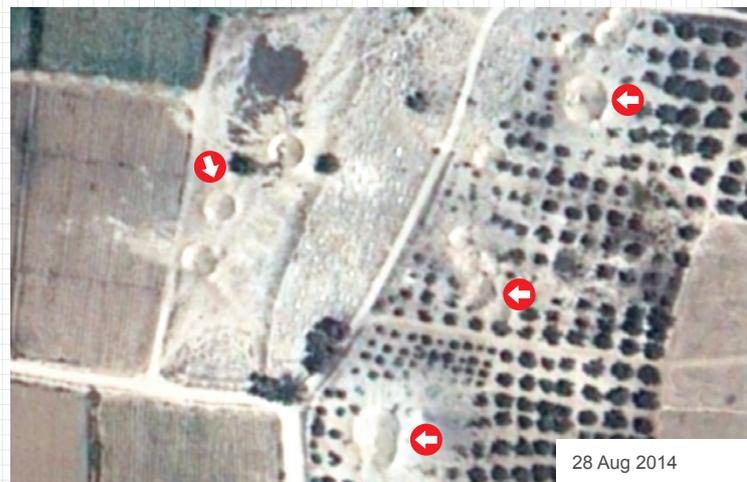
RAZED AREAS

Multiple agricultural areas of the Gaza Strip were heavily damaged during the 2014 conflict and were assessed by UNOSAT using a variety of remote sensing techniques and manual review. Agricultural areas were damaged by razing, as well as by convoys of heavy vehicles driving across them. Razing was a focused effort involving bulldozers or similar equipment and occurred throughout the Gaza Strip and especially in North Gaza and Gaza Governorates. In razed areas the topsoil was visibly scraped away by bulldozer blades in a back-and-forth pattern, resulting in a complete removal of the agricultural fields found at those locations. Heavy vehicle tracks also caused damage to agricultural areas as large numbers of armoured vehicles transited the Gaza Strip, forming new road networks in the process. In some areas they were so common that they constituted a de facto razing of the agricultural fields.
