SITUATION UPDATE FOR KOBANI, ALEPPO GOVERNORATE, SYRIAN ARAB REPUBLIC

Based on Satellite Imagery Acquired 1 & 6 November 2014

Figure 1: Destroyed and damaged structures in Kobani

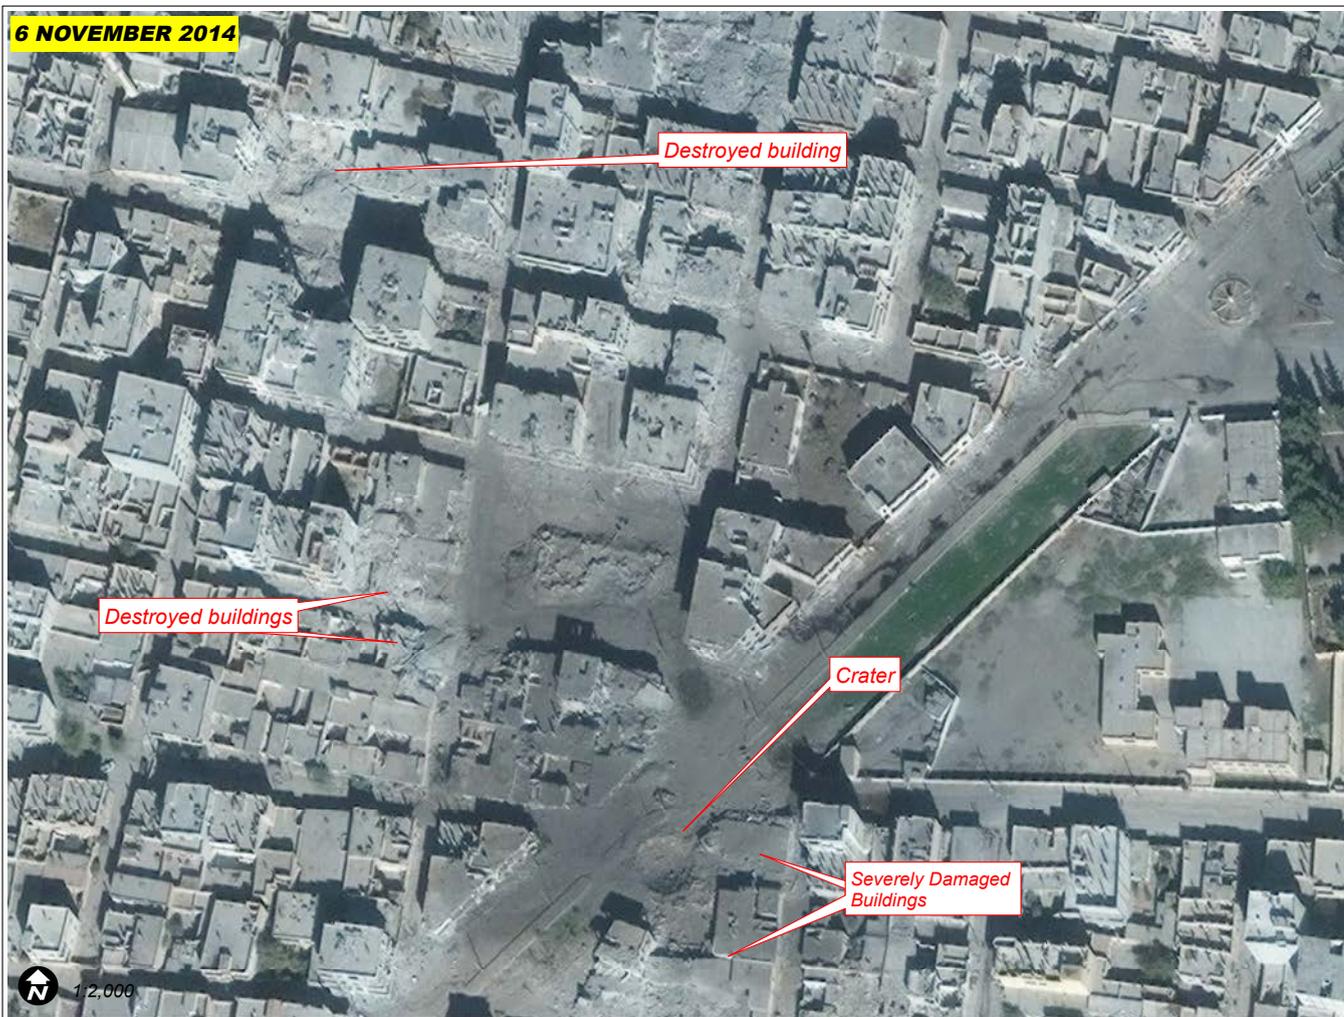
The image shows destruction in a portion of the city of Kobani. Several buildings appear destroyed or heavily damaged; a large crater is also visible on the side of one of Kobani's main streets.

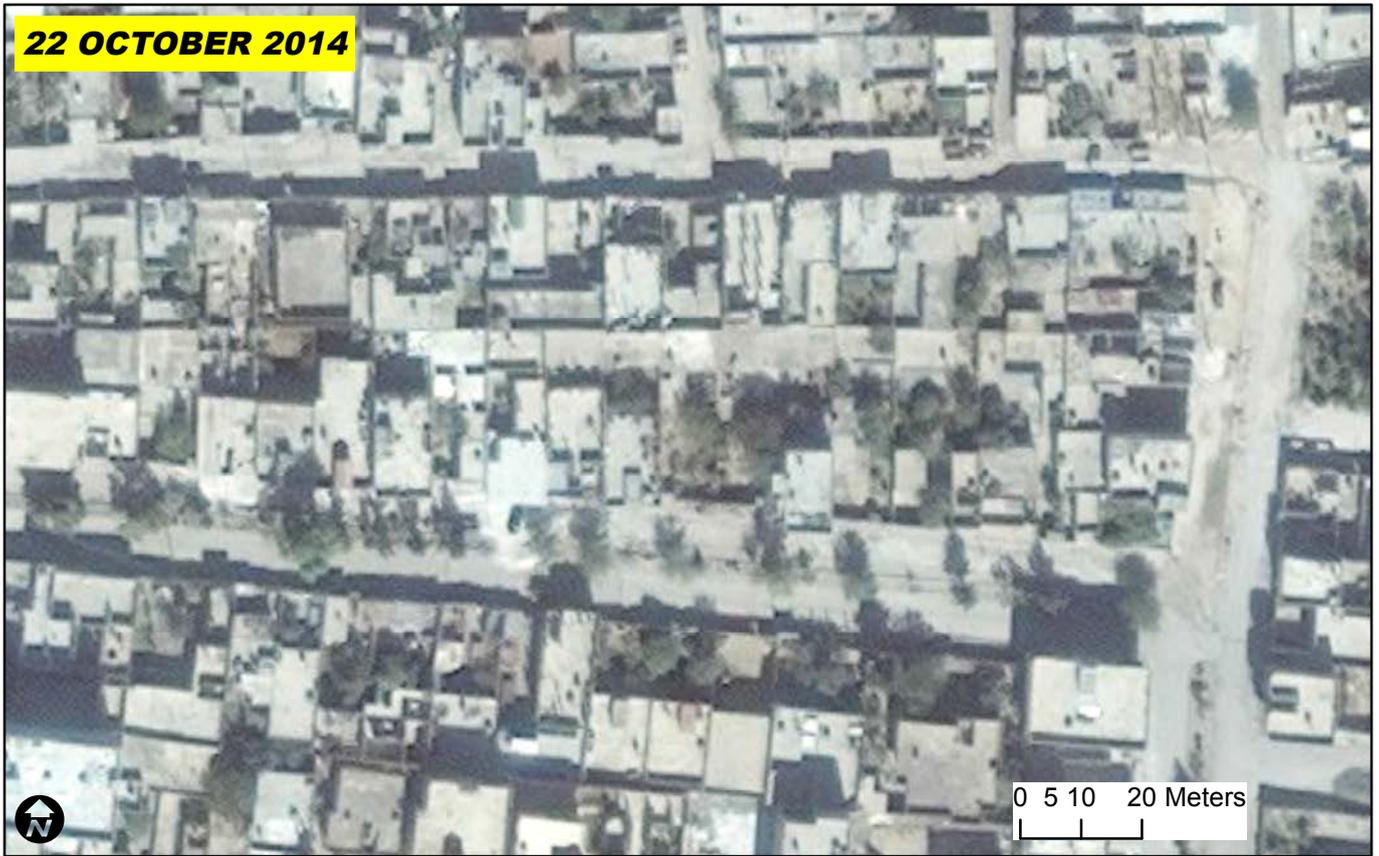
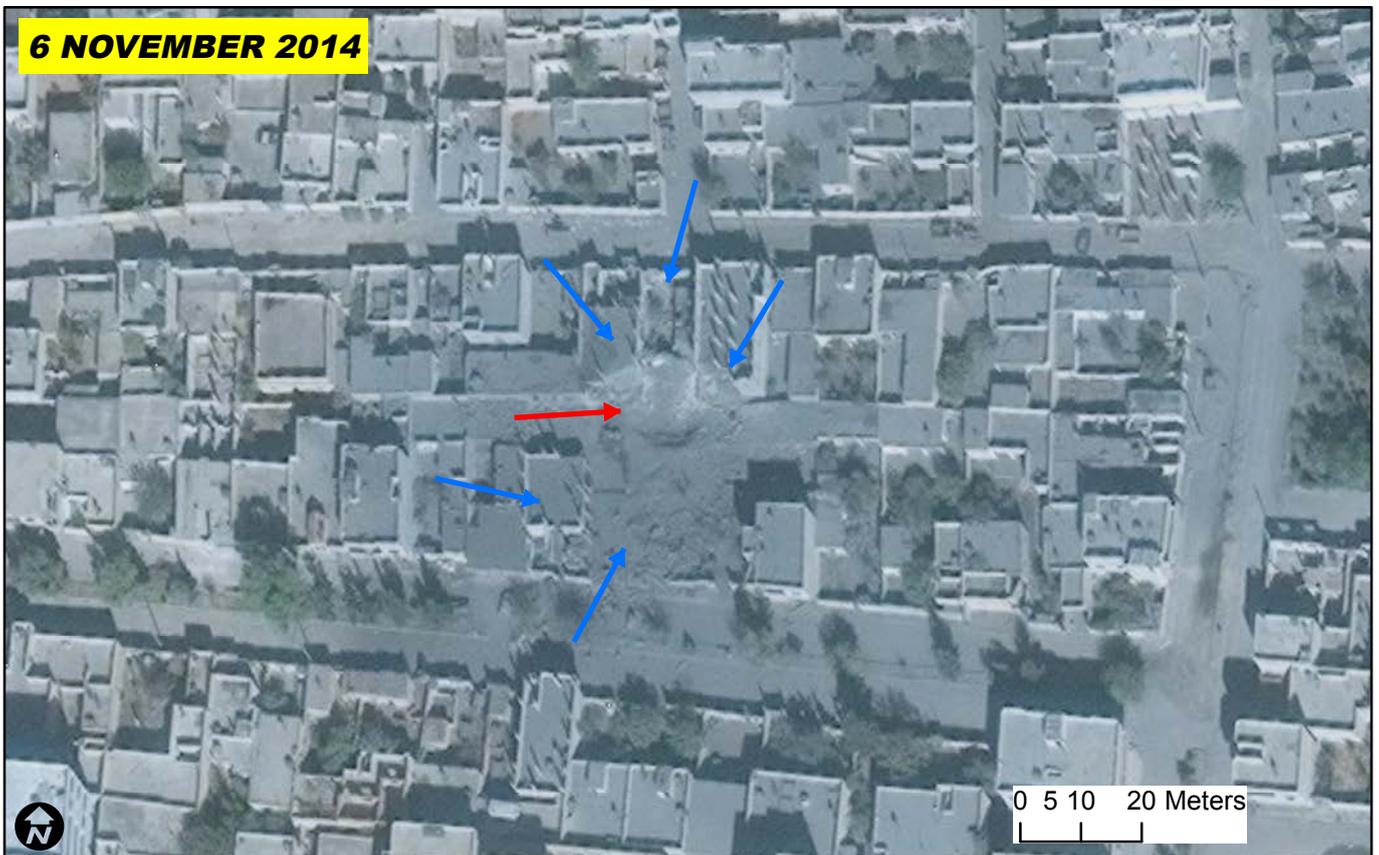
The figure shows a portion of the eastern part of the town of Kobani where a large crater is visible (red arrow) and several buildings around it are destroyed or severely damaged (blue arrows), possibly by an air strike. Images copyright 2014 DigitalGlobe.

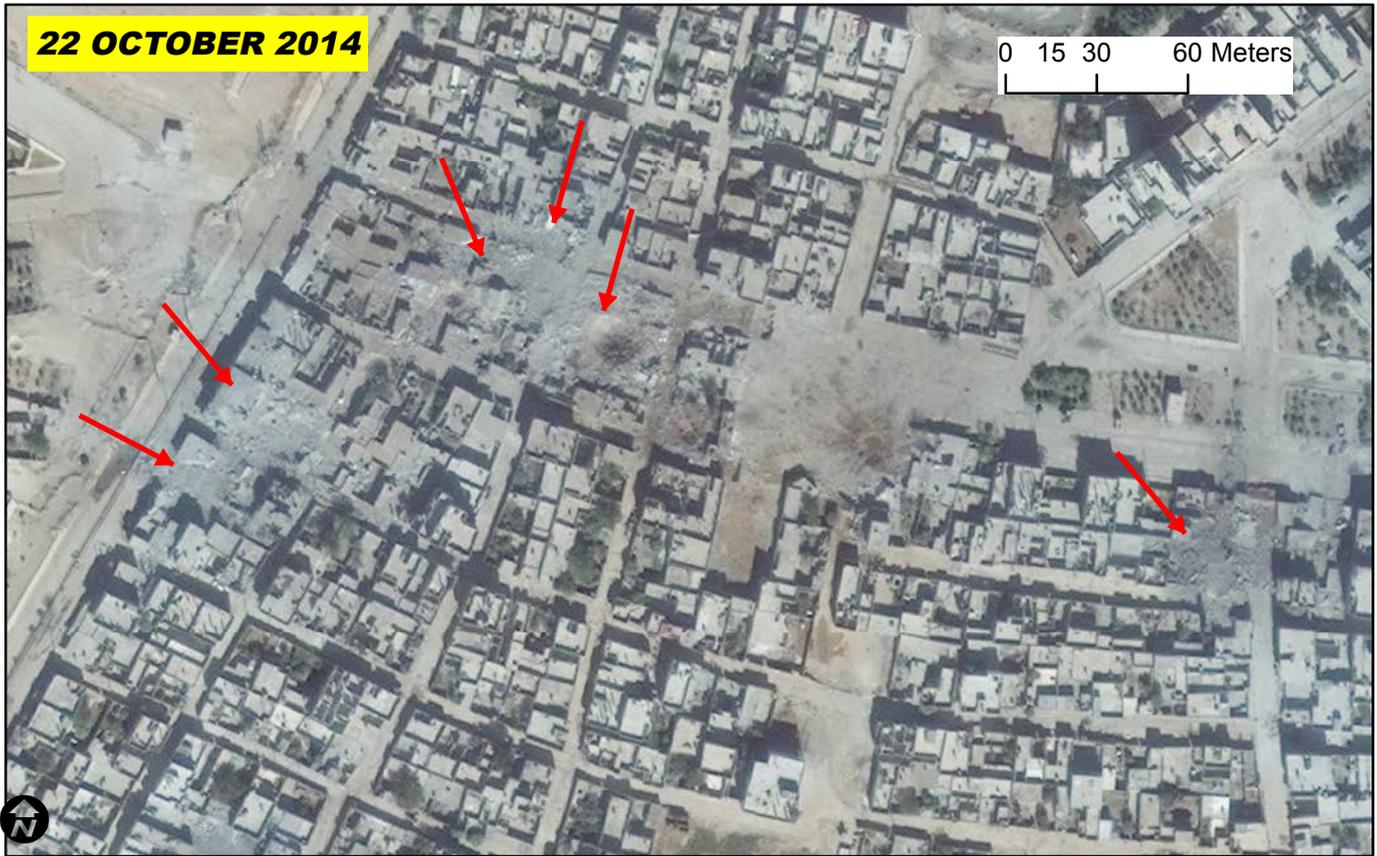
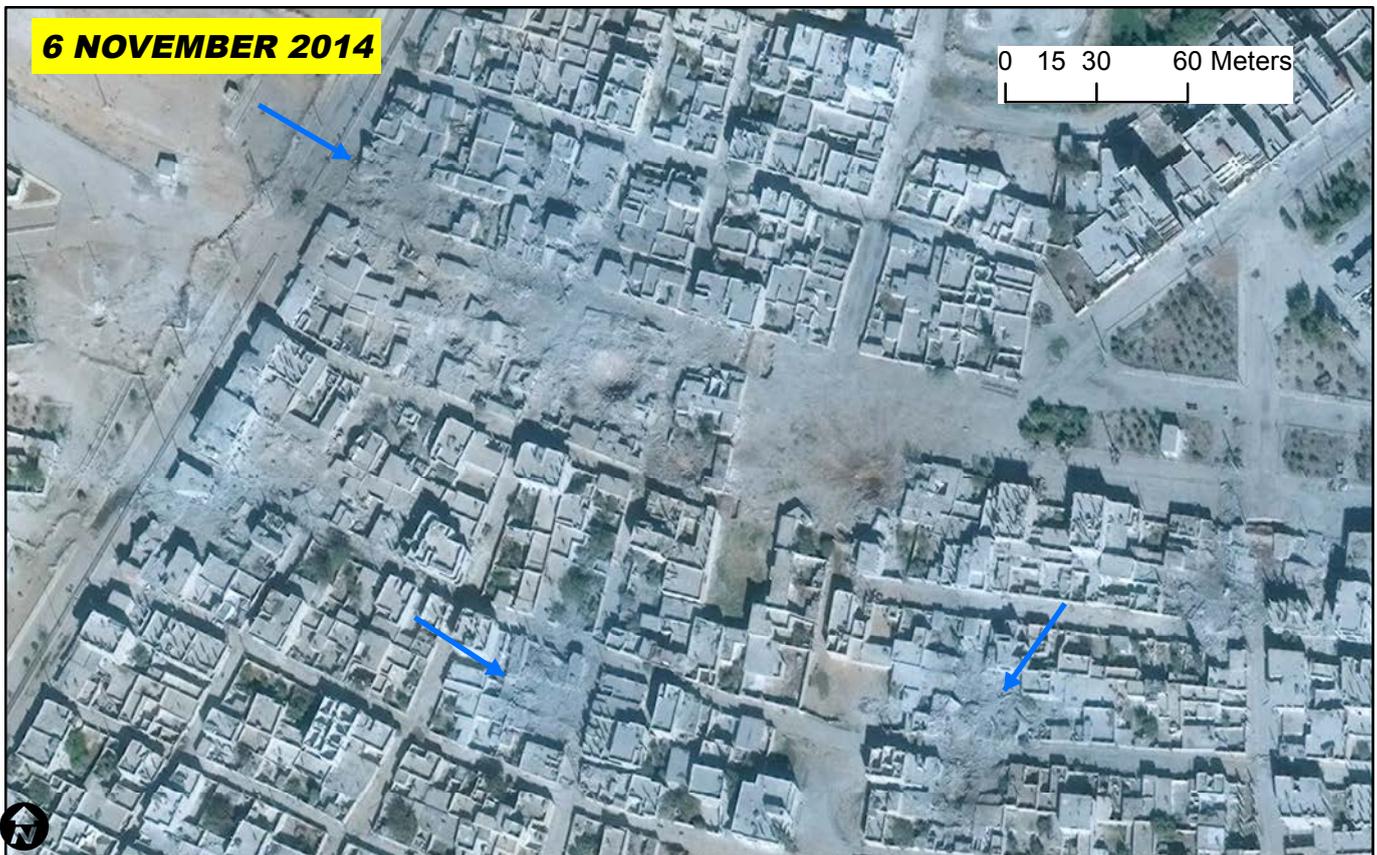
Figure 2: Destroyed and damaged structures in Kobani

The figure shows a portion of the northern part of the town of Kobani that was heavily damaged by 22 October as imagery shows multiple buildings destroyed or severely damaged (red arrows). New imagery collected on 6 November shows that bombardments have continued over the area since 22 October and have caused the destruction of several structures (blue arrows). Images copyright 2014 DigitalGlobe.

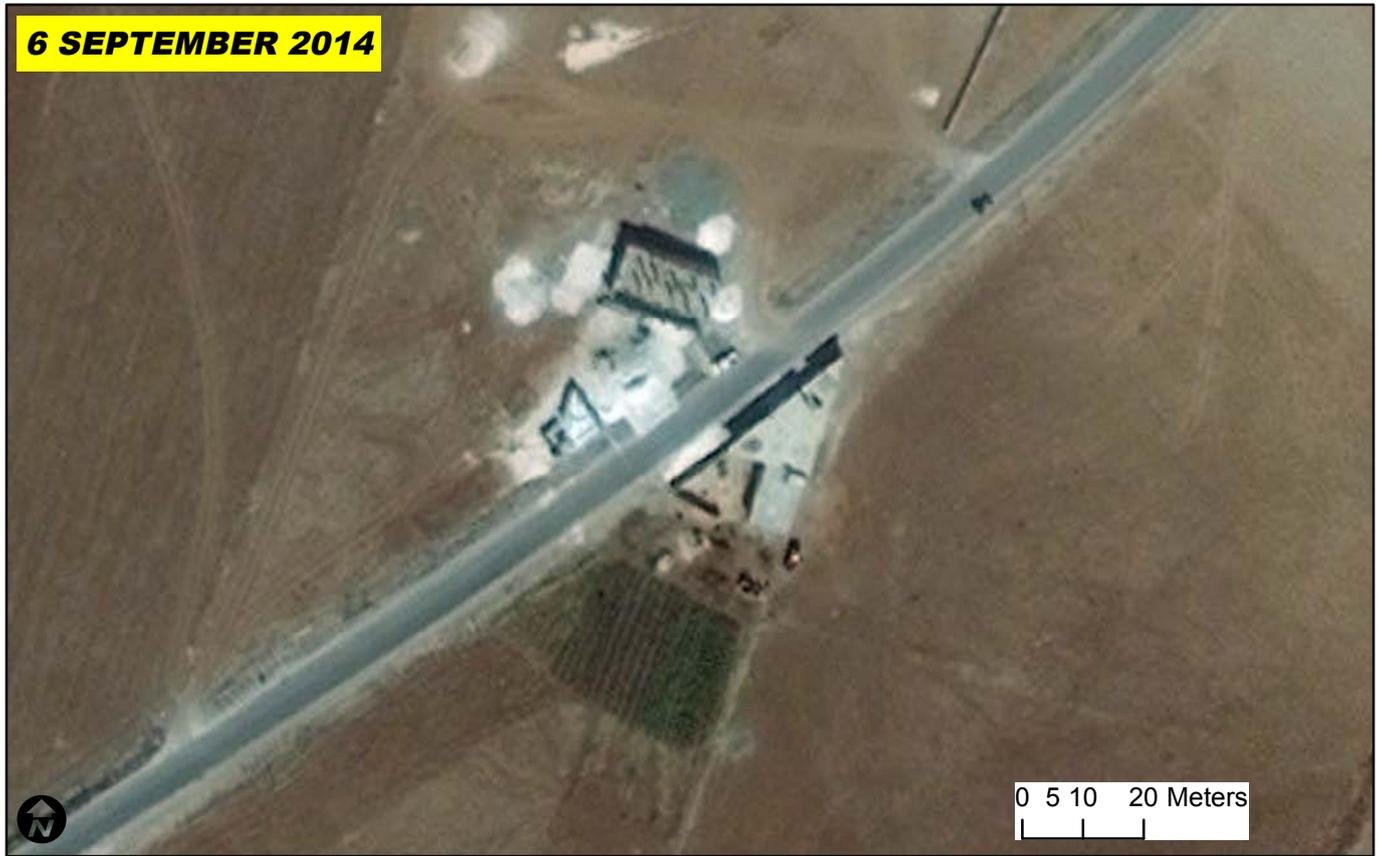
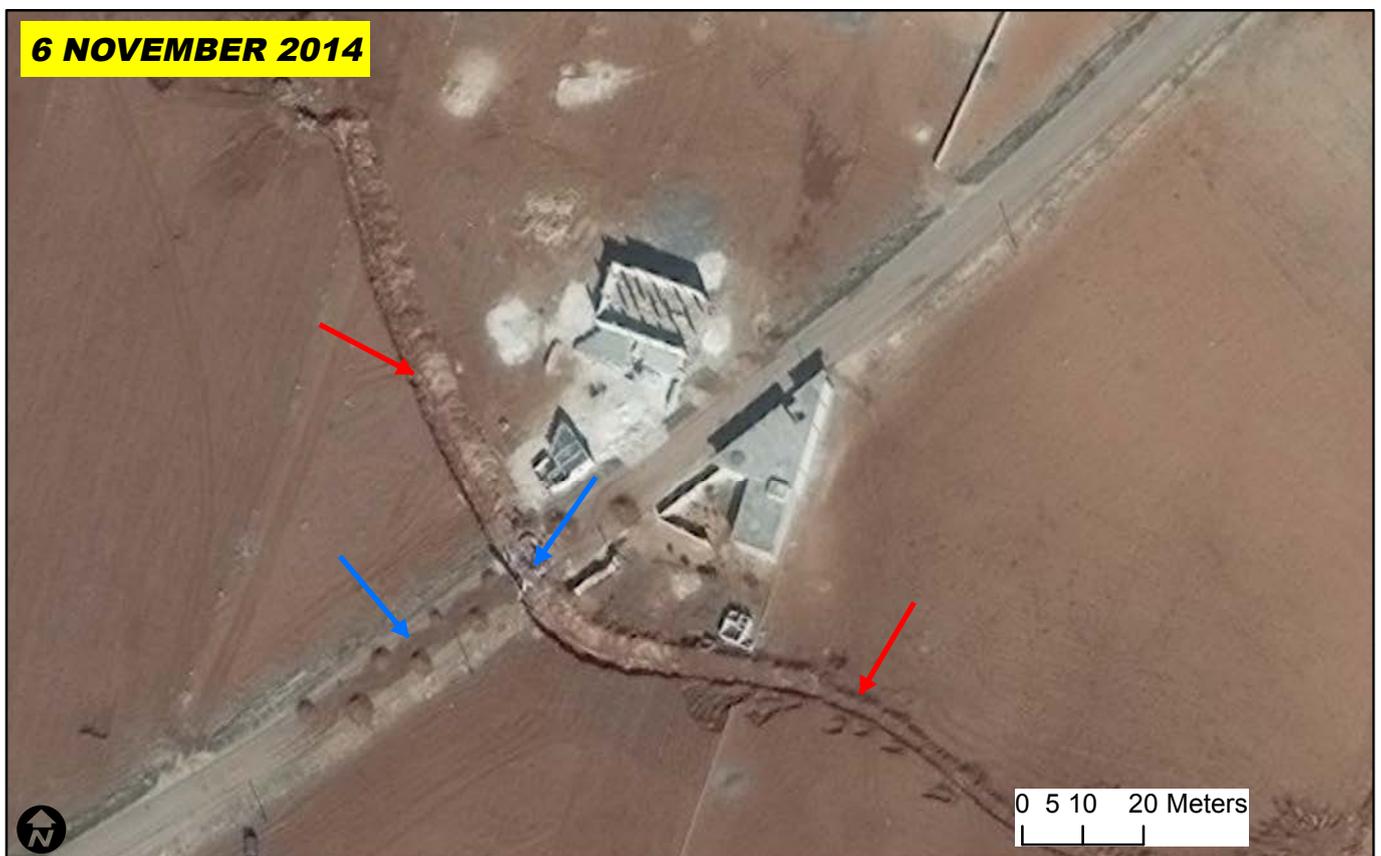
Figure 3: Access control points

UNOSAT analysis also indicates ongoing humanitarian access constraints as imagery shows roadblocks and control points placed along the roads leading to Kobane (blue arrows). A probable fortified fighting line is also visible in this figure (red arrows). Images copyright 2014 DigitalGlobe.

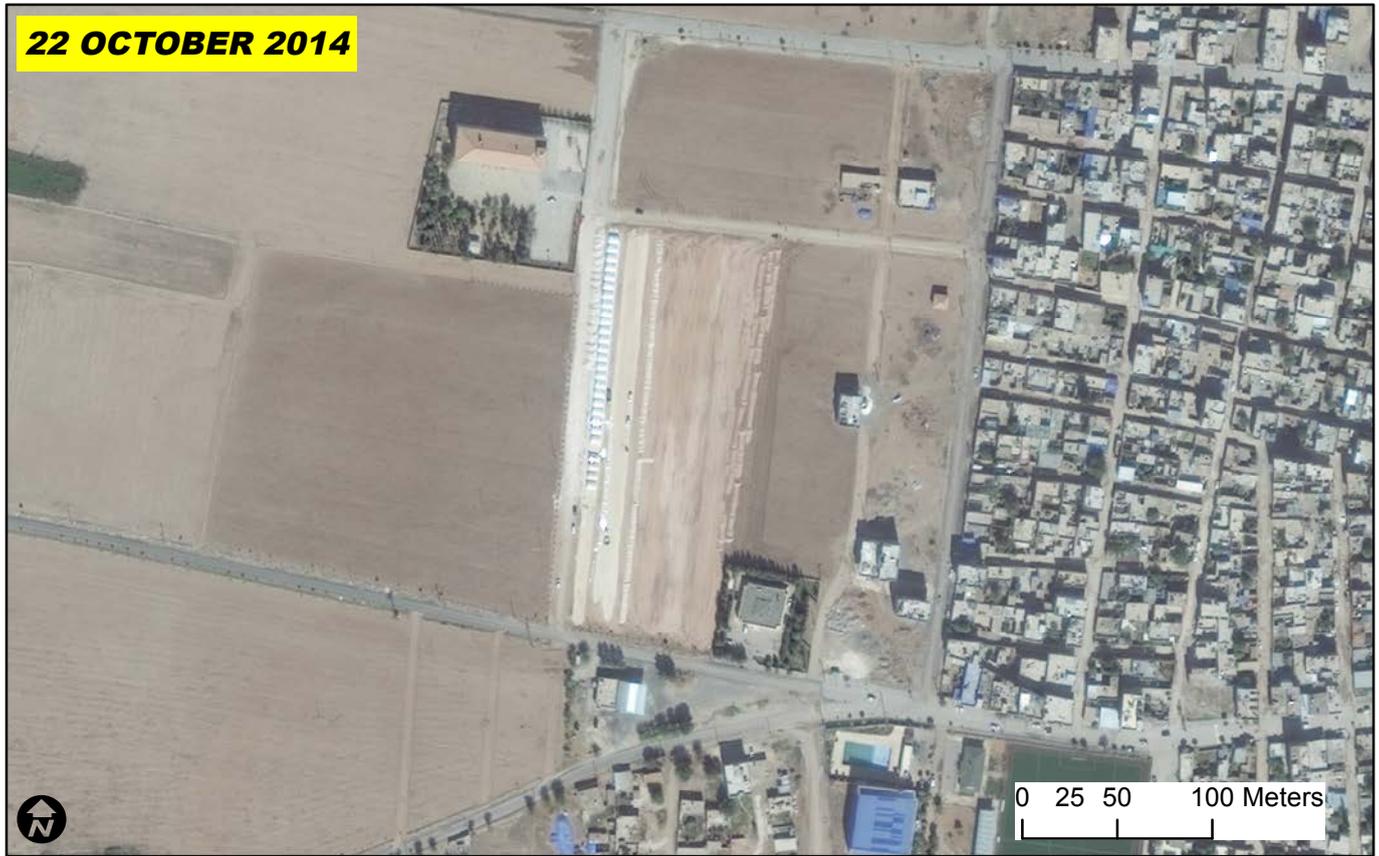
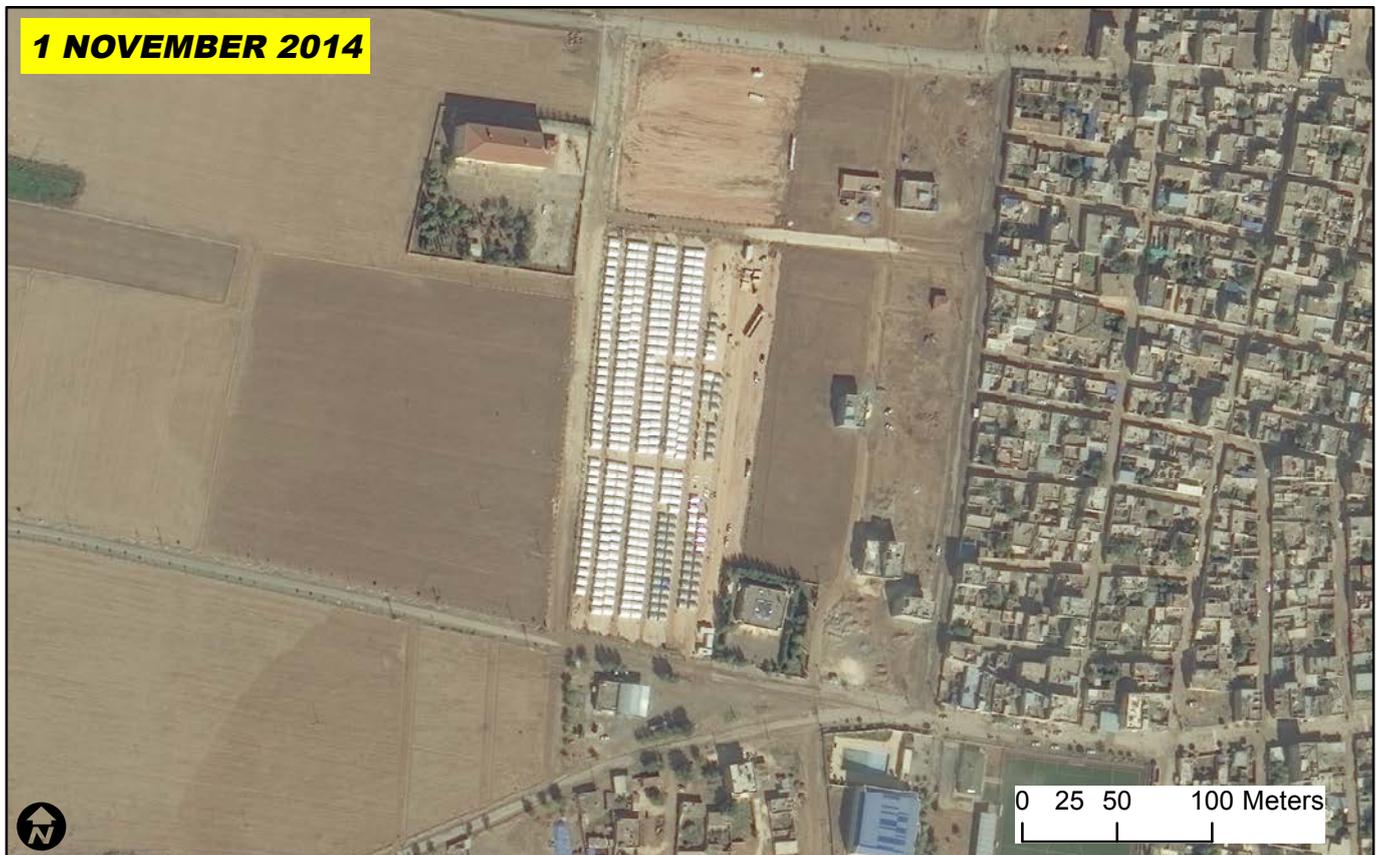
Figure 4: Displaced civilians

Satellite imagery collected 22 October over the Turkish town of Suruc (11 km north east of Kobane) shows a total of 834 tent shelters distributed in 4 different refugee camps. This figure shows an additional refugee camp that is under construction and as of 1 November it has been occupied by a total of 287 new tent shelters. This means an increase of 32 % in the number of tent shelters in Suruc between 22 October and 1 November. Images copyright 2014 DigitalGlobe.
