# LIBYA

## DERNA CITY, DERNÄ GOVERNORATE, EAST PROVINCE

IMAGERY ANALYSIS: 13/09/2023 PUBLISHED 14/09/2023 V1

### Flood impact assessment in Derna City centre, East Province, Libya

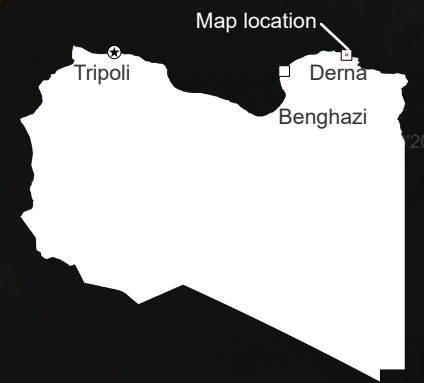
BRIDGES  
DESTROYED  
3

BUILDINGS EXPOSED TO  
RUSHING FLOODWATERS  
2,217  
WITHIN THE  
CITY OF DERNÄ  
886  
WITHIN THE  
MAP EXTENT

This map illustrates satellite-detected flood extent in the centre of Derna (Libya) as observed from a Pléiades imagery acquired on 13 September 2023 at 13:39 local time after the passage of the Mediterranean tropical-like cyclone Daniel. Extensive damage and destructions are observed in the city centre and the port area. 2217 buildings were affected by the rushing floodwaters in Derna and 886 in this sector of the city.
